ZOË KELIHER  
Sr. Air Safety Investigator  
Office of Aviation Safety – Western Pacific Region

██████████ (FEDERAL AVIATION ADMINISTRATION INSPECTOR)

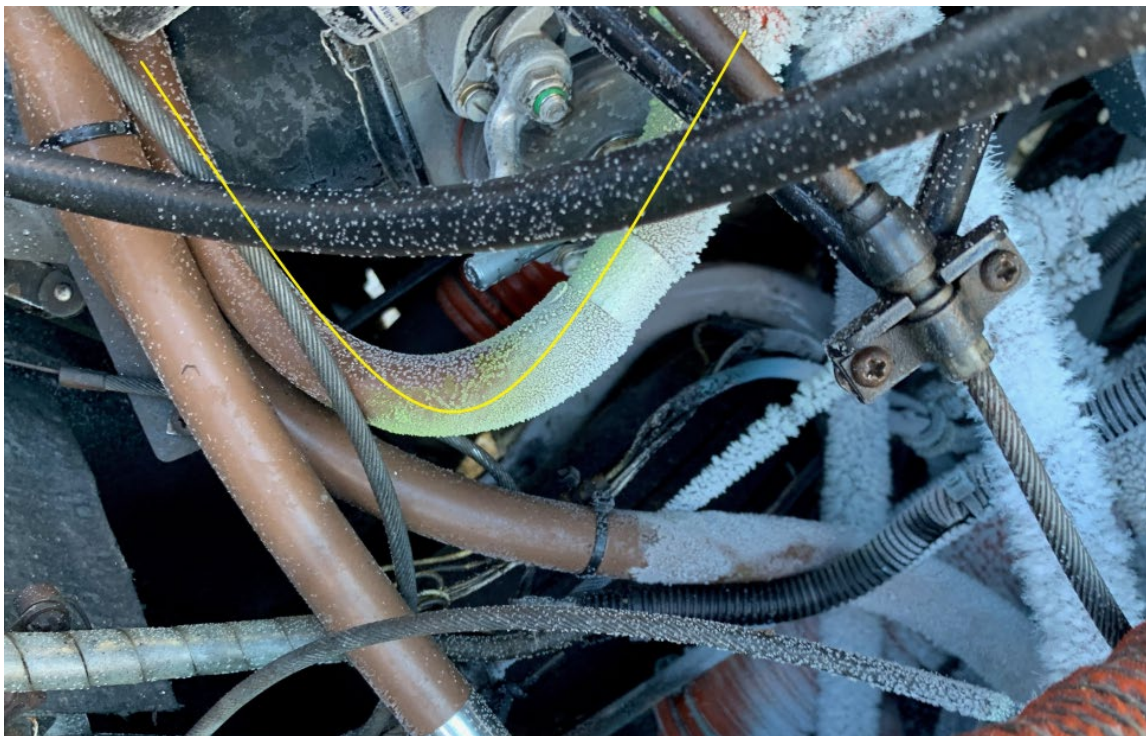
Mr. ██████████ stated that he examined N55641 on 11/25/2024 in Gillette, Wyoming (GCC). He stated that after removing the engine cowling, he observed the flexible fuel line that runs from the firewall to the engine-driven fuel pump. He stated that the B-nut securing the line at the pump inlet was loose and could be turned approximately one-half turn by hand before the fitting came off. He stated that there was visible fuel staining and spray residue at the pump inlet area. He stated that the fuel line routing showed marks consistent with prior rubbing near the nose-gear area. Mr. Hanson stated that, based on these observations, the engine's loss of power was consistent with fuel starvation due to the loose pump-inlet fitting allowing air ingestion or interrupting normal fuel delivery.

Figure 1: Fuel line showing fuel spray

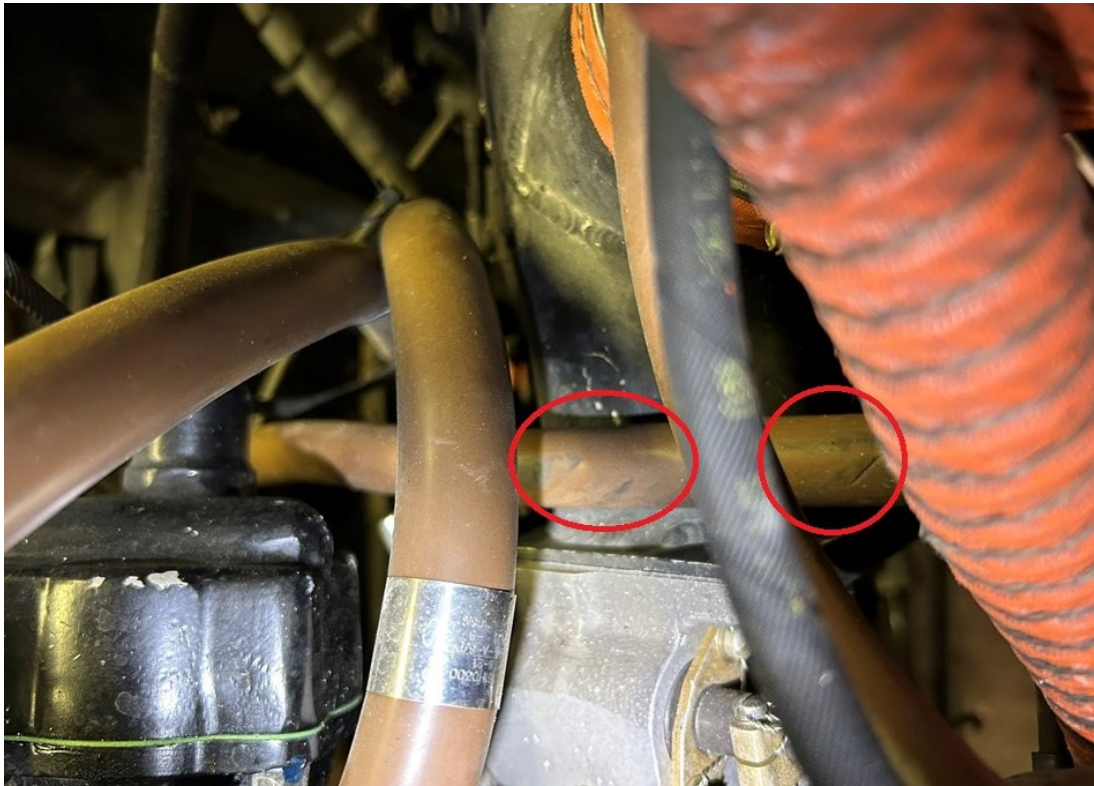
*Figure 2: Rub marks on hose*

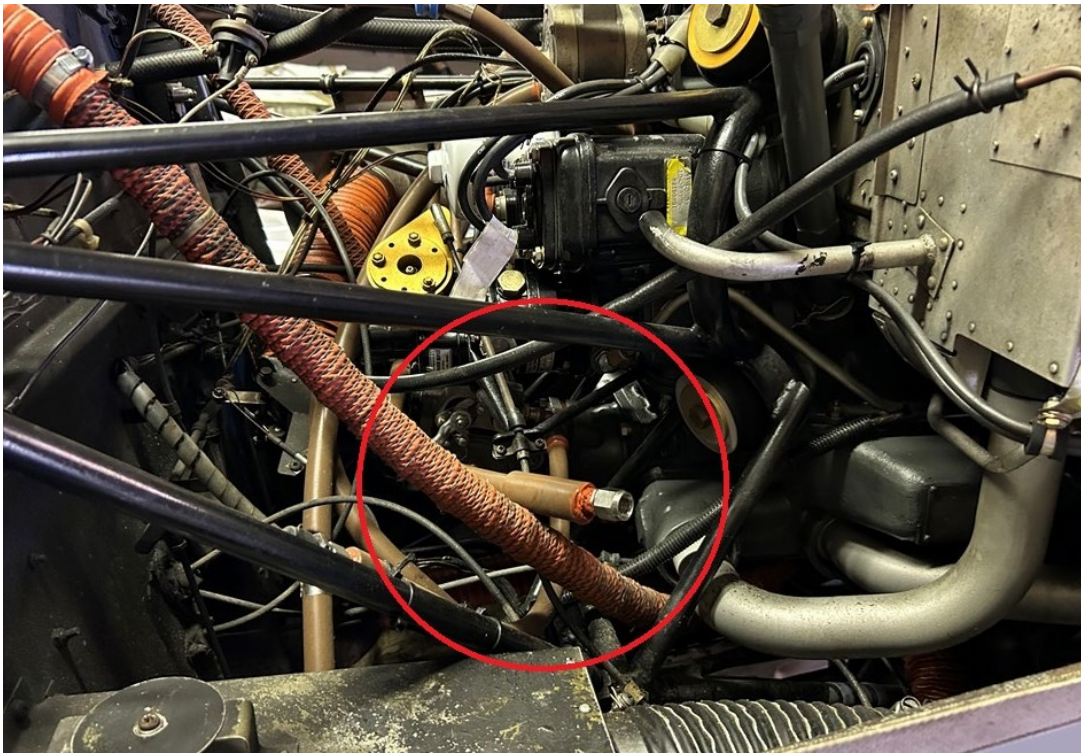
*Figure 3: Hose after loosened*

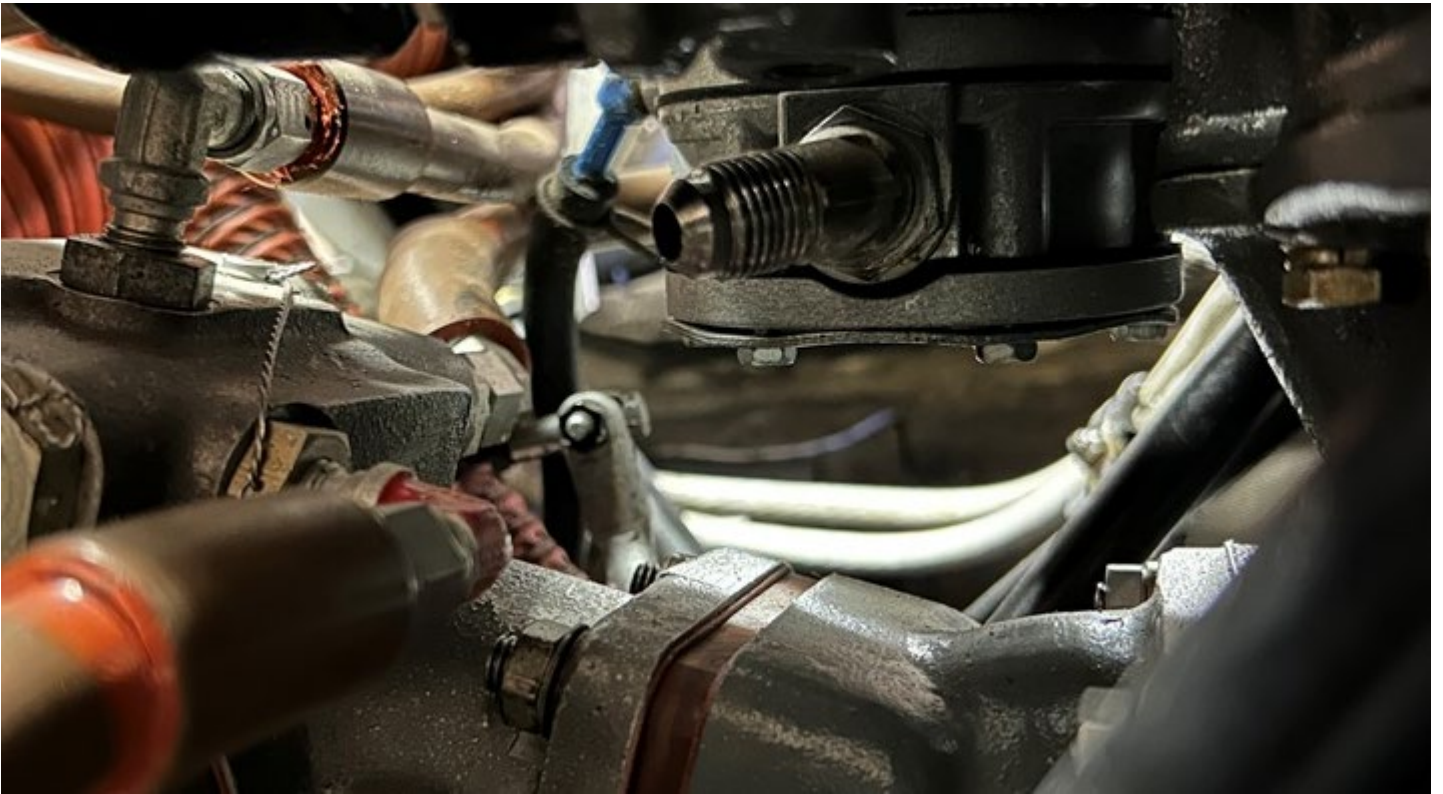
*Figure 4: Inlet to pump*
