# National Transportation Safety Board

WPR25LA053

## **ENGINE EXAMINATION**

Location: Spokane, Washington  
Date: December 2, 2024  
Time: 1530 Pacific daylight time  
Airplane 1: N29GA, Gulfstream AM CORP COMM DIV690D

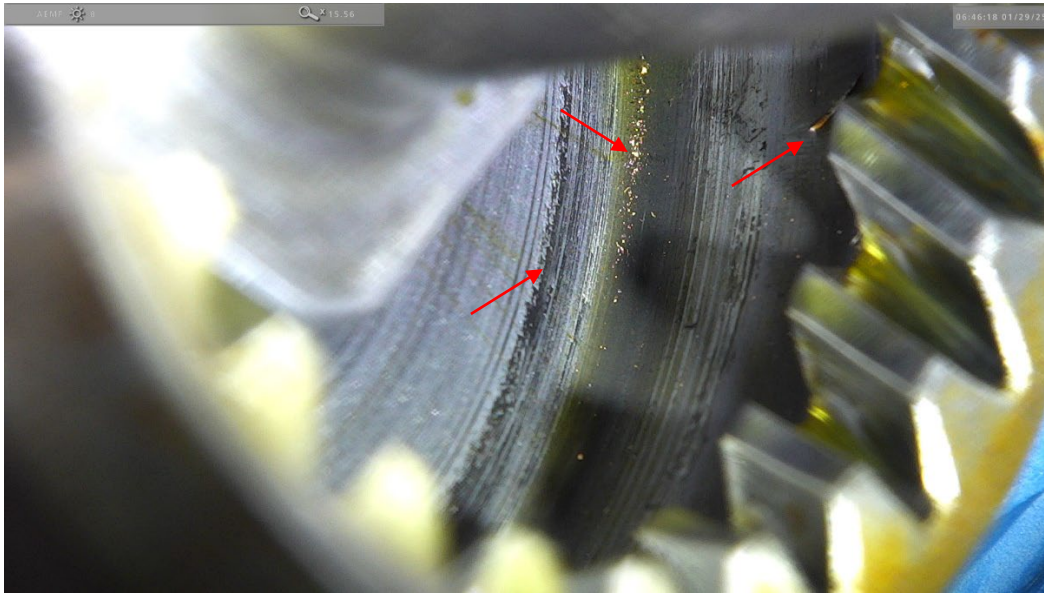
Using the engine starter, the engine was motored several times to ensure there were no fuel or oil leaks. The engine started during the first attempt to start. The engine was operated at various power setting for about 10 min and then shut down. A visual examination of the exterior for leaks was conducted, no leaks observed. The engine was then restarted and operated at various power settings for about 10 min. The anti-ice valve was activated from the control room and a corresponding increase of about 15° F in the exhaust gas temperature (EGT) was observed. An abnormal voltage reading from the airframe torque transducer was observed. The engine was shut down and a differential oil pressure transducer was attached to the auxiliary port of the lab torque measurement block. The engine was then restarted and operated at various power settings, the differential oil pressure reading from the torque measurement block reached a maximum of 103 psi. The engine was then shut down and removed from the test stand. The nose cone, propeller shaft and flange, planetary gear assembly, NTS quill and coupler shafts, and the diaphragm assembly were removed. The torque sensor helical cam gear was manipulated by hand and a slight binding was noted. The torque sensor assembly was then removed from the engine and placed under a microscope. Scoring and copper in color debris was observed in the area forward of the internal splines within the helical cam gear. Damage to the aft edges of all of the helical spline teeth on the helical cam gear shaft was observed. The damage to the torque sensor assembly was consistent with the helical cam gear being driven aft as would be expected during a propeller strike. The

aft position would account for the anomalous differential oil pressure (torque indications) during the engine test run.

**Figure 4: View of scoring and copper in color debris forward of internal splines within the helical cam gear (left engine).**

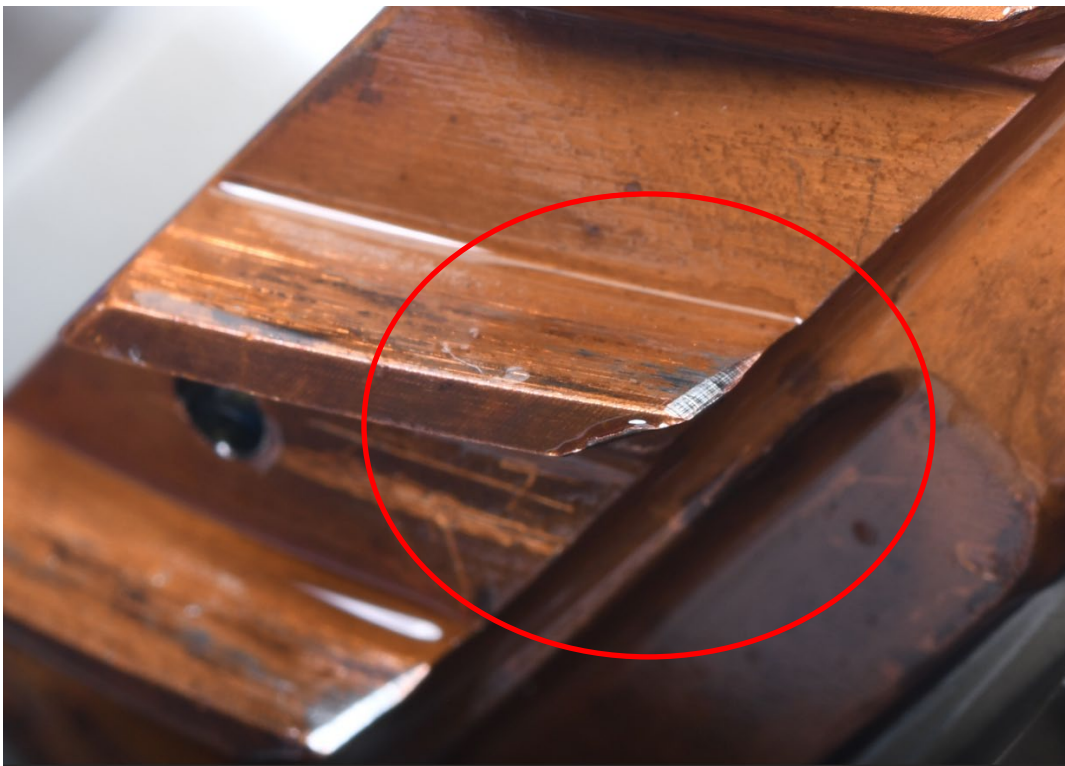
**Figure 5: View of damage to helical spline teeth on the helical cam gear shaft (left engine).**

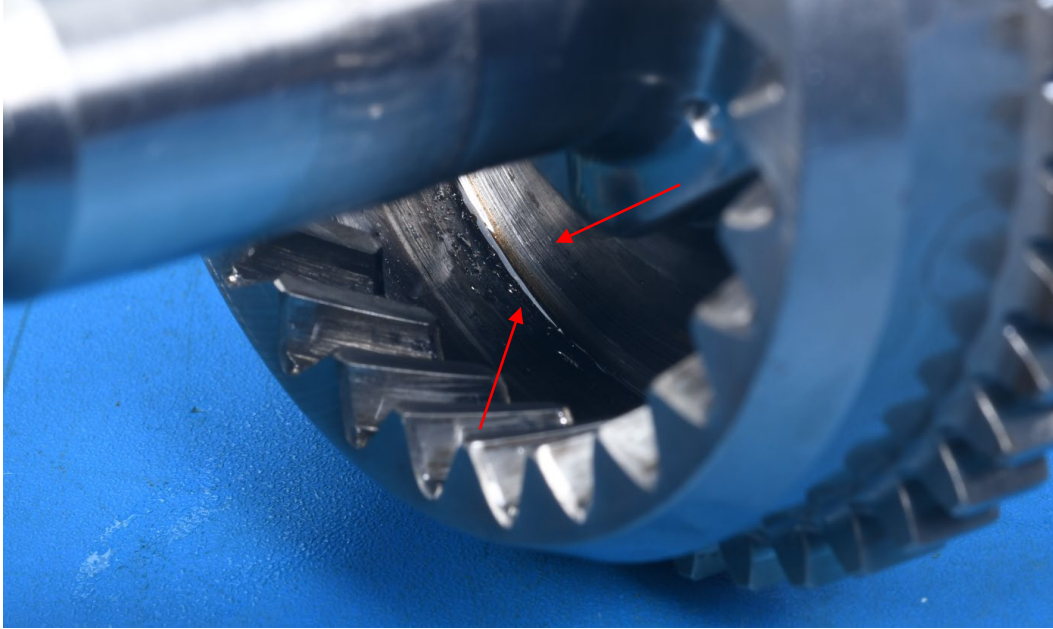
Using the engine starter, the engine was motored several times to ensure there were no fuel or oil leaks. The engine started during the first attempt to start. During the first application of power, an abnormal reading from both the aircraft torque transducer (voltage) and the differential oil pressure was observed. As the power to the engine was increased, a shift in differential oil pressure was noted and a corresponding change in the reading from the aircraft torque transducer was also observed. Prior to the shift in the differential oil pressure the reading from the torque measurement block reach a maximum of 89 psi. The engine was operated at various power settings for about 20 min. The anti-ice valve was activated from the control room and a corresponding increase of about 15° F in the exhaust gas temperature (EGT) was observed. The engine was then shut down and removed from the test stand. The nose cone, propeller shaft and flange, planetary gear assembly, NTS quill and coupler shafts, and the diaphragm assembly were removed. The torque sensor assembly was then removed from the engine and placed under a microscope. Scoring and copper in color debris was observed in the area forward of the internal splines within the helical cam gear. Damage to the aft edges of all of the helical spline teeth on the helical cam gear shaft was observed. The damage to the torque sensor assembly was consistent with the helical cam gear being driven aft as would be expected during a propeller strike. The damage to the helical cam gear assembly would account for the anomalous differential oil pressure (torque indications) during the engine test run.

**Figure 9: View of scoring and copper in color debris forward of internal splines within the helical cam gear (right engine).**

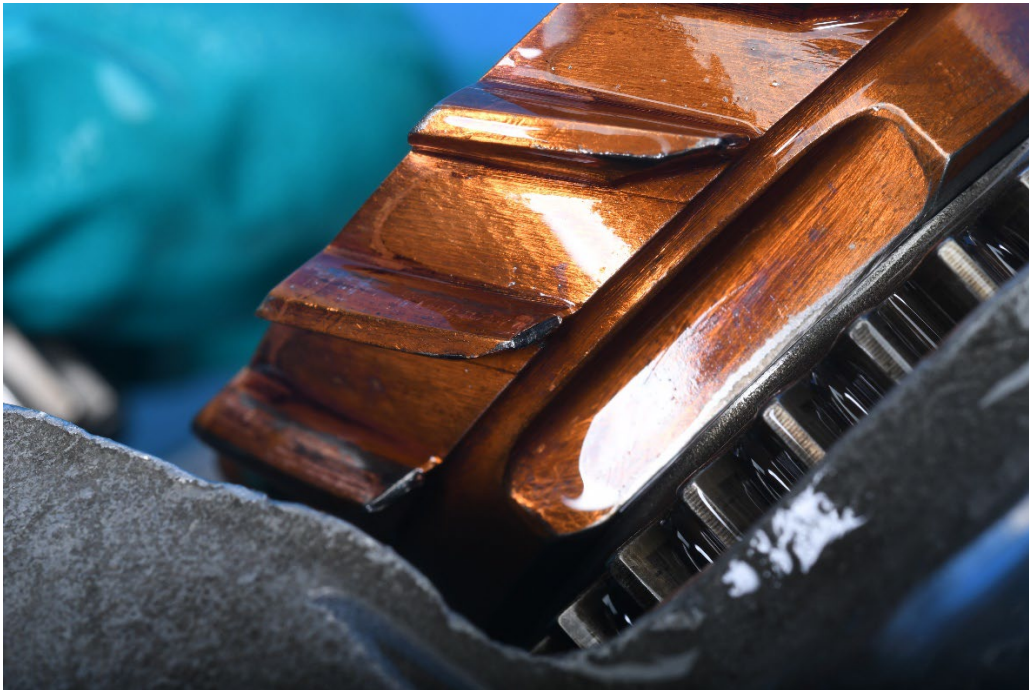
**Figure 10: View of damage to helical spline teeth on the helical cam gear shaft (right engine).**
