Eric M. Gutierrez  
Air Safety Investigator  
Western Pacific Region

**Date:** December 5, 2024

**Subject:** WPR25LA053, Memorandum for Record

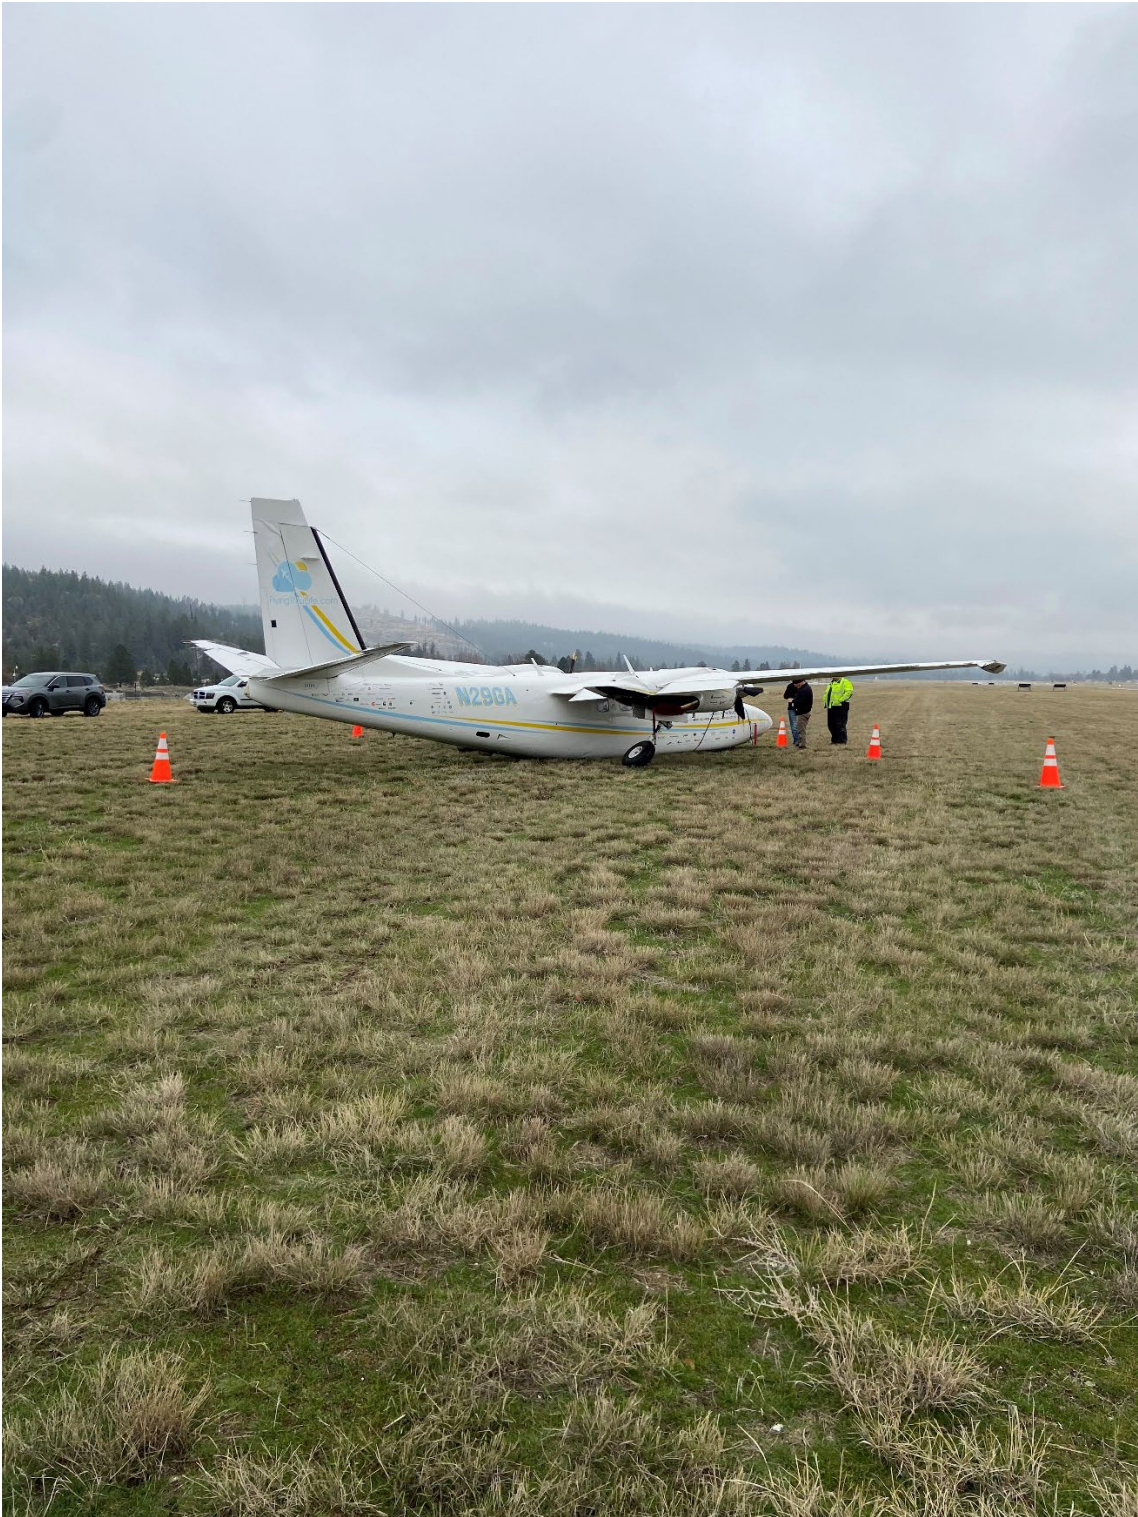
*Figure 1: Rear view of accident airplane (Courtesy of FAA)*

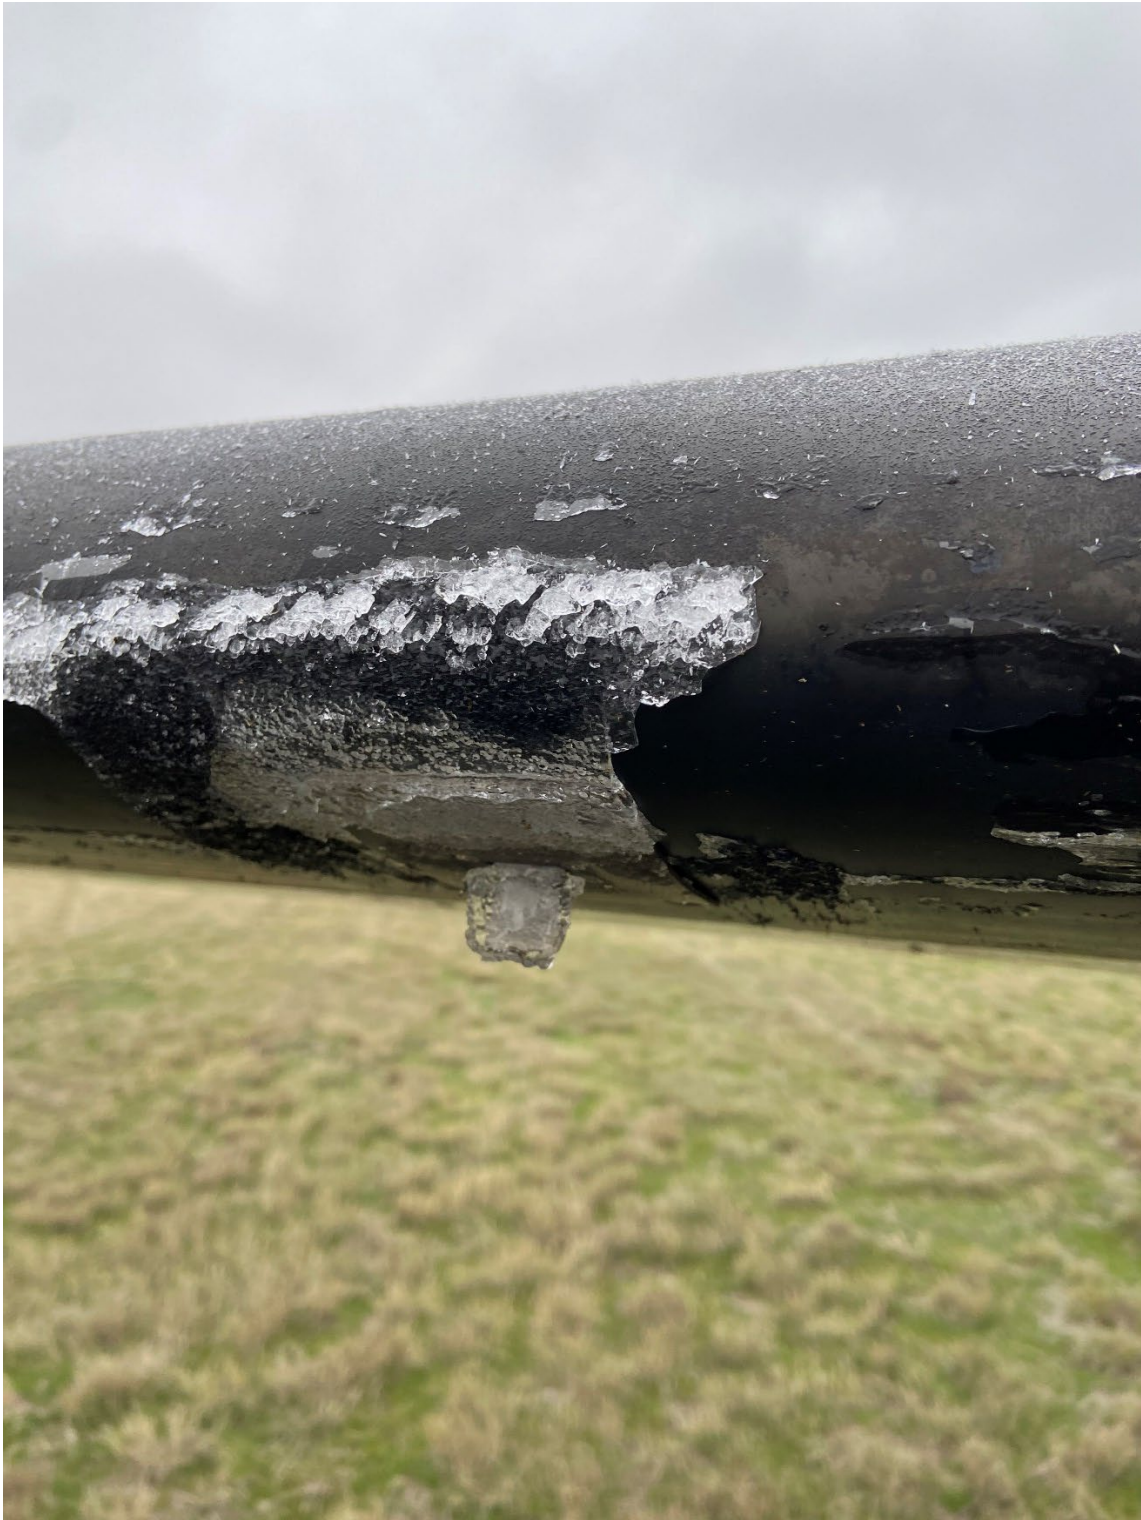
*Figure 2: View of ice on stall warning vane (Courtesy of FAA)*

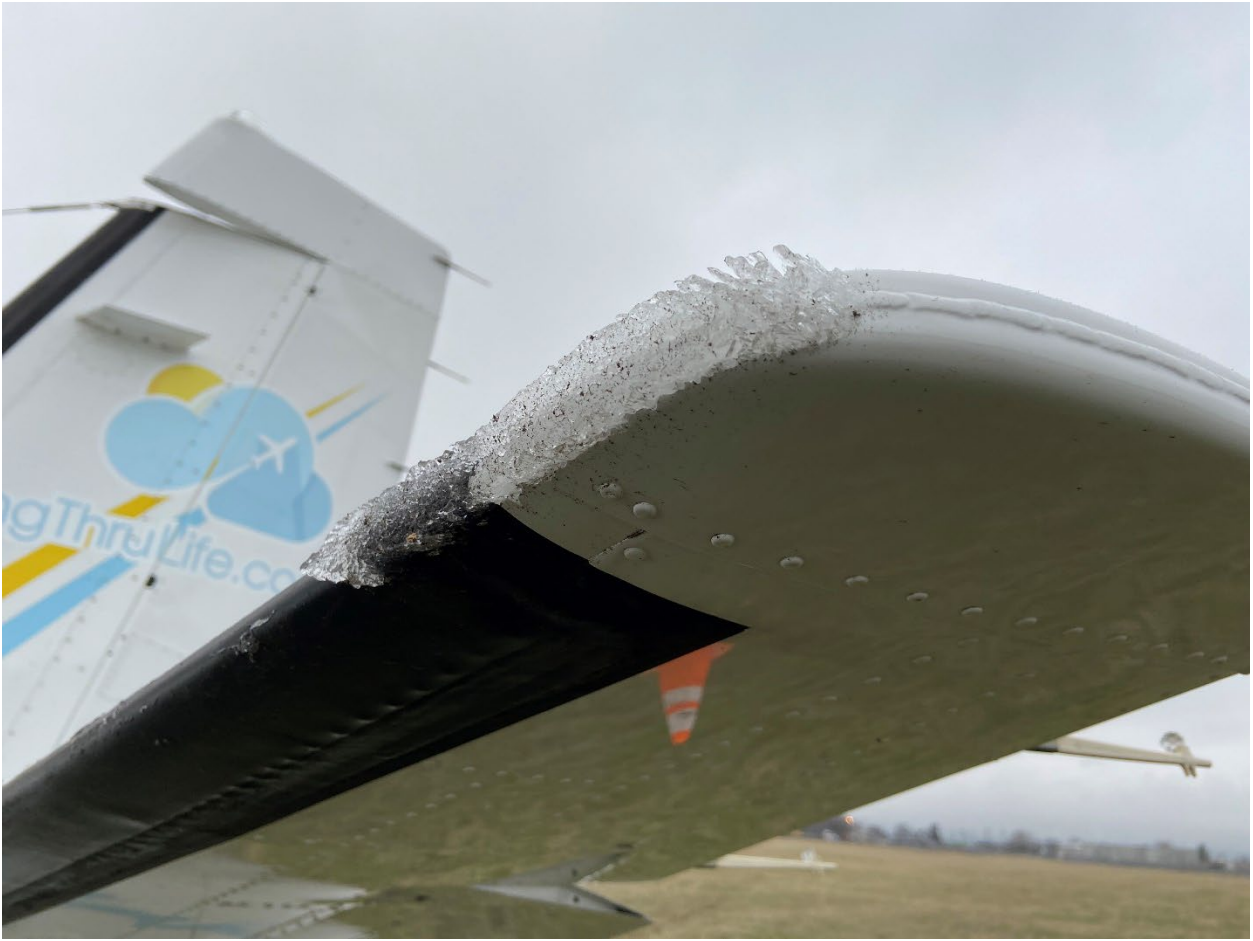
*Figure 3: View of ice on leading edge of horizontal stabilizer. (Courtesy of FAA)*

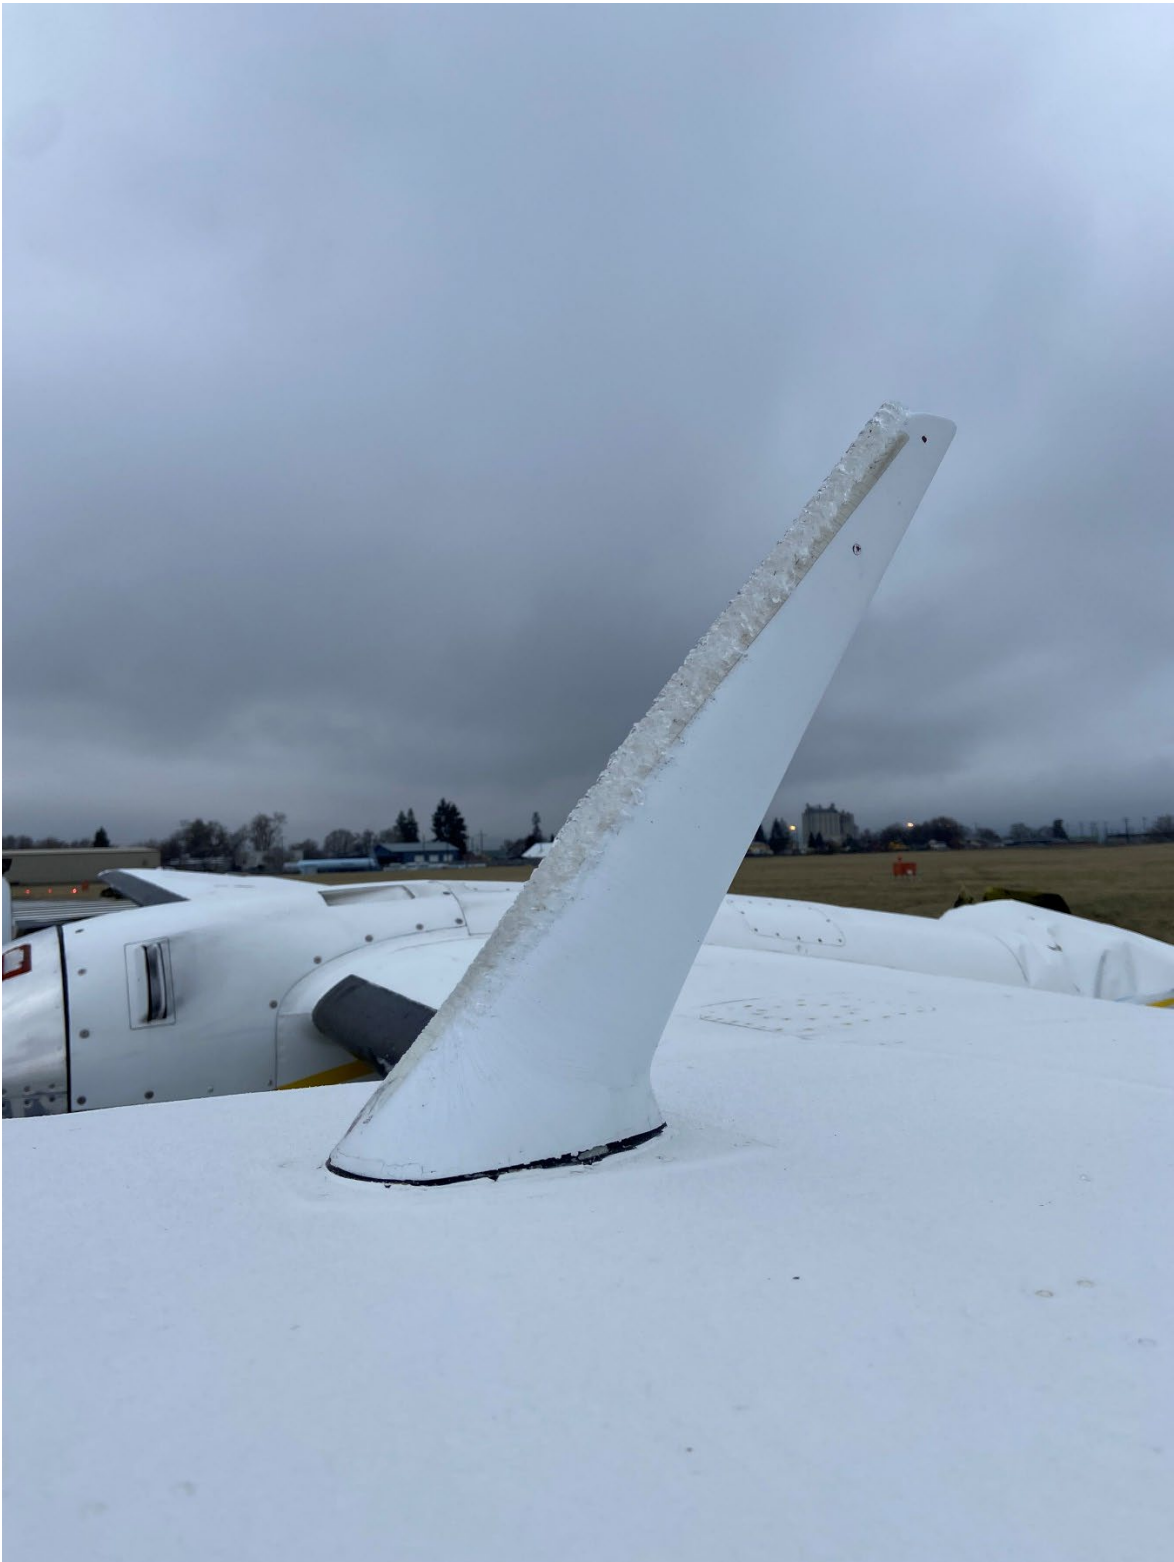
*Figure 4: View of ice on fuselage antennas. (Courtesy of FAA)*
