# National Transportation Safety Board

WPR25LA053

## **AIRFRAME AND ENGINE EXAMINATION**

Location: Spokane, Washington  
Date: December 2, 2024  
Time: 1530 Pacific daylight time  
Airplane 1: N29GA, Gulfstream AM CORP COMM DIV690D

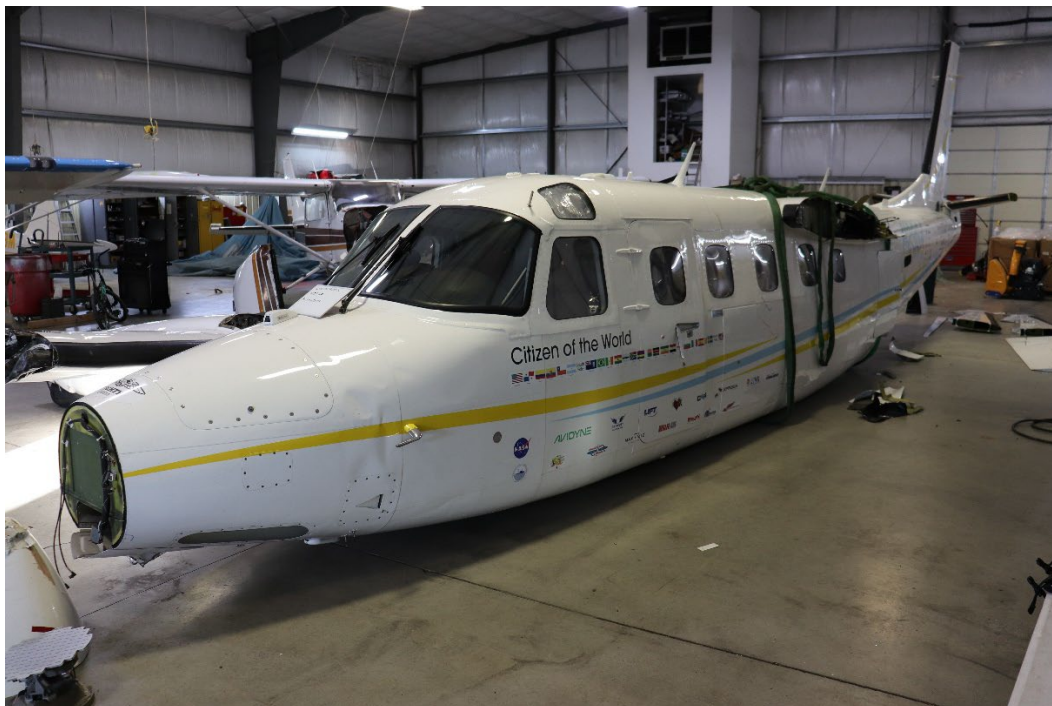
Examination of the recovered wreckage revealed that the nose landing gear was in the retracted position, in the nose wheel well. Buckling and crushing was observed throughout the fuselage. The left wing was separated at the wing root by recovery personnel to facilitate recovery. The left-wing main landing gear remained attached to the wing via its attach points, and exhibited impact damage.

**Figure 1: Front view of wreckage during examination.**

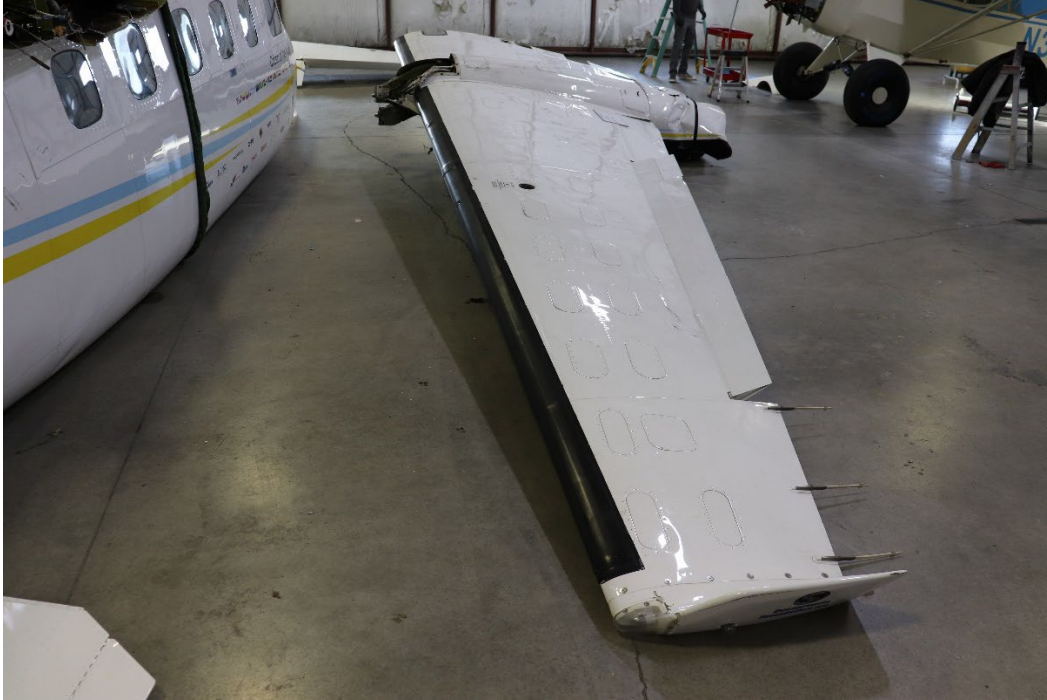
**Figure 2: View of left-wing during examination.**

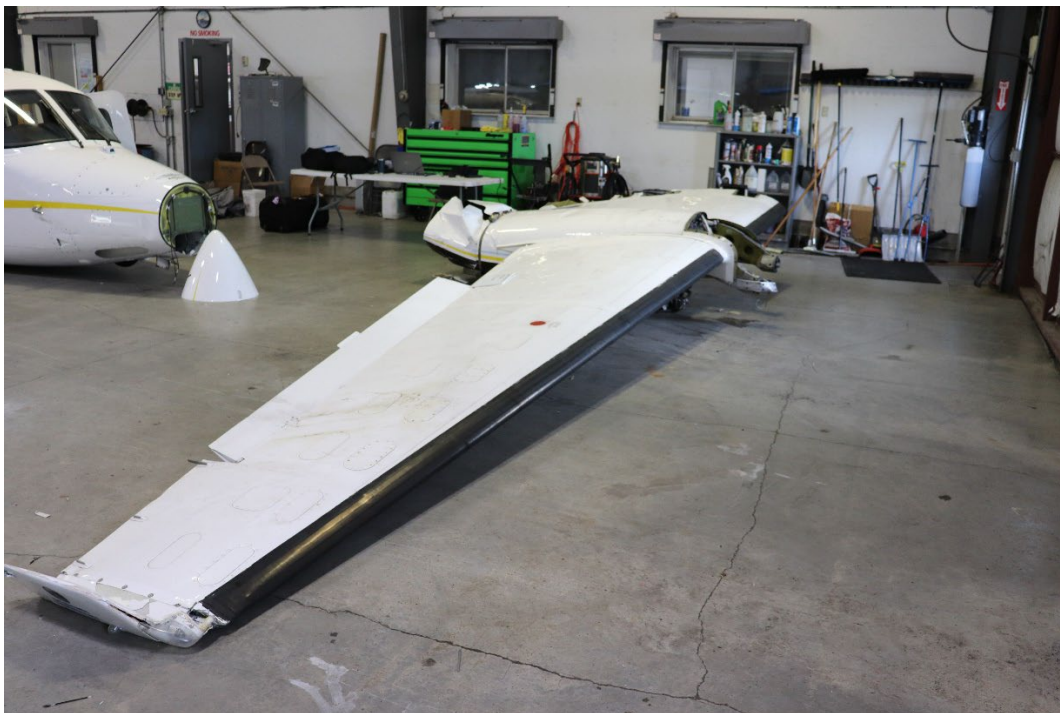
The right wing was separated at the wing root by recovery personnel to facilitate recovery. The right-wing main landing gear remained attached to the wing via its attach points, and an exhibited impact damage.

**Figure 3: View of right-wing during examination.**

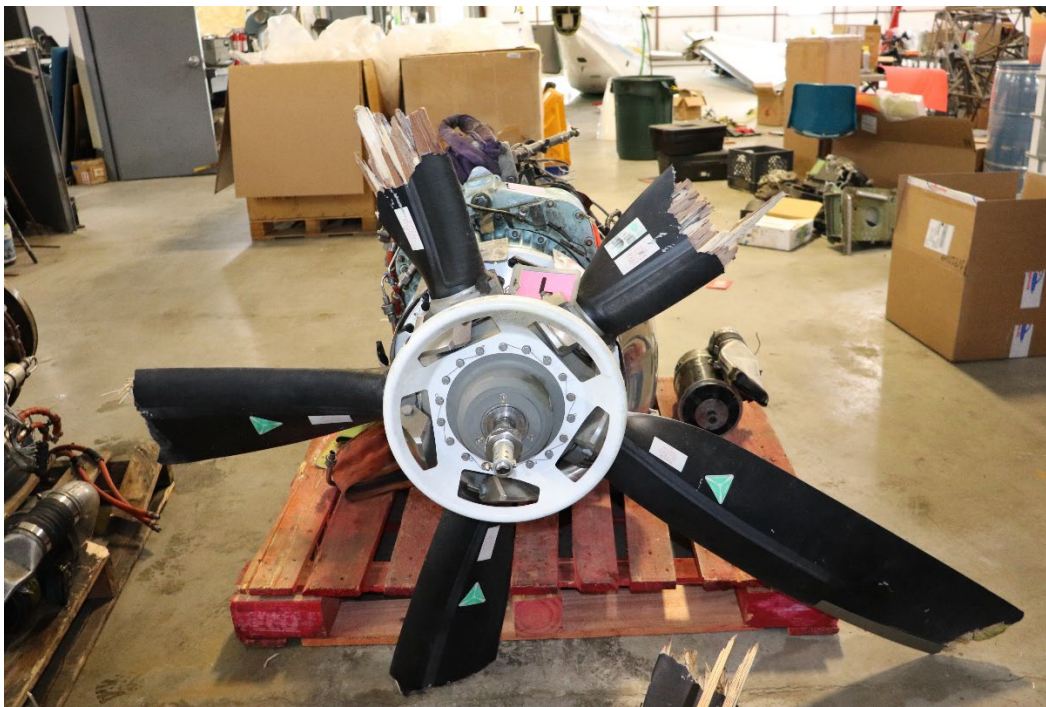
The left engine had been separated from the airframe by the recovery personal. The starter/generator was separated from the engine due to a fractured bracket. Damage to the top of the propeller governor was observed, consistent with contact with the starter/generator. No visible damage was observed to the 1<sup>st</sup> stage compressor impeller or the 3<sup>rd</sup> stage turbine rotor. The power section of the turbine was manually rotated with no binding, and a corresponding rotation was observed on the propeller output shaft. The chip detector was removed, and no visible debris was observed

**Figure 4: View of left engine during examination.**

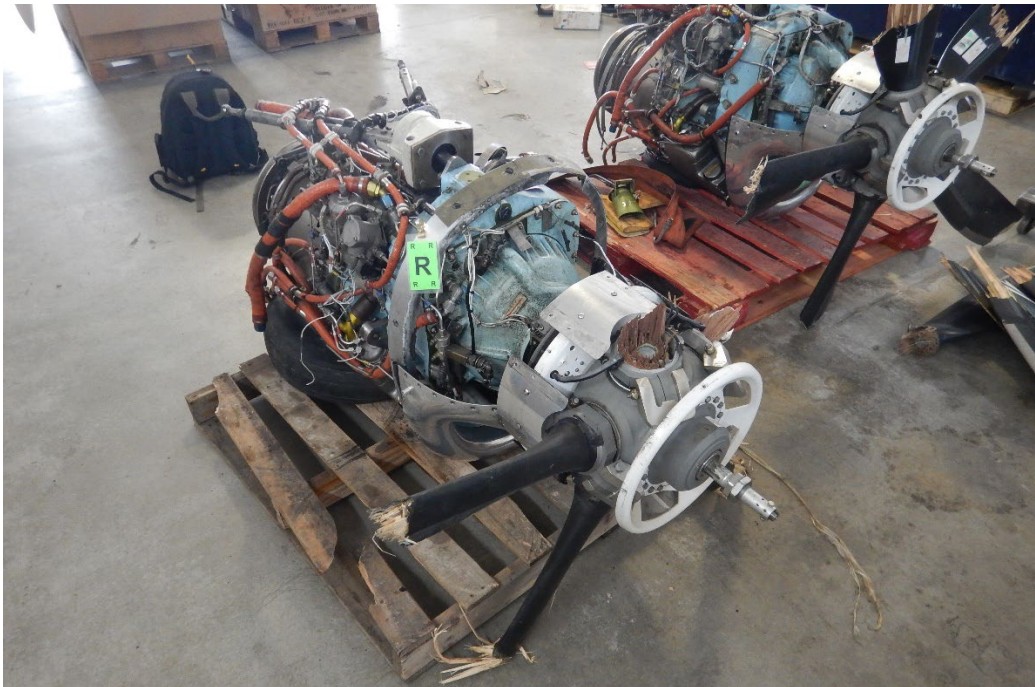
The right engine had been separated from the airframe by the recovery personal. No visible damage was observed to the exterior of the engine. No visible damage was observed to the 1<sup>st</sup> stage compressor impeller or the 3<sup>rd</sup> stage turbine rotor. The power section of the turbine was manually rotated with no binding, and a corresponding rotation was observed on the propeller output shaft. The chip detector was removed, and no visible debris was observed.

**Figure 5: View right engine during examination.**
