WPR25LA056

## INVESTIGATION PHOTOGRAPHS

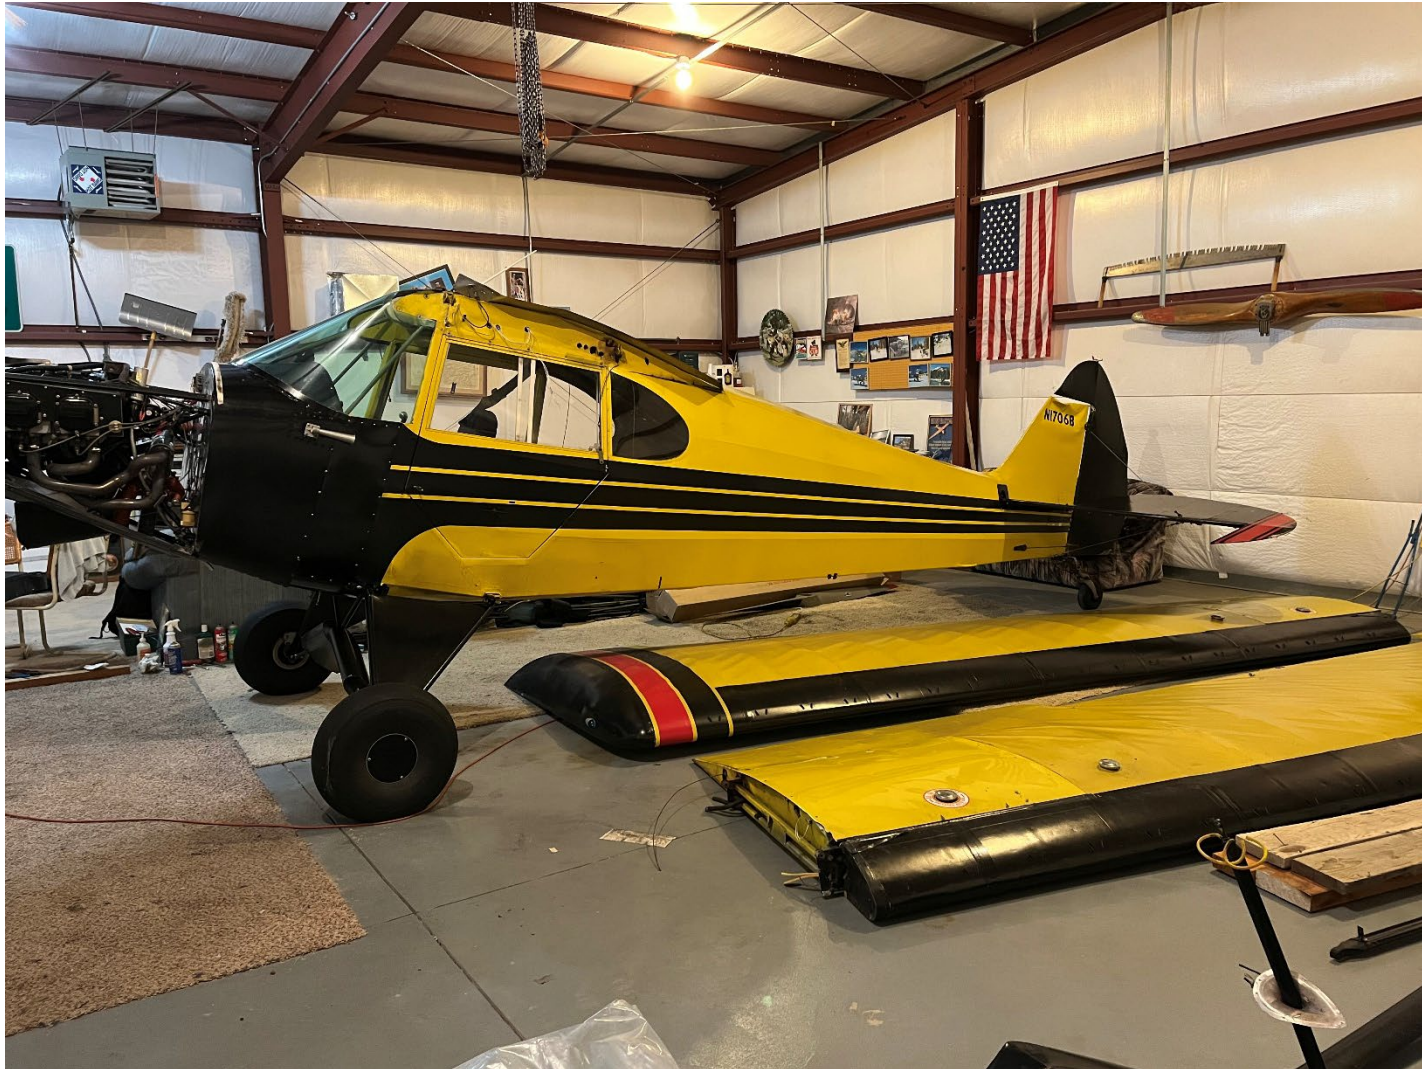
**Photograph 1 - View of airplane from the left. (Courtesy of the FAA.)**

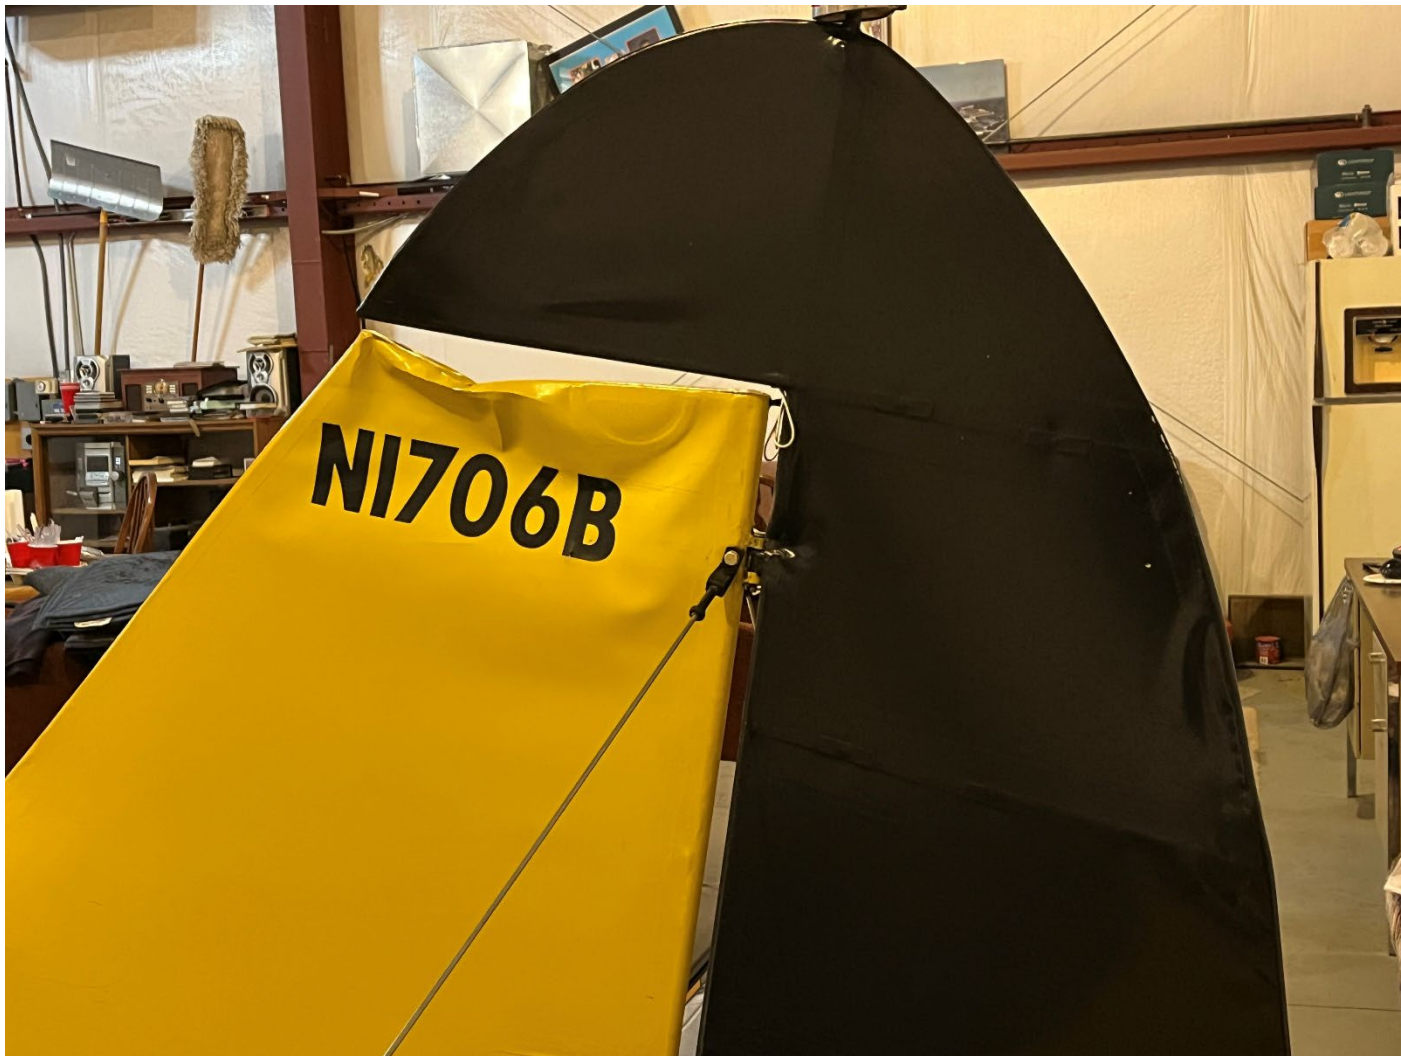
**Photograph 2 - View of substantial damage to vertical stabilizer. (Courtesy of the FAA.)**

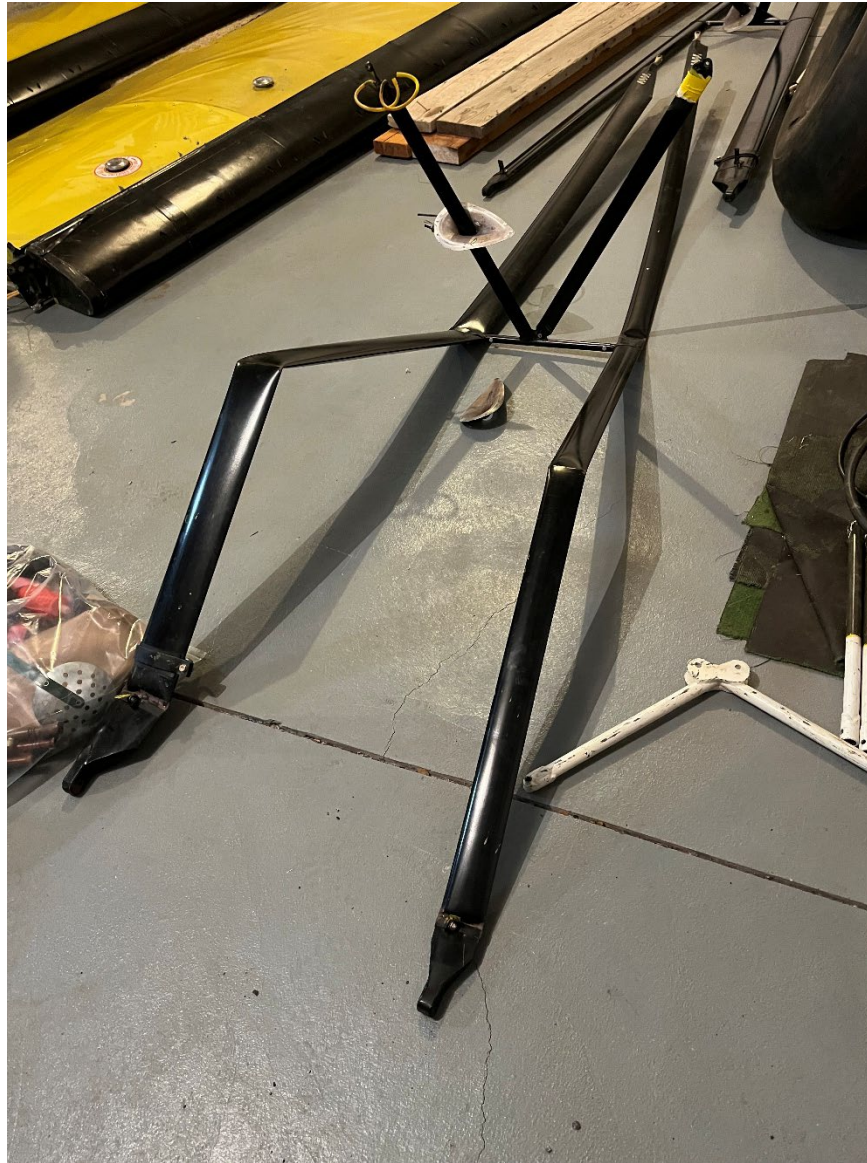
**Photograph 3 - View of substantial damage to wing strut. (Courtesy of the FAA.)**

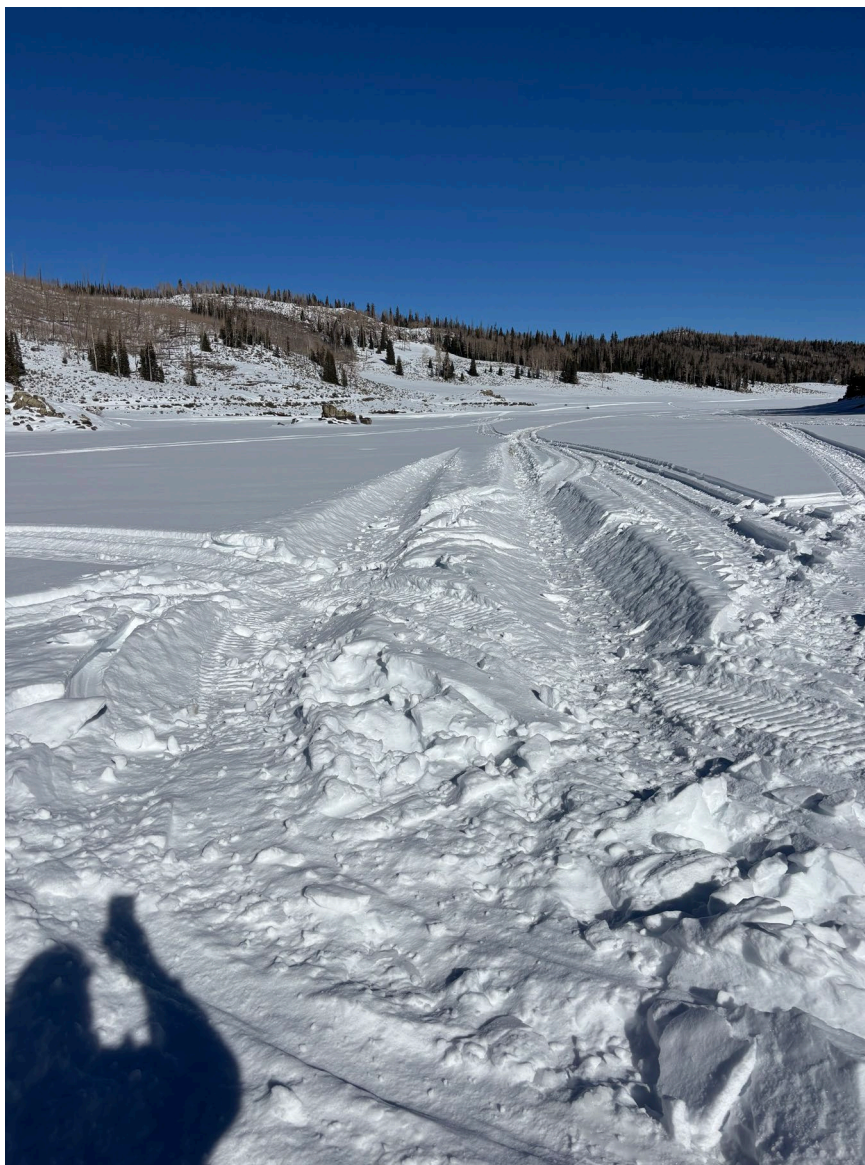
**Photograph 4 - View of accident site. (Courtesy of the pilot.)**
