# National Transportation Safety Board

Office of Research and Engineering

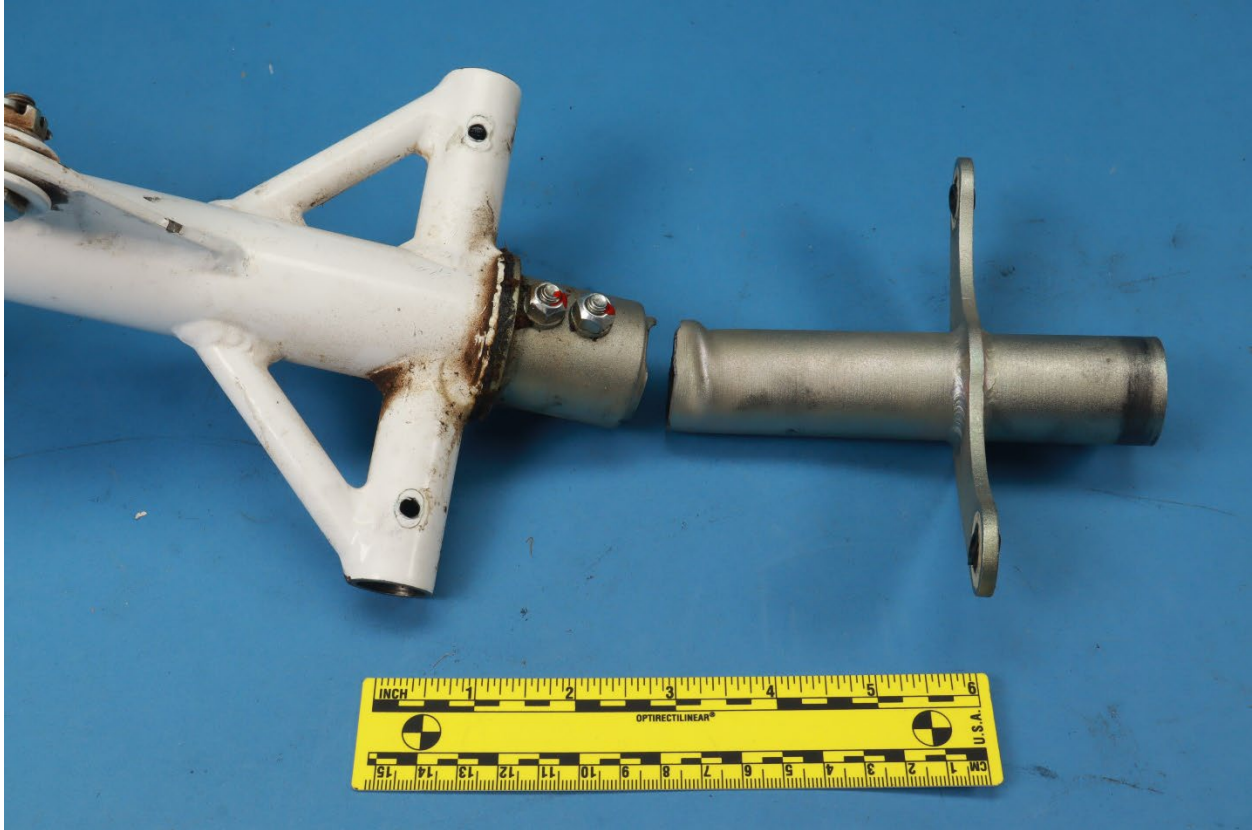
**Figure 2.** Fracture in the nose landing gear steering tube.

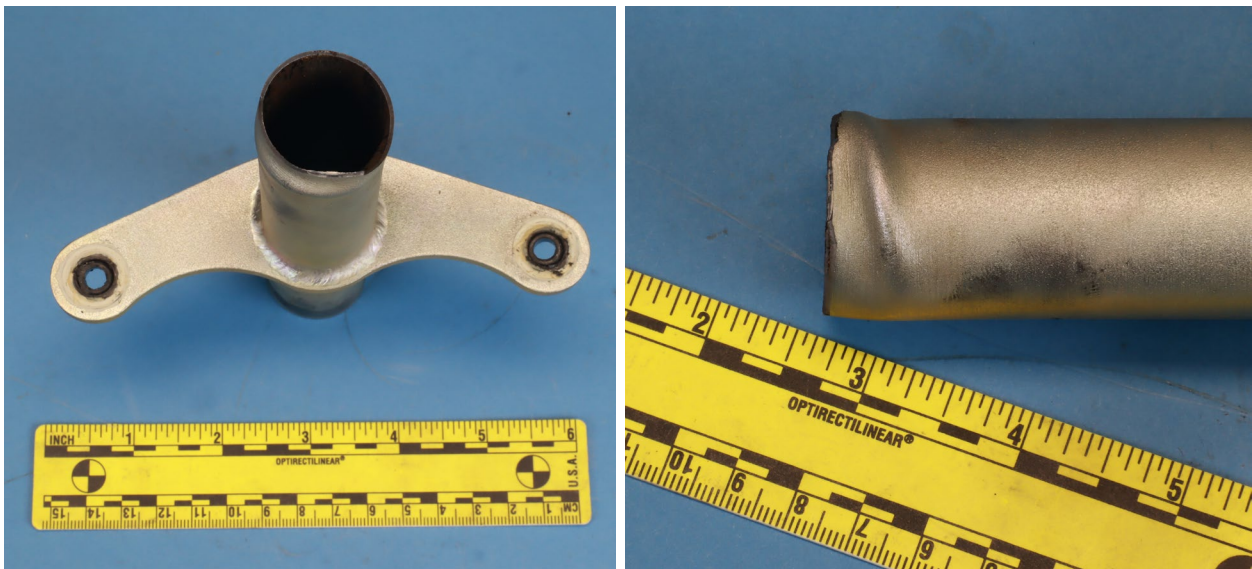
**Figure 3.** Plastic deformation and buckling of the steering tube.

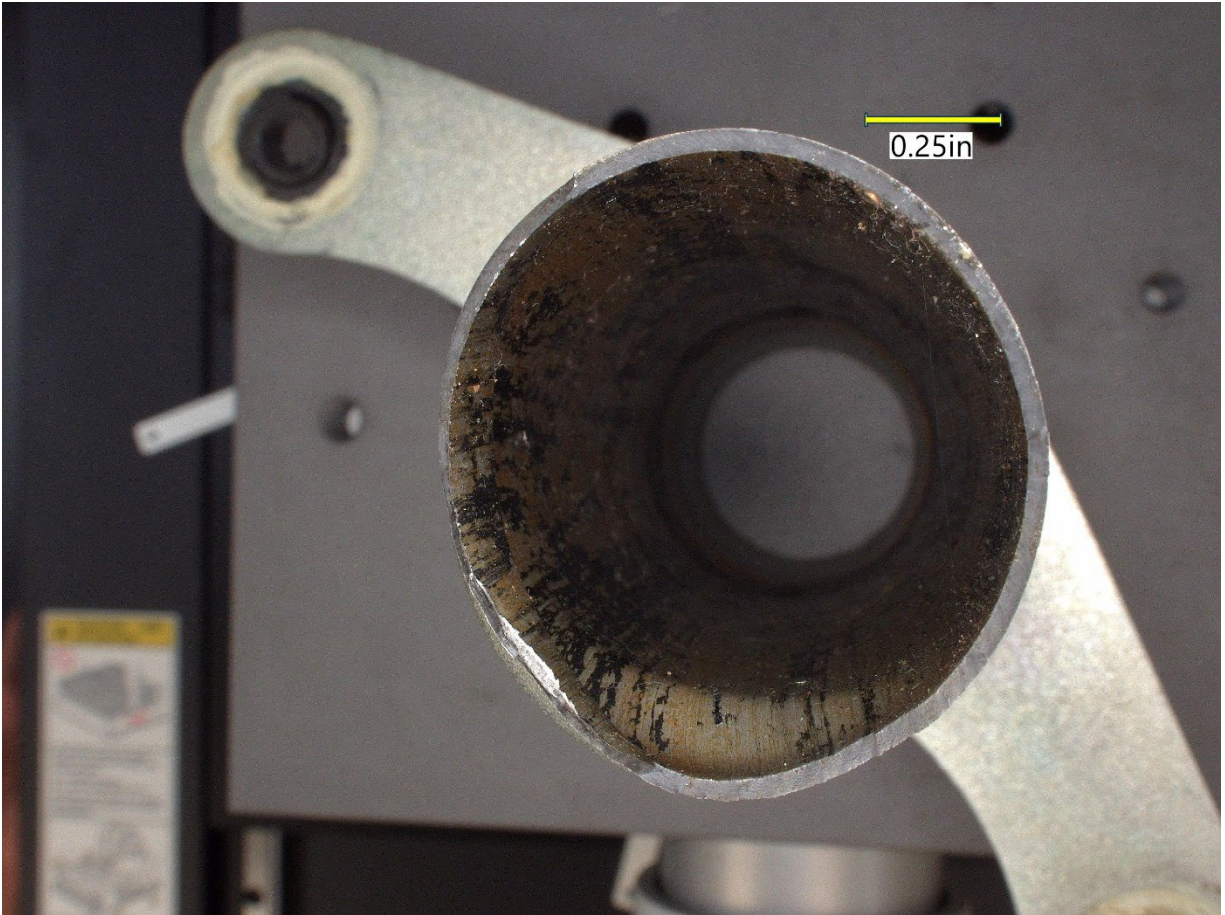
**Figure 4.** Fracture surface exhibiting slant fracture.

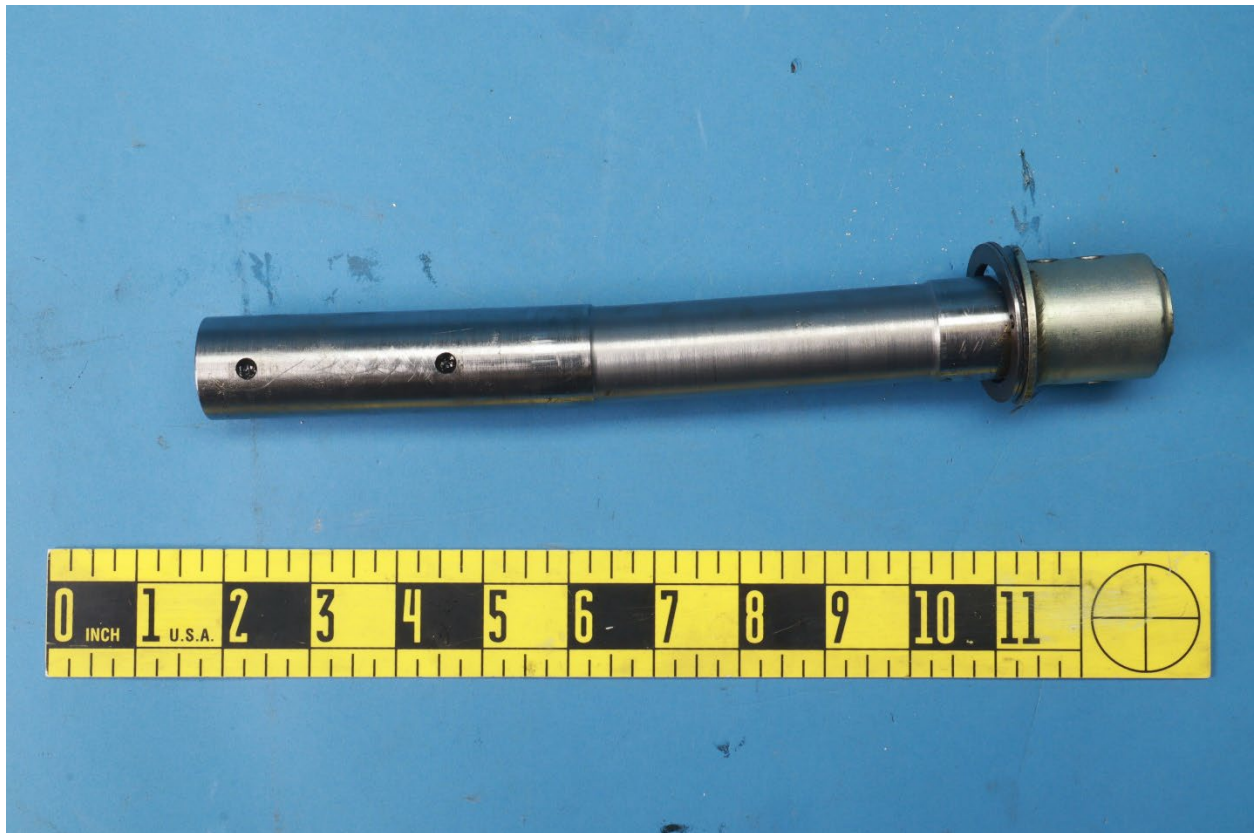
**Figure 5.** Steering axle exhibiting bending deformation.
