WPR25LA060

## INVESTIGATION PHOTOGRAPHS

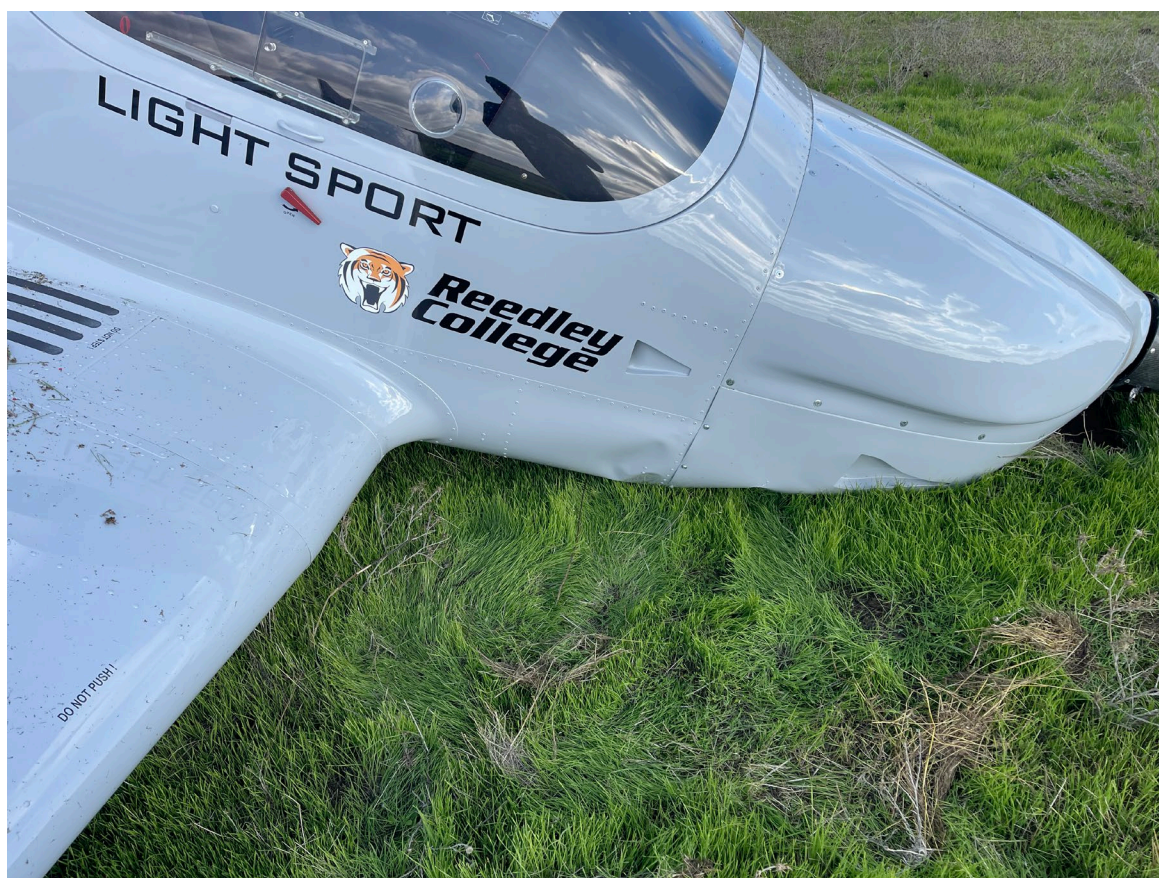
**Photograph 1 - Forward lower fuselage damage. (Courtesy of FAA)**

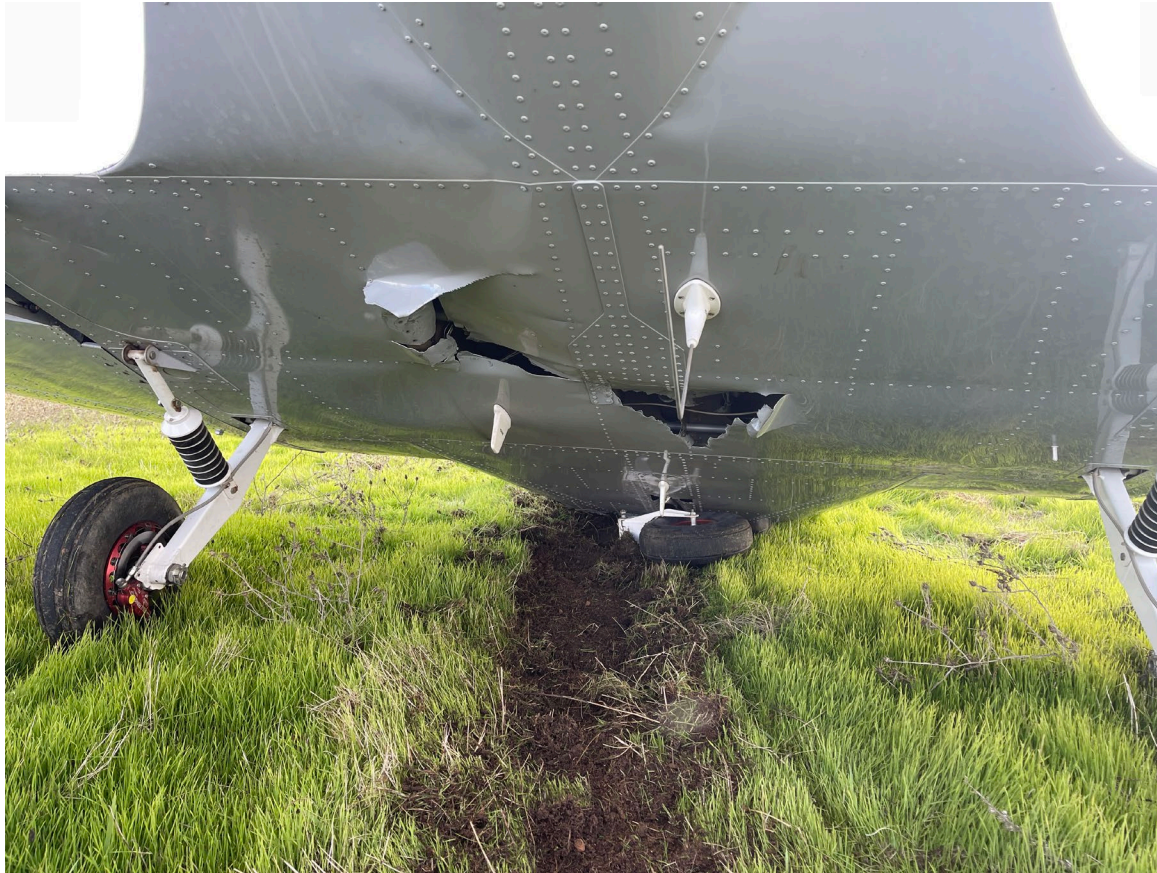
**Photograph 2 - Lower fuselage damage. (Courtesy of FAA)**

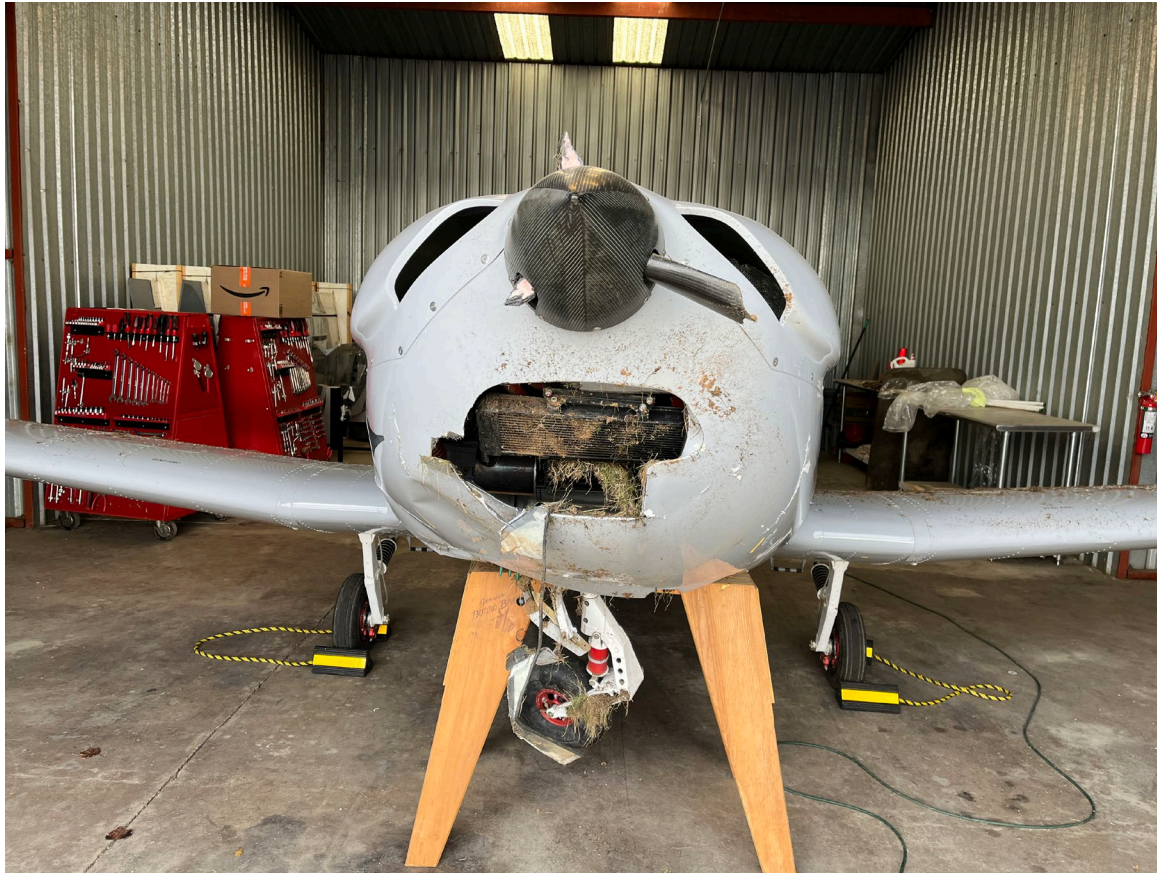
**Photograph 5 - Airplane at nose gear examination. (Courtesy of FAA)**

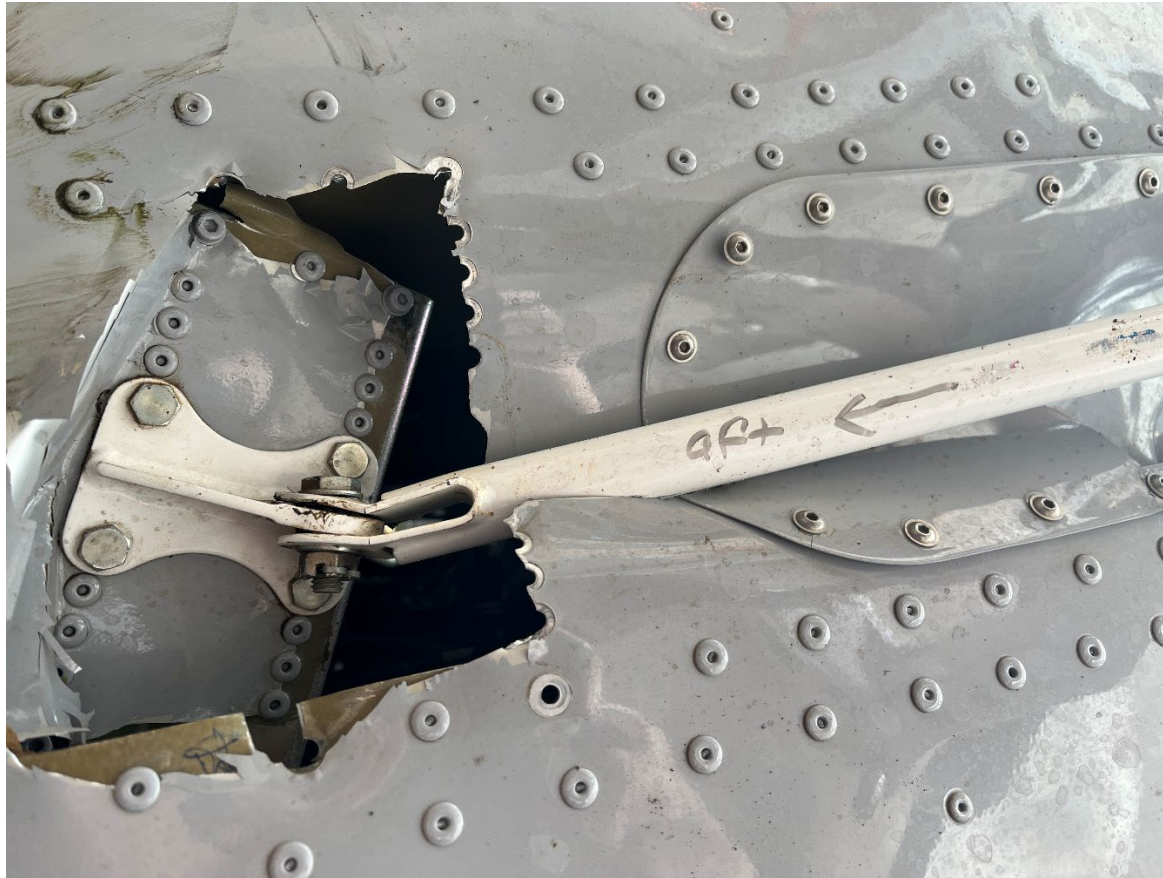
**Photograph 6 - Damage to gear strut. (Courtesy of FAA)**

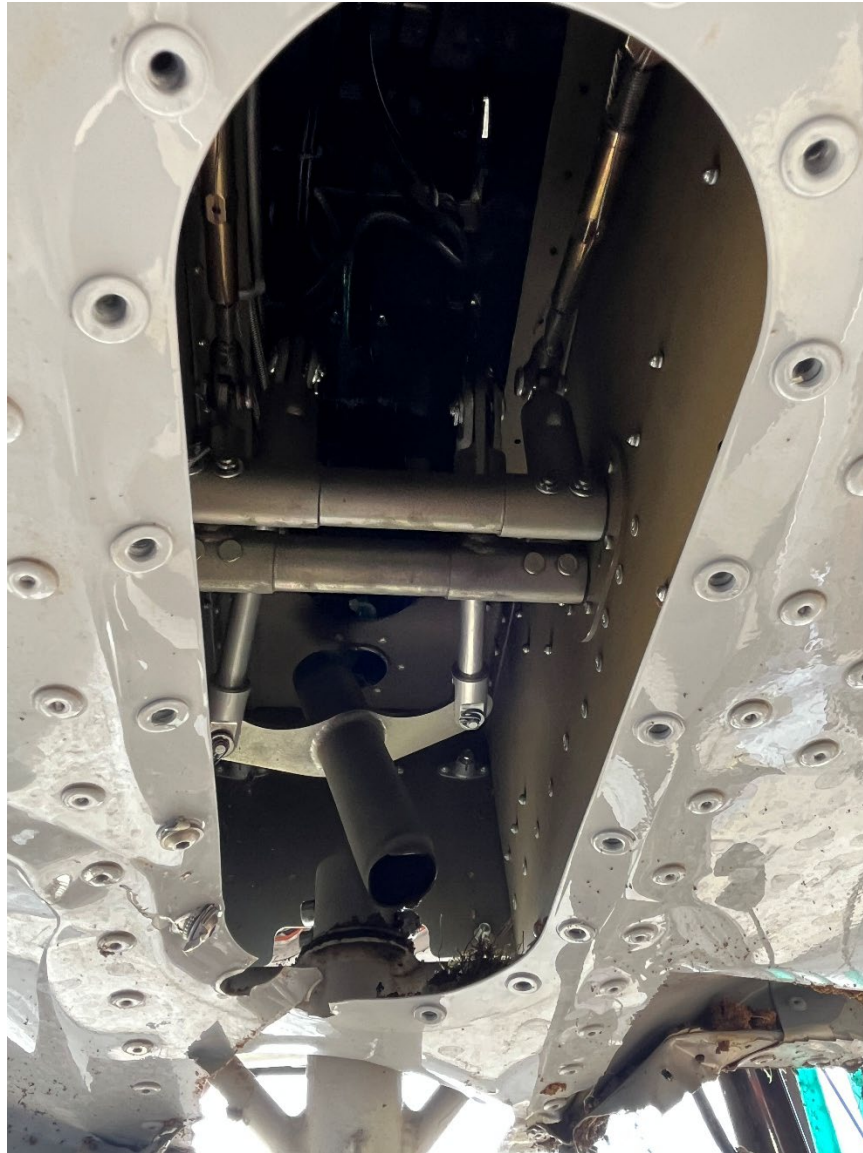
**Photograph 7 - Damage to pillar. (Courtesy of FAA)**
