WPR25LA069

## INVESTIGATION PHOTOGRAPHS

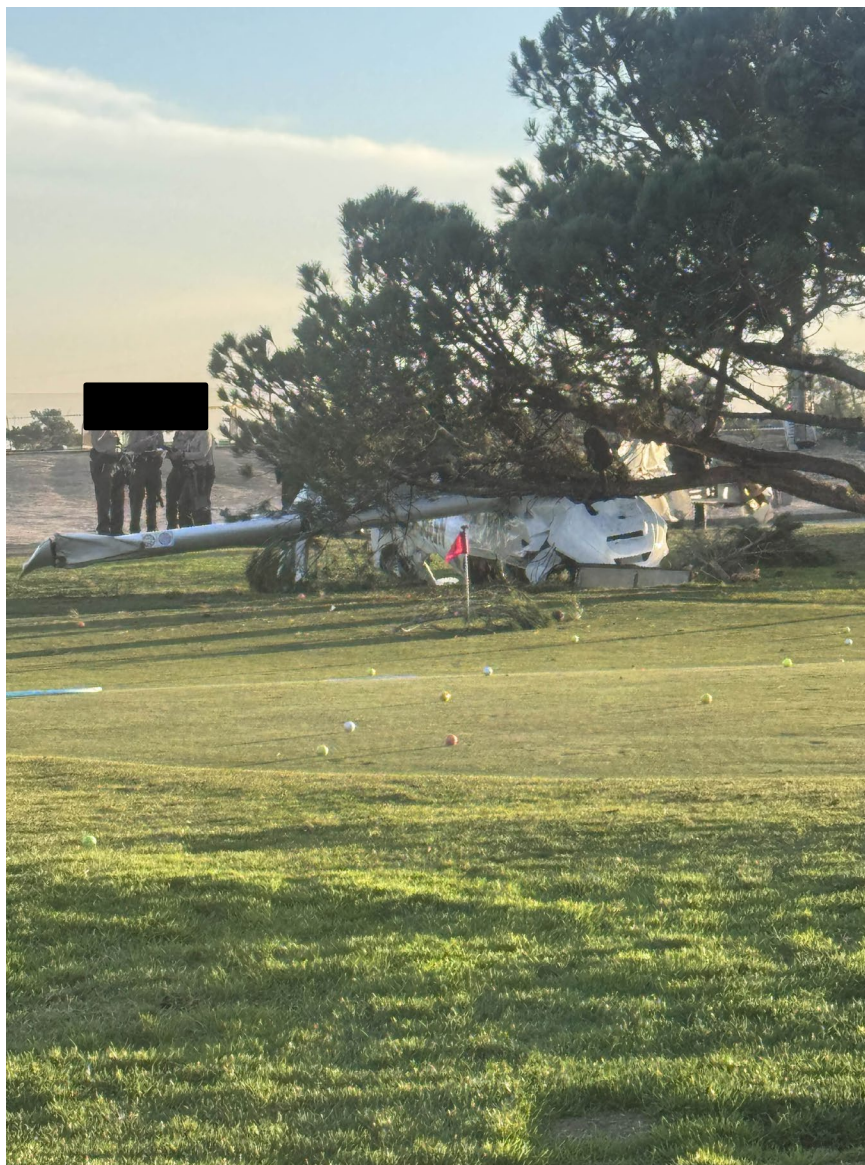
**Photograph 1 - N519CV at the accident site. (Courtesy of the Operator)**

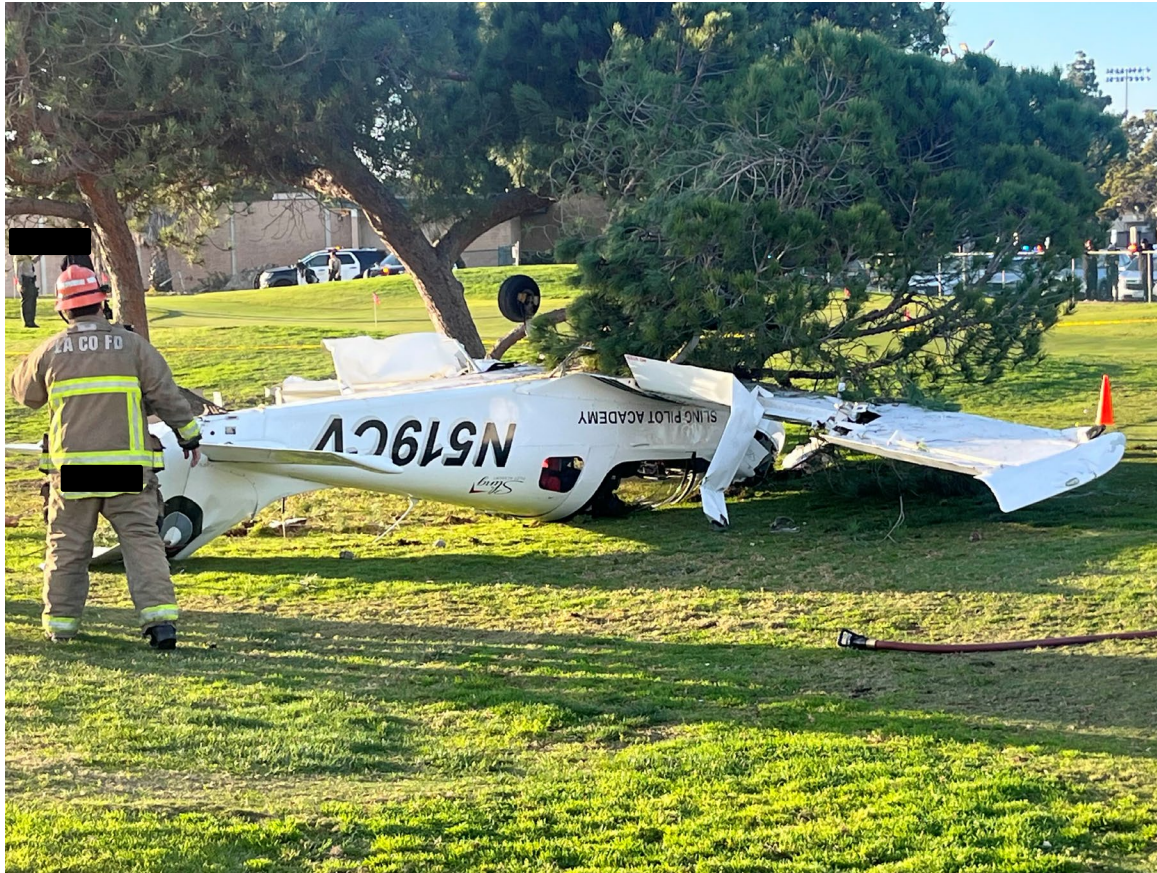
**Photograph 2 - Substantial damage to the right wing, vertical stabilizer, and rudder. (Courtesy of the operator)**

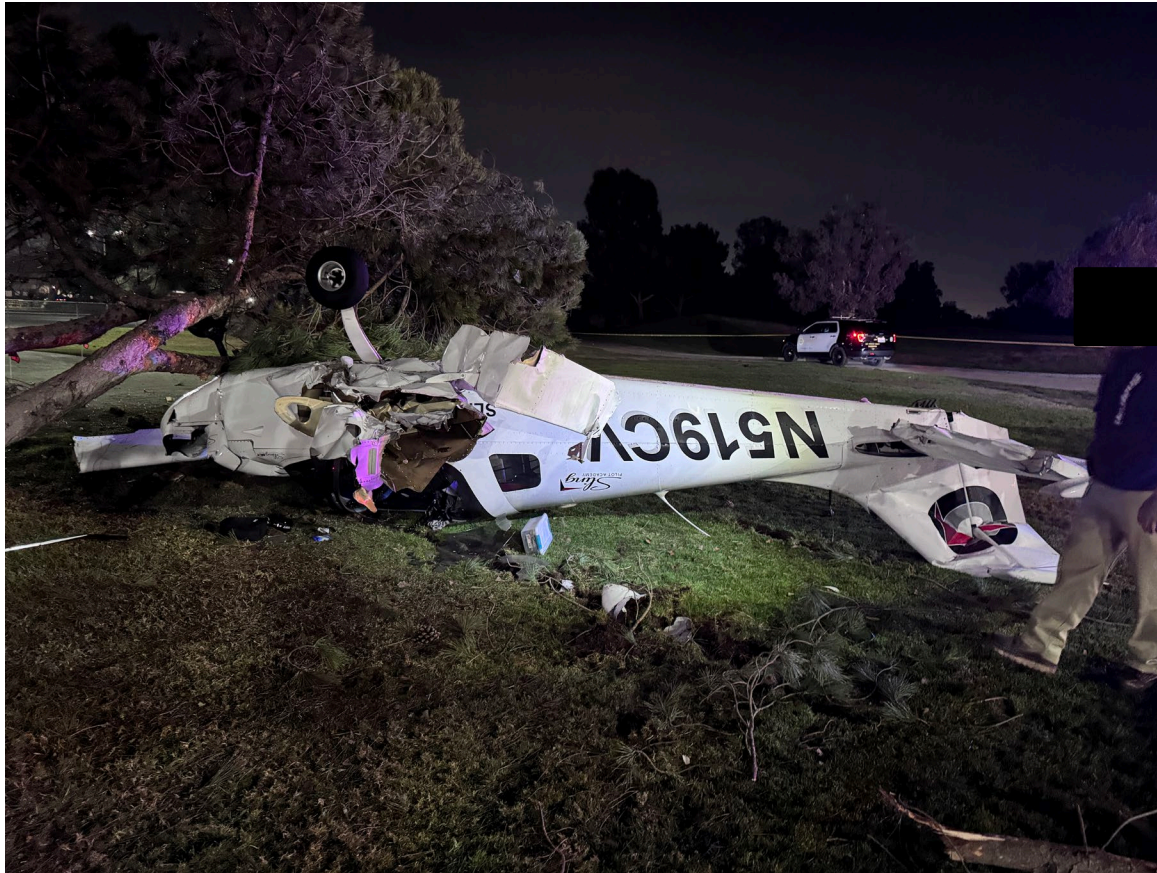
**Photograph 3 - Substantial damage to the fuselage, left wing, left horizontal stabilizer, and elevator. (Courtesy of the operator)**
