WPR25LA070

## INVESTIGATION PHOTOGRAPHS

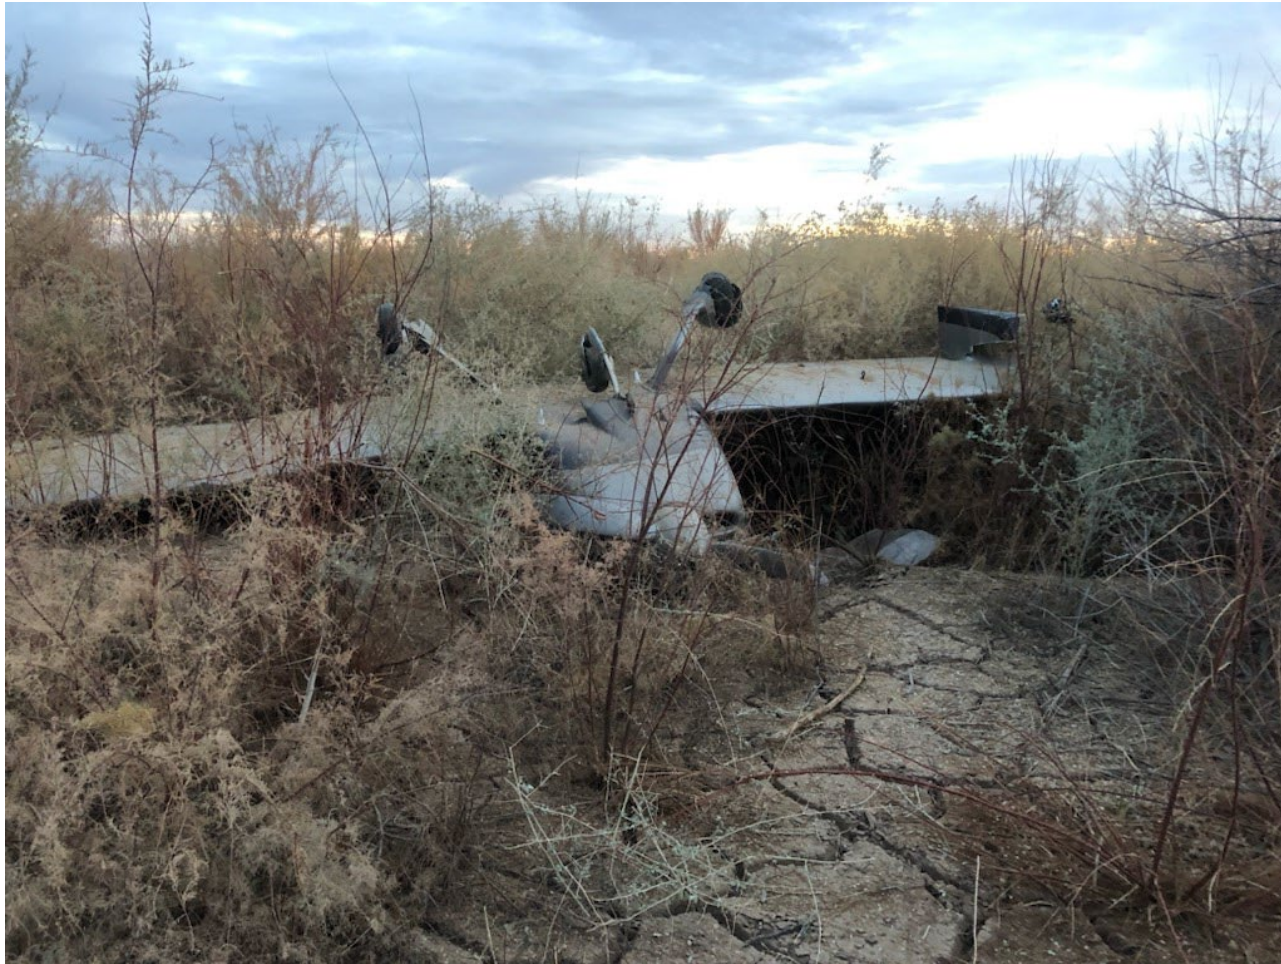
**Photograph 1 - View of inverted airplane with substantial damage to the right wing (Courtesy of Pilot)**

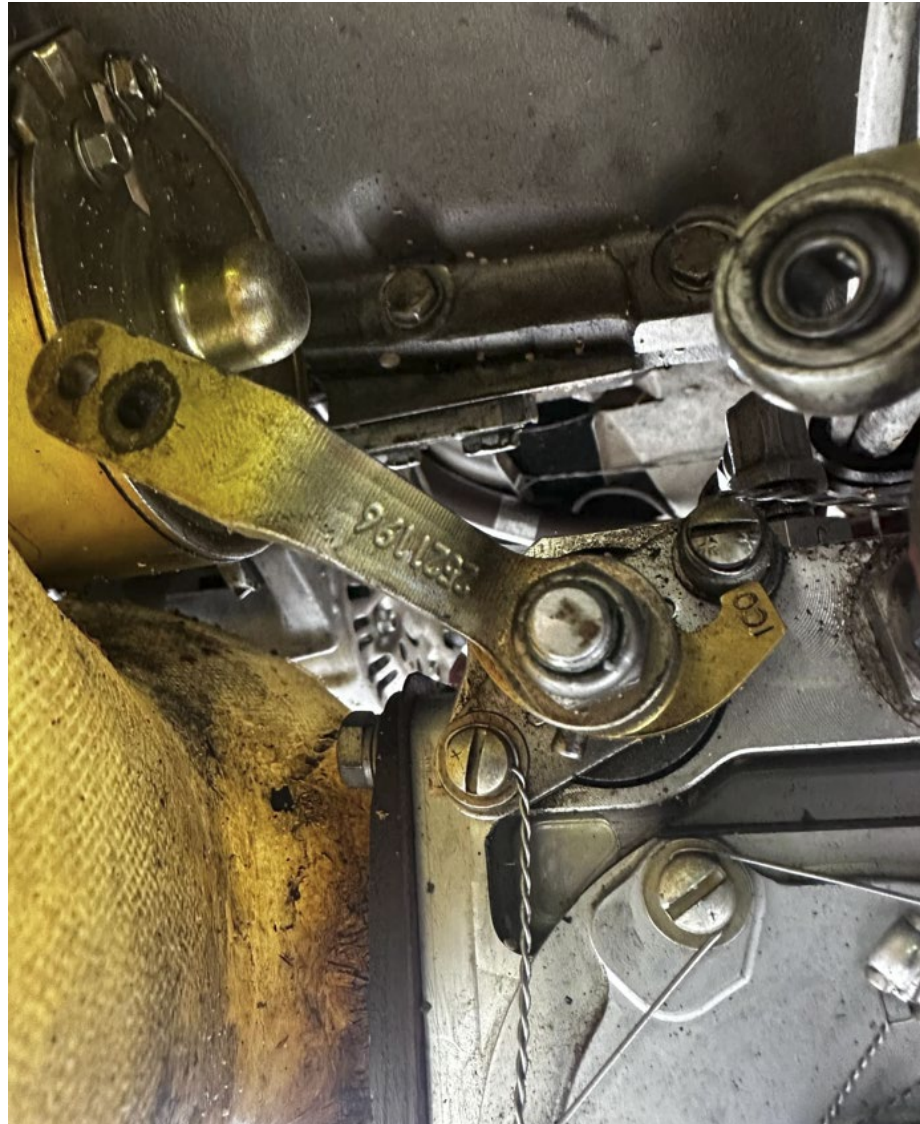
**Photograph 2 - View of the mixture control arm and the bellcrank rod end bearing, absent the connecting bolt, washers and castellated nut (Courtesy of Aircraft Recovery)**
