# National Transportation Safety Board

WPR25LA071

## **AIRFRAME AND ENGINE EXAM**

Location: Gallup, New Mexico  
Date: 12/27/2024  
Time: 2103 MST  
0403Z  
Airplane: 1976 Cessna T210L

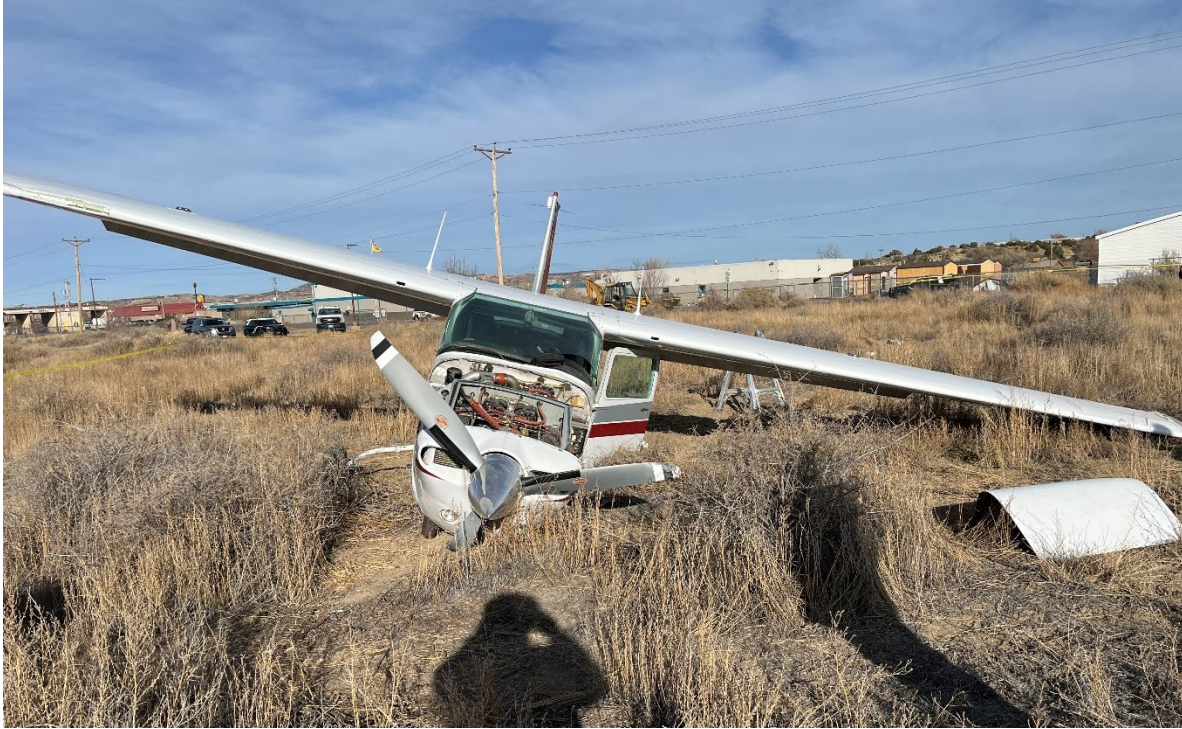
According to the pilot, as the airplane entered the base turn to land on runway 24 at GUP, she noted the airplane was descending faster than expected and added engine power; however, the engine did not respond. The pilot verified the position of the engine controls and fuel selector and noted each fuel tank appeared to be half-full. The pilot stated they were unable to reach the runway and initiated a forced landing in a vacant lot about 1,800 ft west of runway 24. During the forced landing, the airplane impacted power lines and rough terrain, which resulted in substantial damage to the right wing and fuselage. (See Fig. 1)

Fig. 1: The airplane at the accident site. (Courtesy of the FAA)

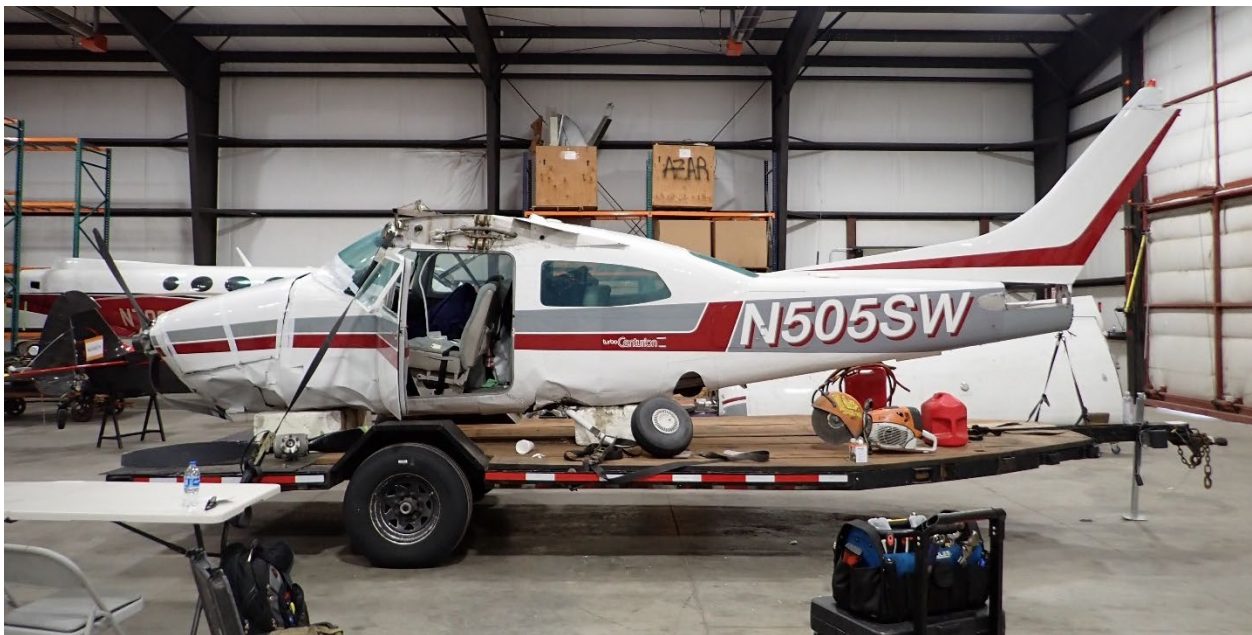
The lower forward fuselage had been crushed up and aft. The lower engine cowl was crushed. The windscreen was cracked and broken along the lower left corner. The lower fuselage adjacent to the main landing gear well was buckled. The nose keel beams were deformed, and the engine was canted nose down. (See Fig. 2)

Fig. 2: The fuselage viewed from the left.

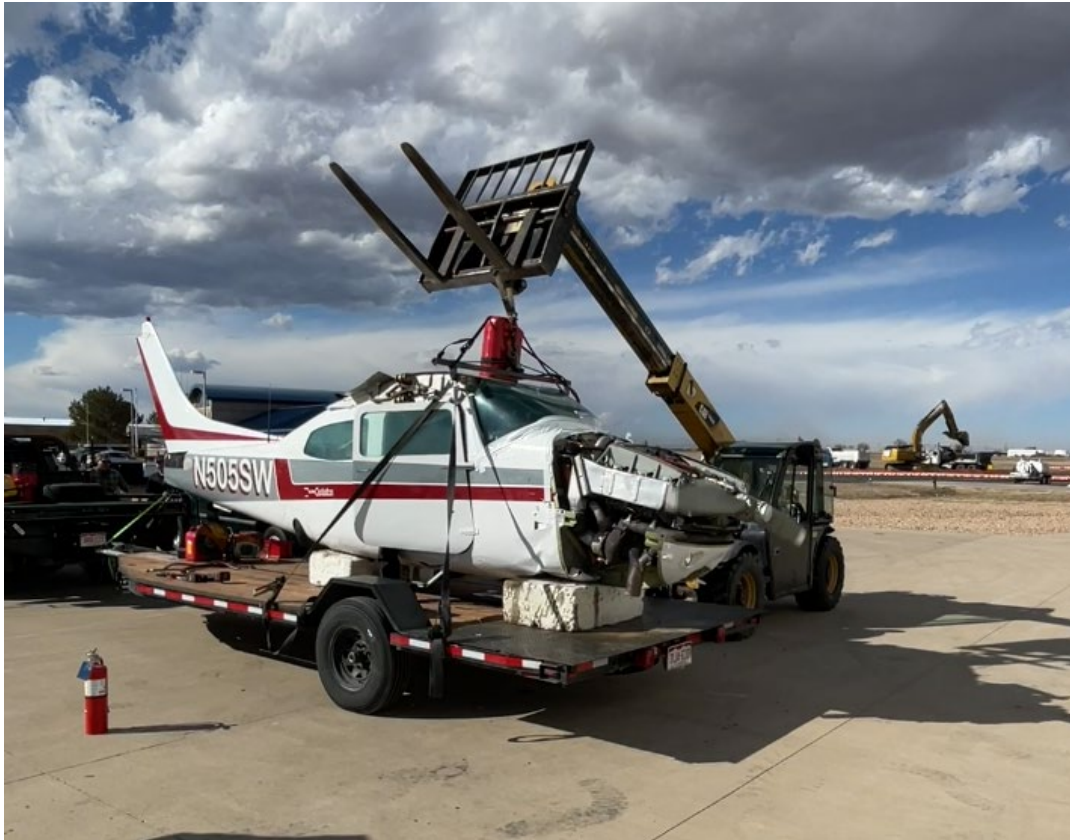
The original propeller blades were bent, rendering it unsuitable for use during engine run; it was removed and replaced with a surrogate. The damaged fuel line between the left collector tank and the fuel selector was removed and a temporary fuel can was plumbed into the left inlet of the fuel selector and the fuselage was mounted to a flatbed trailer. The engine started without hesitation, could attain 2,700 RPM, and idled at about 700 RPM. The mag drops were 75/100.

The fuel selector was moved to the right fuel tank position, causing fuel to be drawn from the right collector tank. The engine ran for another 6 minutes at about 1800 RPM. (See Fig. 3.)

Fig 3: The airplane mounted on a trailer with the engine running.

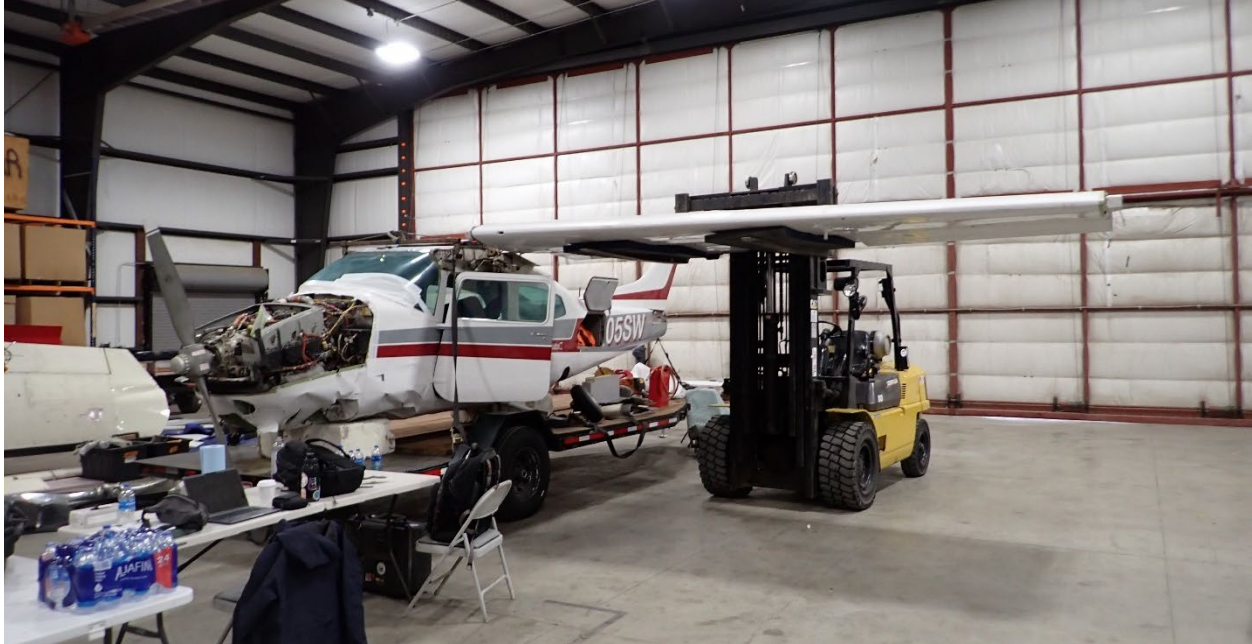
The wings were each raised using a forklift and moved adjacent to their respective wing roots. (See Fig 4.) The wiring for the fuel quantity indicators was reconnected, and the wings were situated to simulate dihedral. Fuel was added to each wing fuel tank in increments, and the corresponding fuel gauge was read at each increment. The following observations were made:

Fig 4: Airplane with left wing raised to fuselage and leveled.
