# National Transportation Safety Board

Office of Research and Engineering

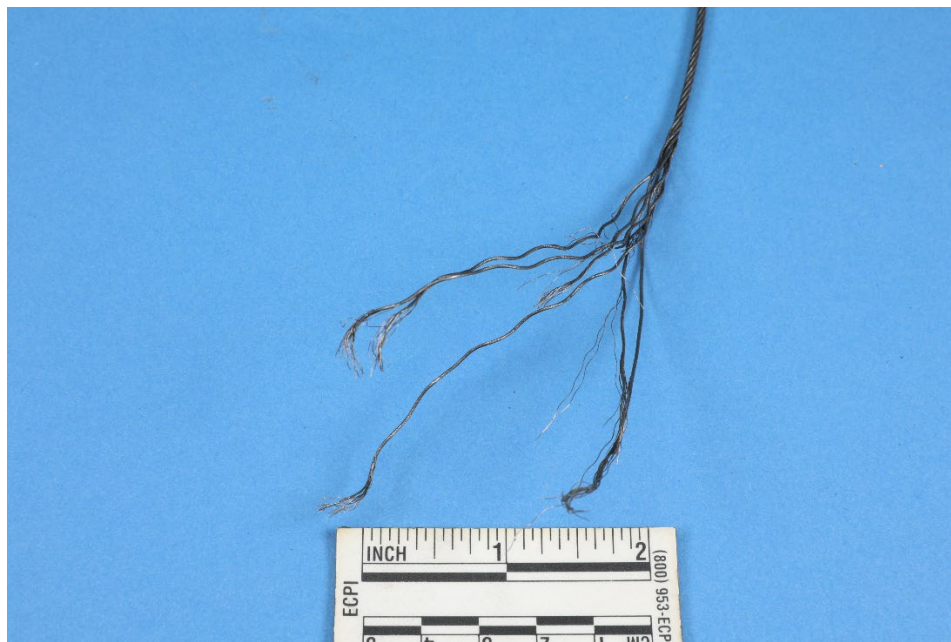
**Figure 4.** Fractured end of cable portion "A".

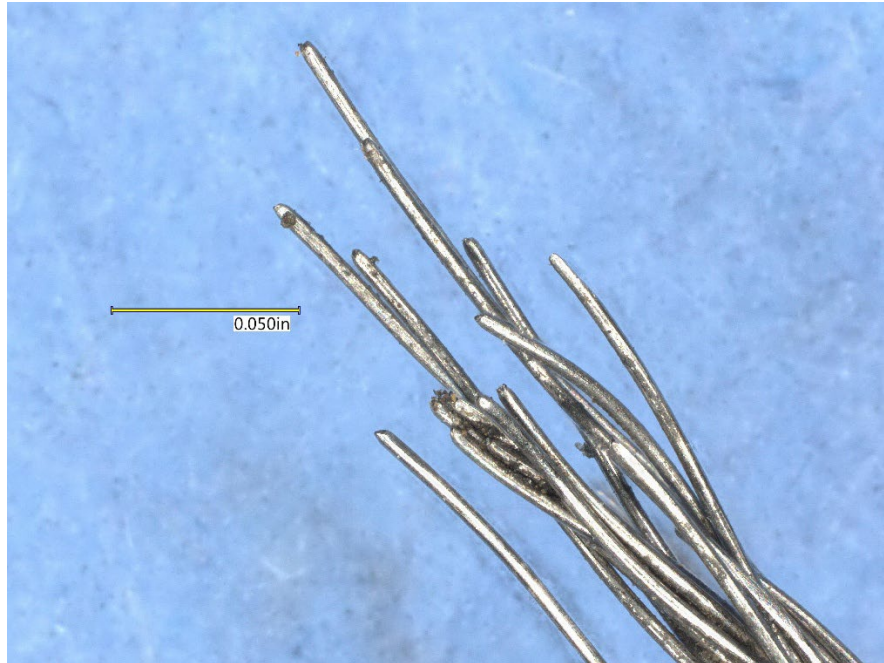
**Figure 5.** Fractured wires on cable portion "A".

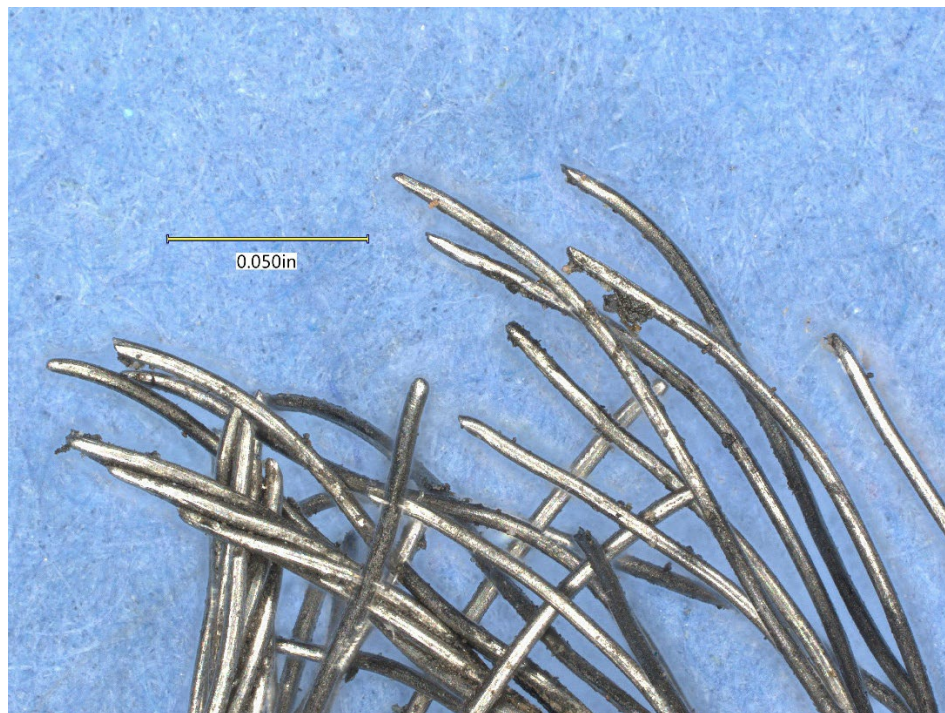
**Figure 6.** Fractured wires on cable portion "A".

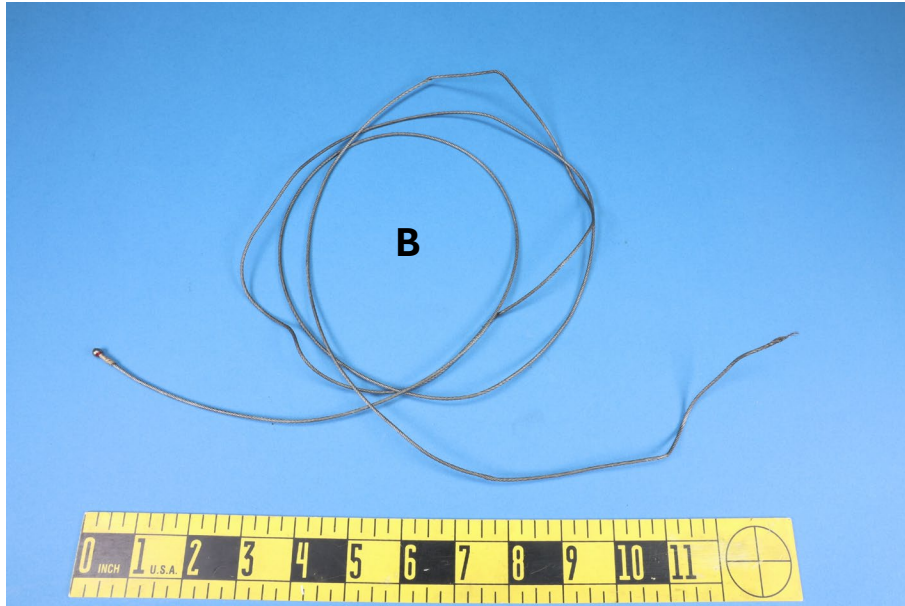
**Figure 7.** Control cable portion "B".

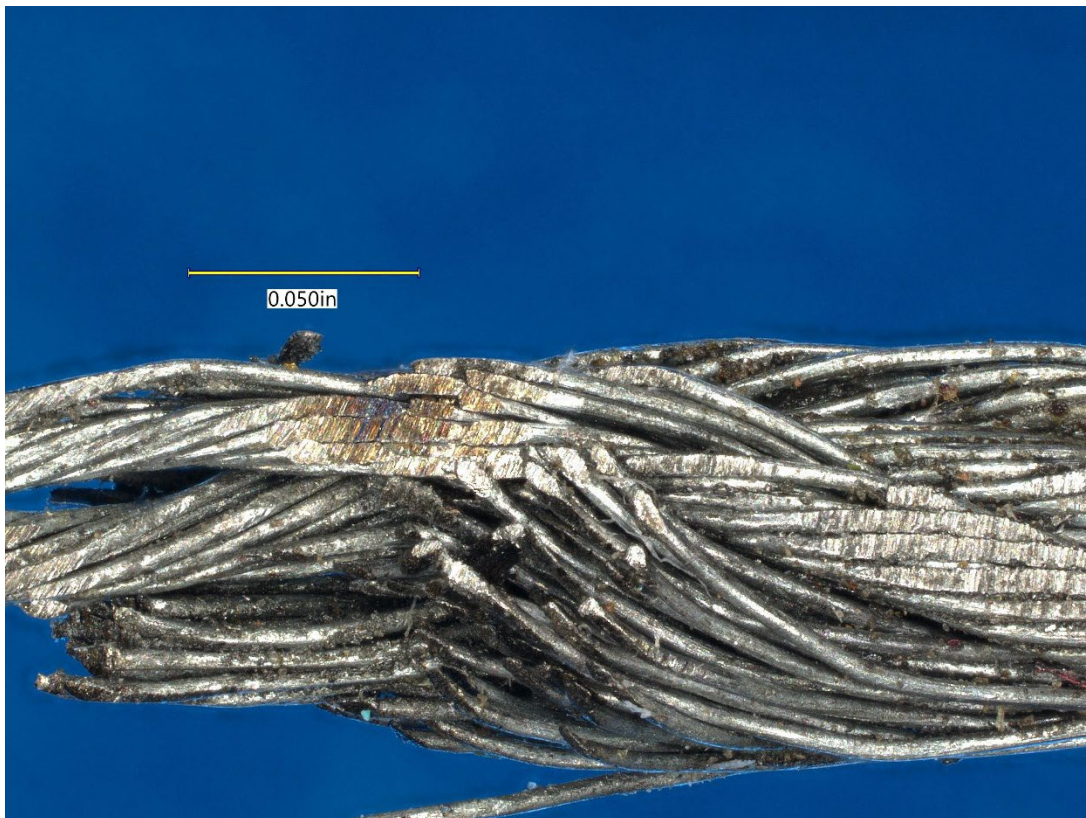
**Figure 8.** Fractured end of cable portion B.

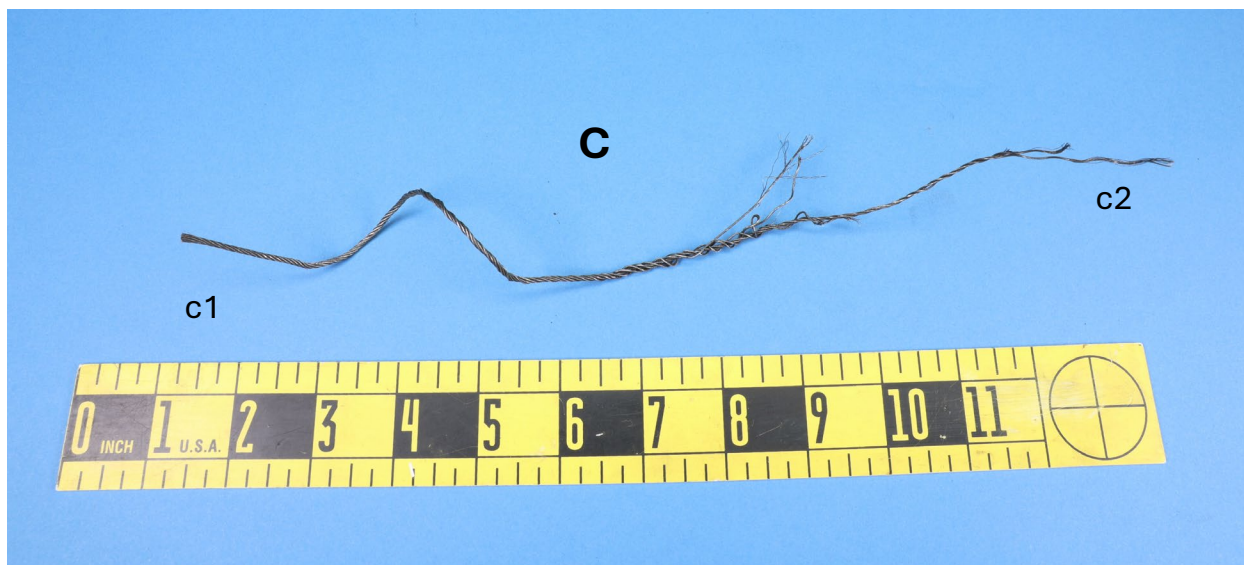
**Figure 9.** Control cable portion "C".
