WPR25LA080

## INVESTIGATION PHOTOGRAPHS

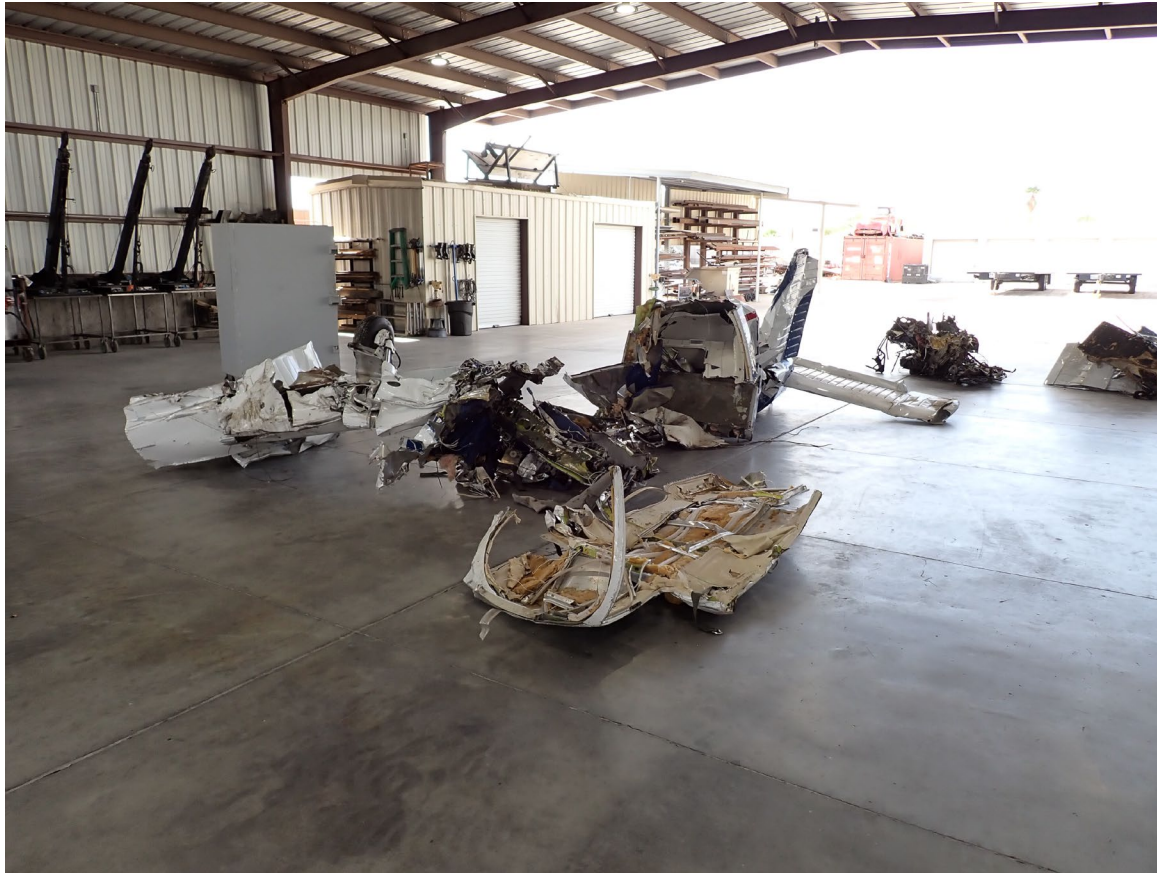
**Photograph 1 - Airplane wreckage layout following initial recovery**

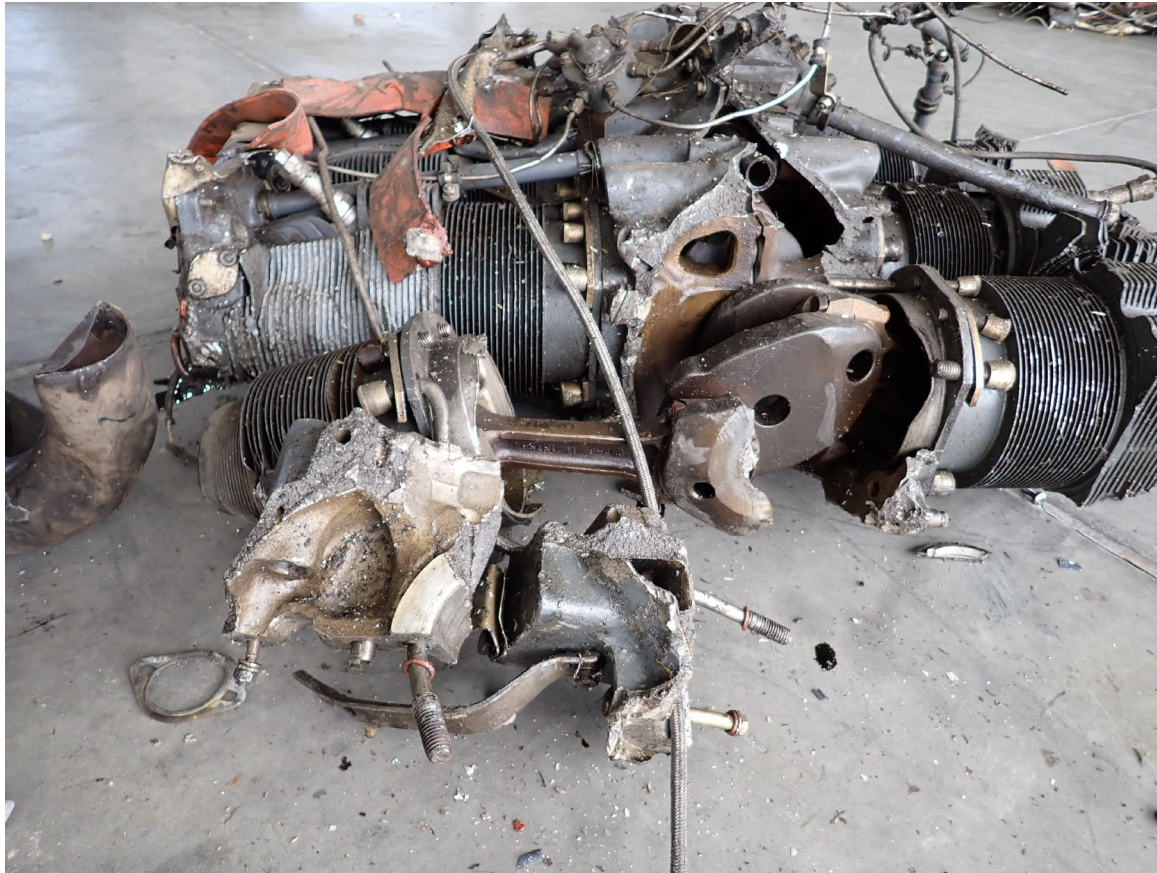
**Photograph 2 - Forward engine case during initial layout**

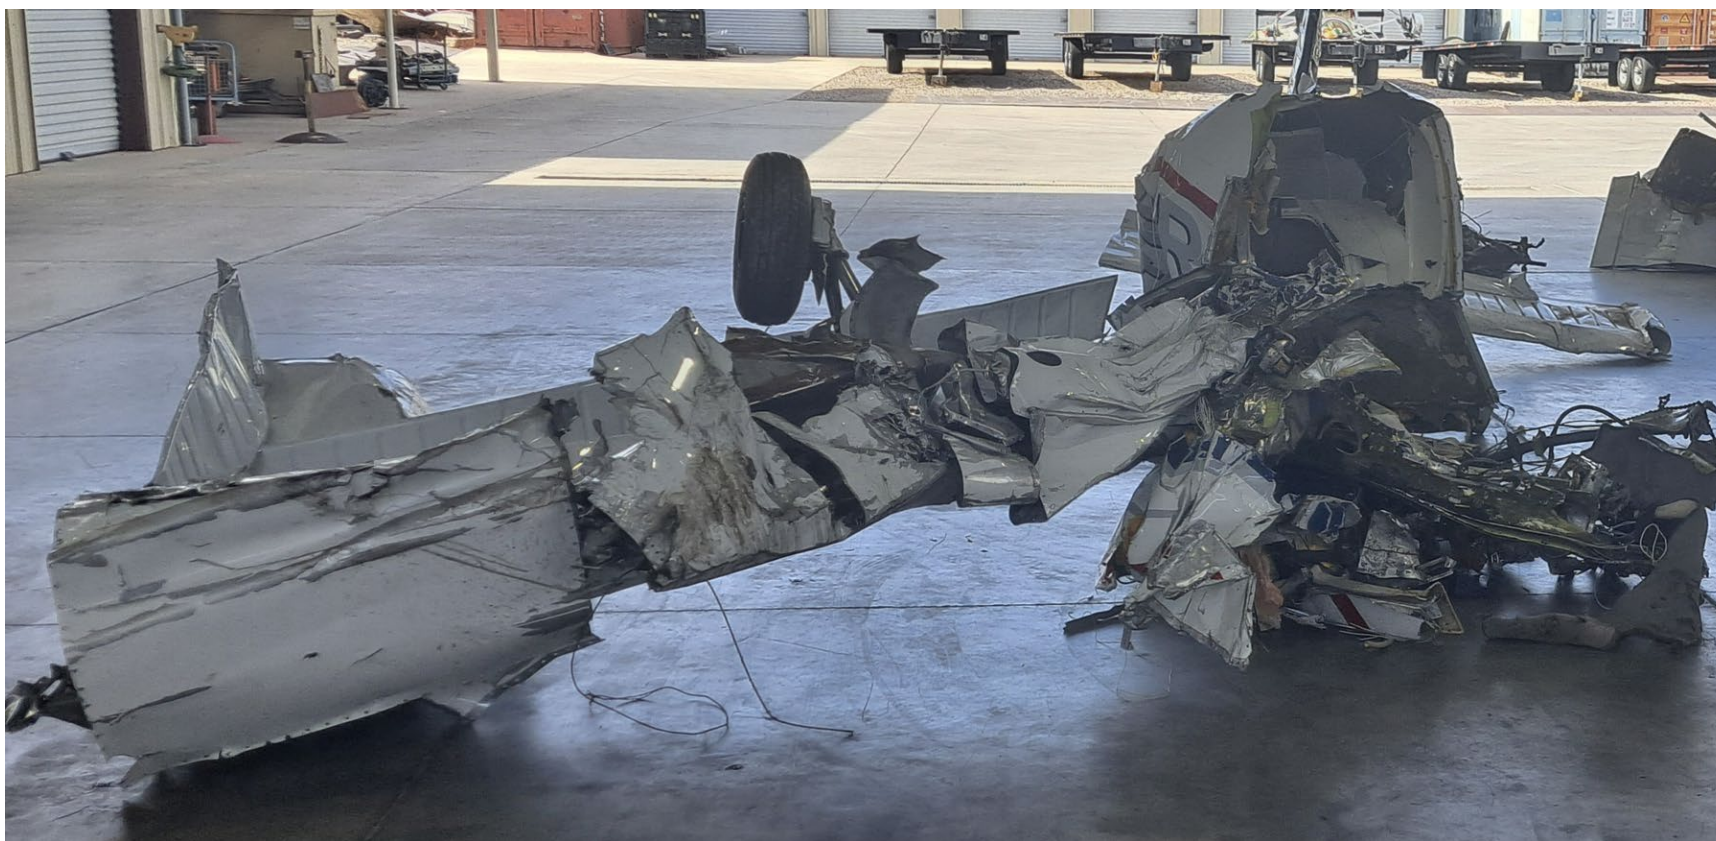
**Photograph 3 - Left wing and fuselage during initial layout (Courtesy of Piper Aircraft Company)**

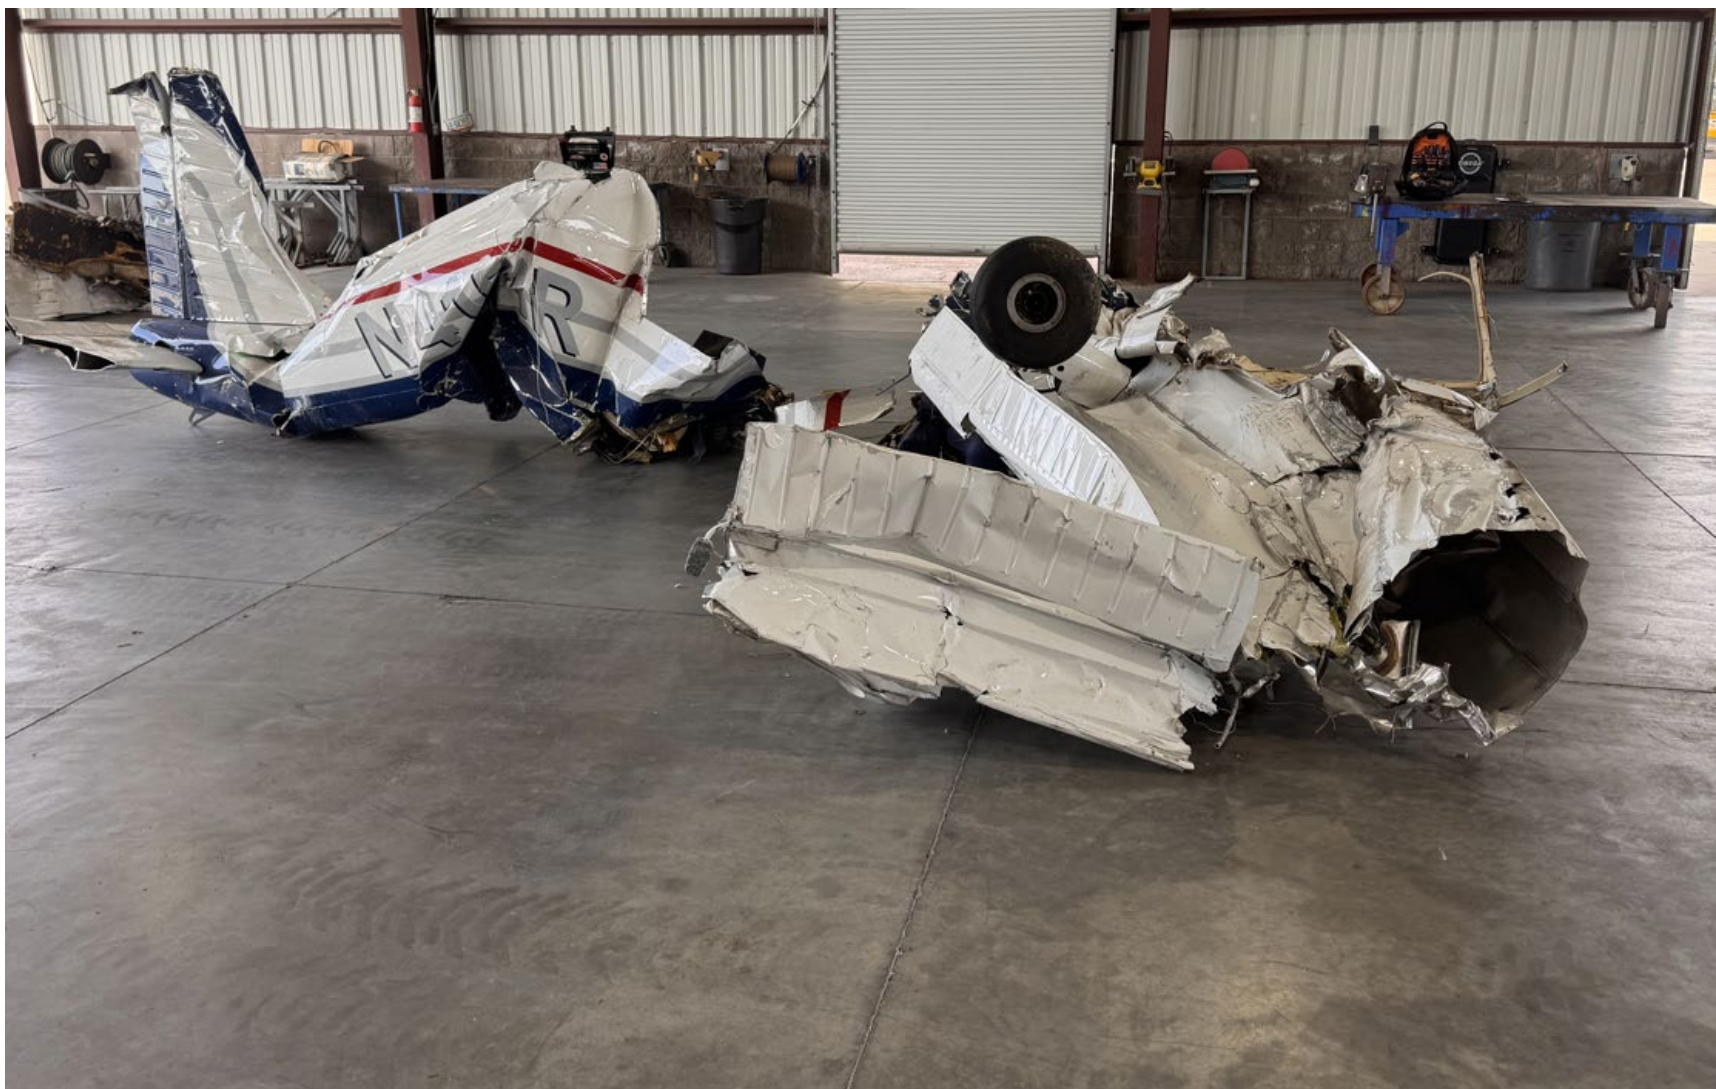
**Photograph 4 - View of left wing during initial layout (Courtesy of Federal Aviation Administration)**

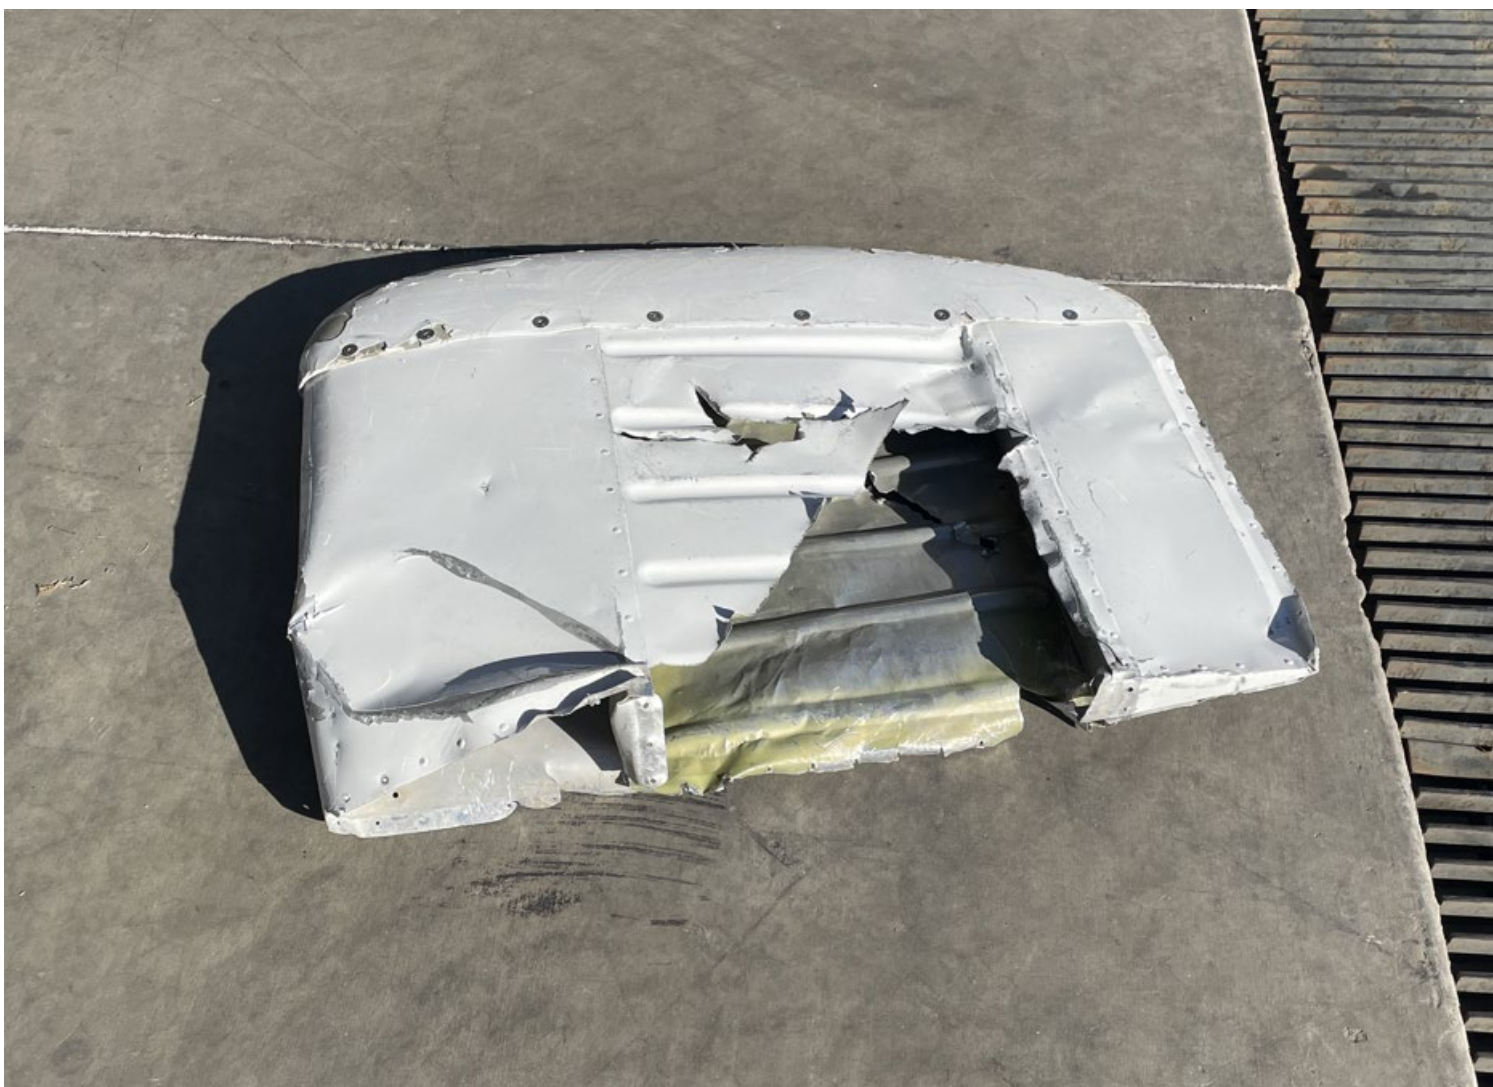
**Photograph 5 - Right stabilator end cap after second retrieval**

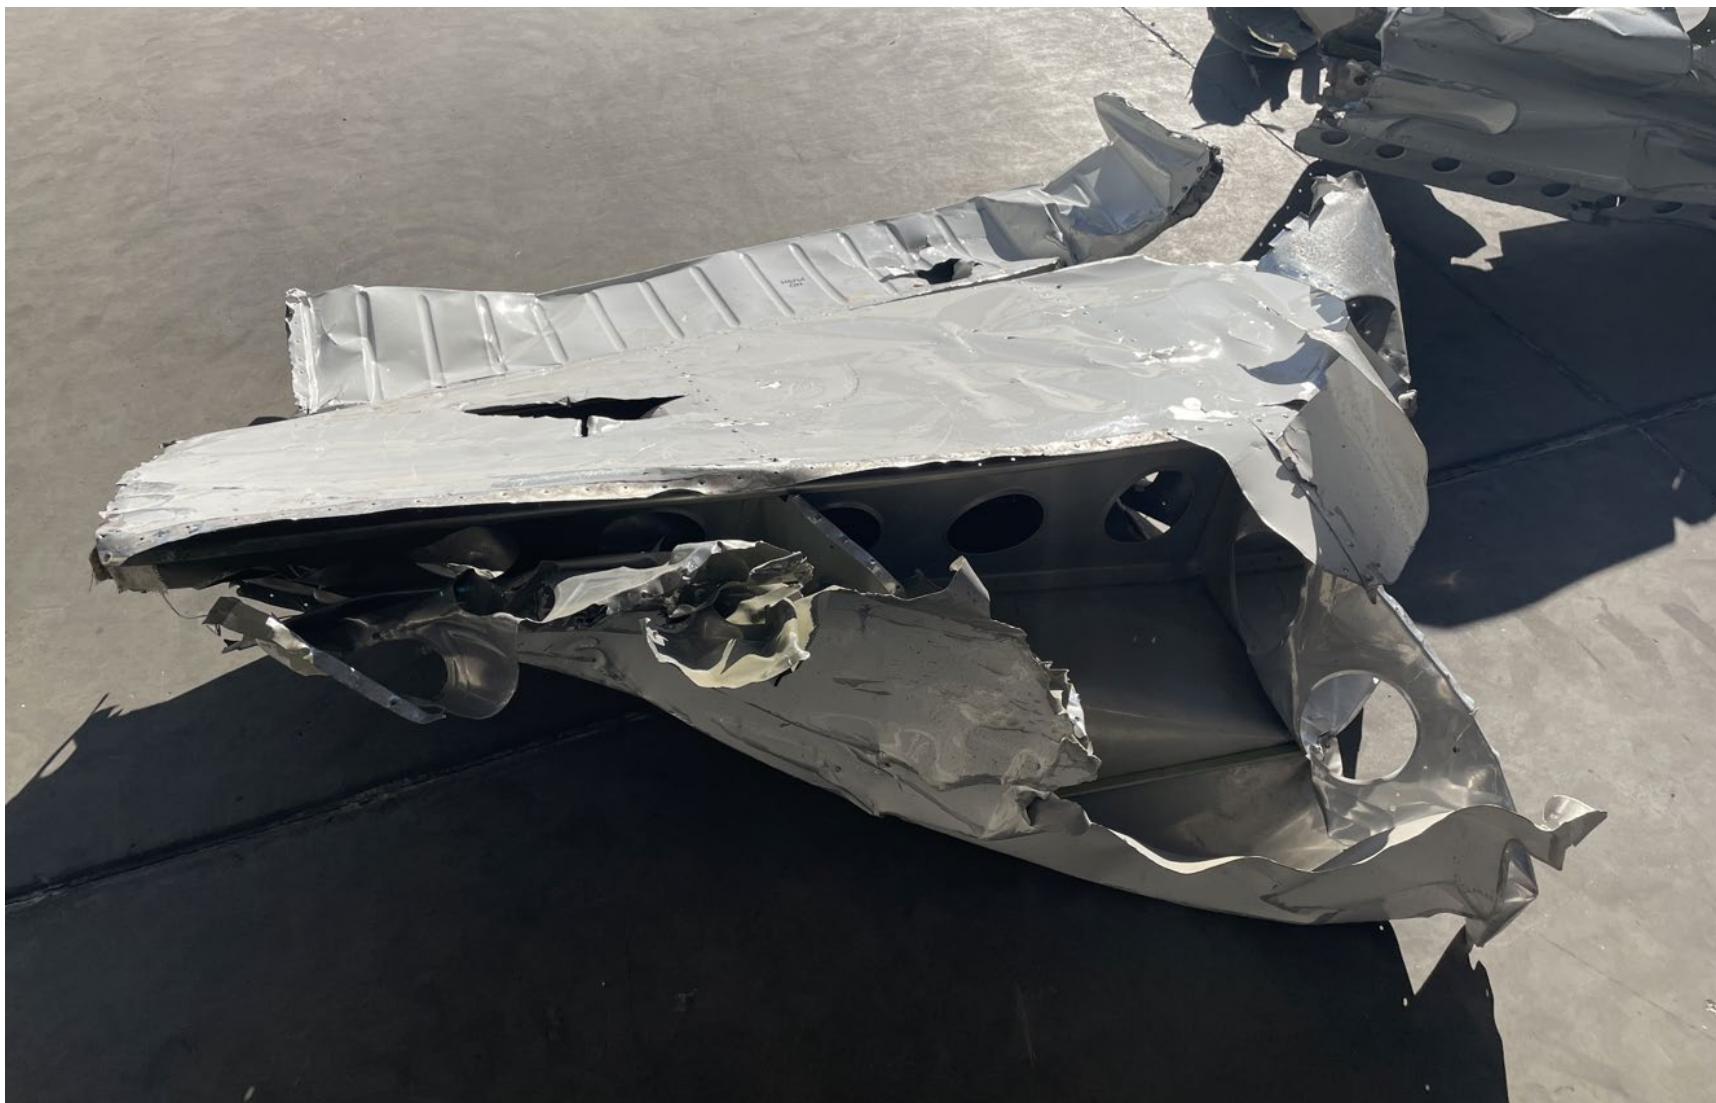
**Photograph 6 - Inboard right wing section after followup retrieval**

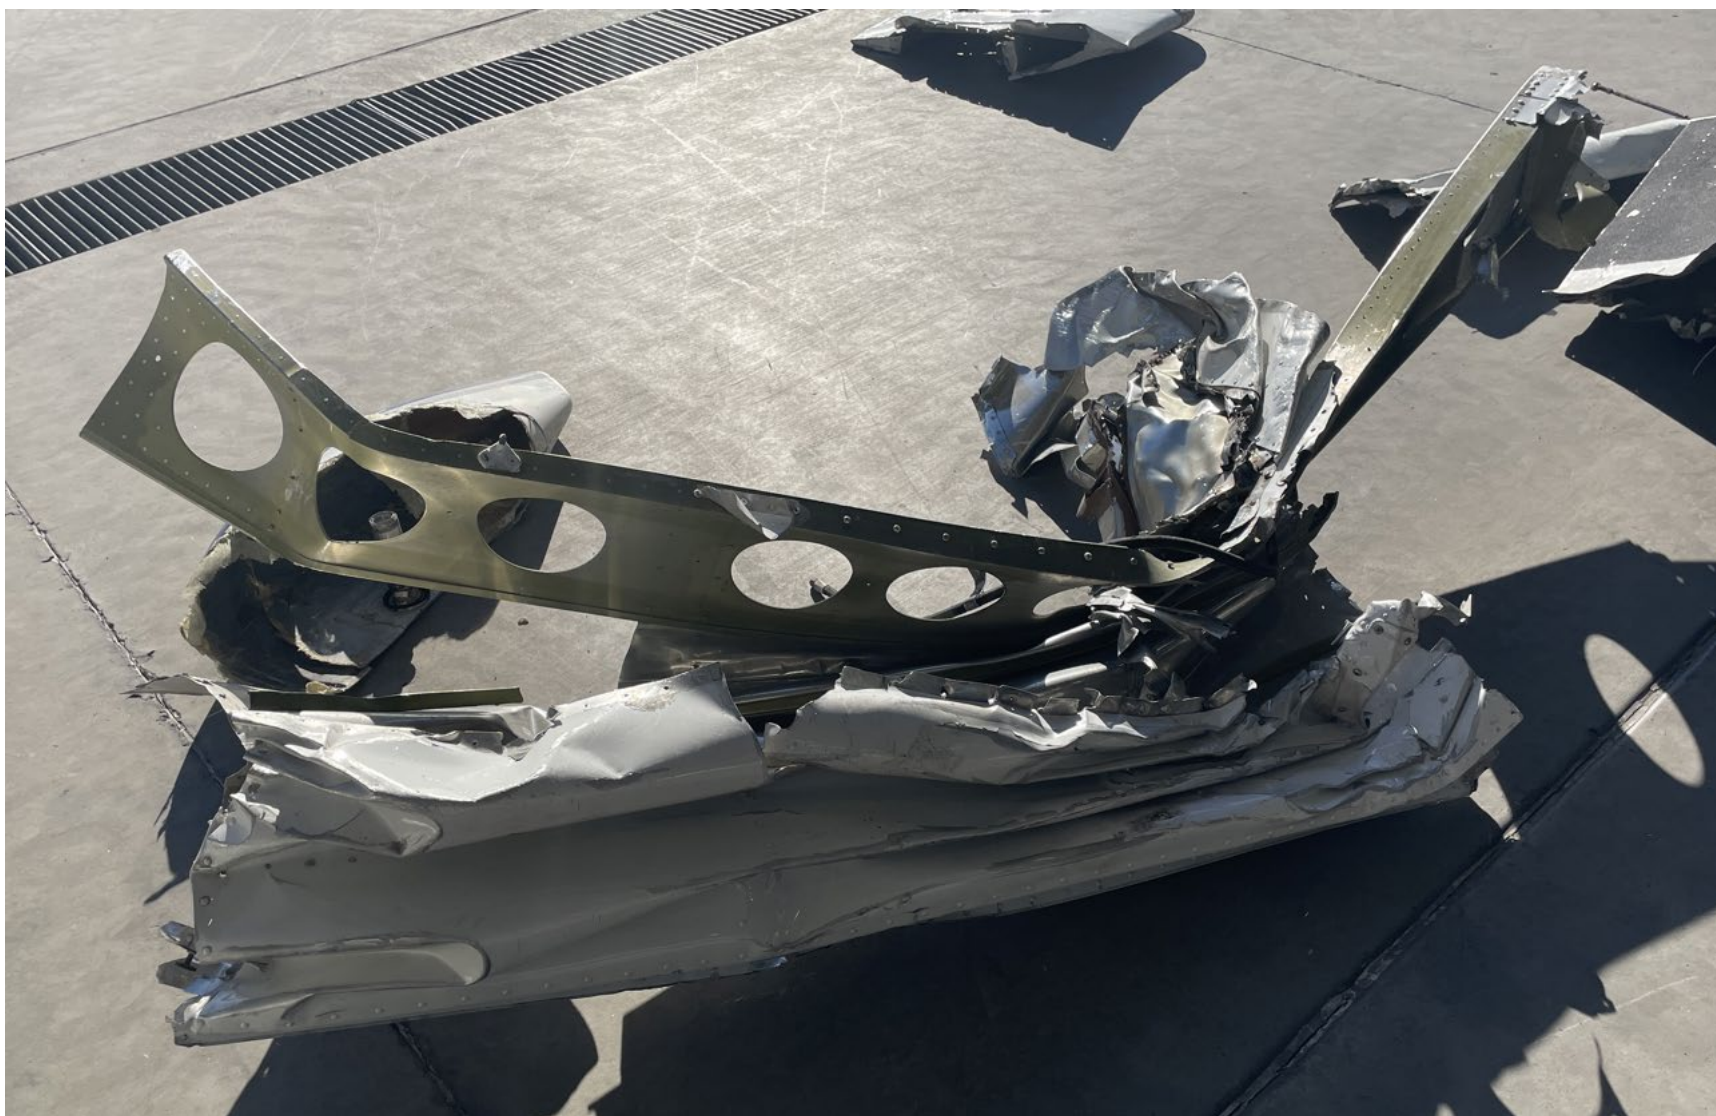
**Photograph 7 - Midspan right wing after followup retrieval**
