# National Transportation Safety Board

WPR25LA080

## **WRECKAGE EXAMINATION REPORT**

Location: Round Mountain, Nevada  
Date: January 2, 2025  
Time: 1230 Pacific standard time  
Airplane: Piper PA-32-300, Registration N4151R

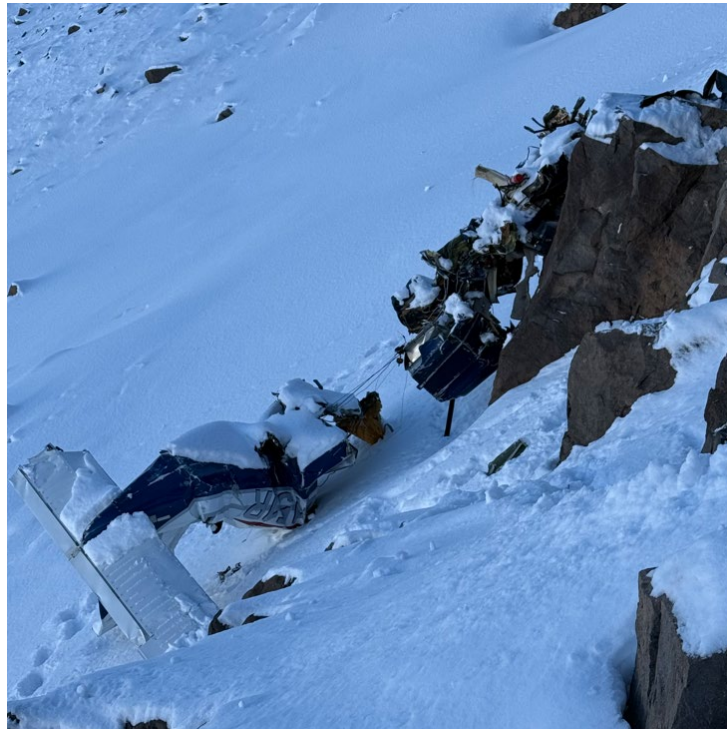
The wreckage was located by law enforcement about 60 nm north of the last recorded ADS-B data point at the base of the northeastern face of Mt. Jefferson at an elevation of about 11,000 ft msl. Photographs provided by the recovery team showed that the main wreckage came to rest at the base of a mountain ridge. The empennage, comprised of the vertical stabilizer, rudder, horizontal stabilizer, and stabilator, was separated from the fuselage and collocated with the main wreckage. The left wing, fuselage, and engine compartment came to rest a few ft from the main wreckage.

**Figure 1: Airplane at accident site (courtesy of recovery team)**
