# National Transportation Safety Board

WPR25LA082

## **ONBOARD IMAGE RECORDER**

Location: Columbia, California  
Date: January 23, 2025  
Time: 1515 Pacific Standard Time (PST)  
2315 Coordinated Universal Time (UTC)  
Airplane: Cessna 172K, private operator, N79910

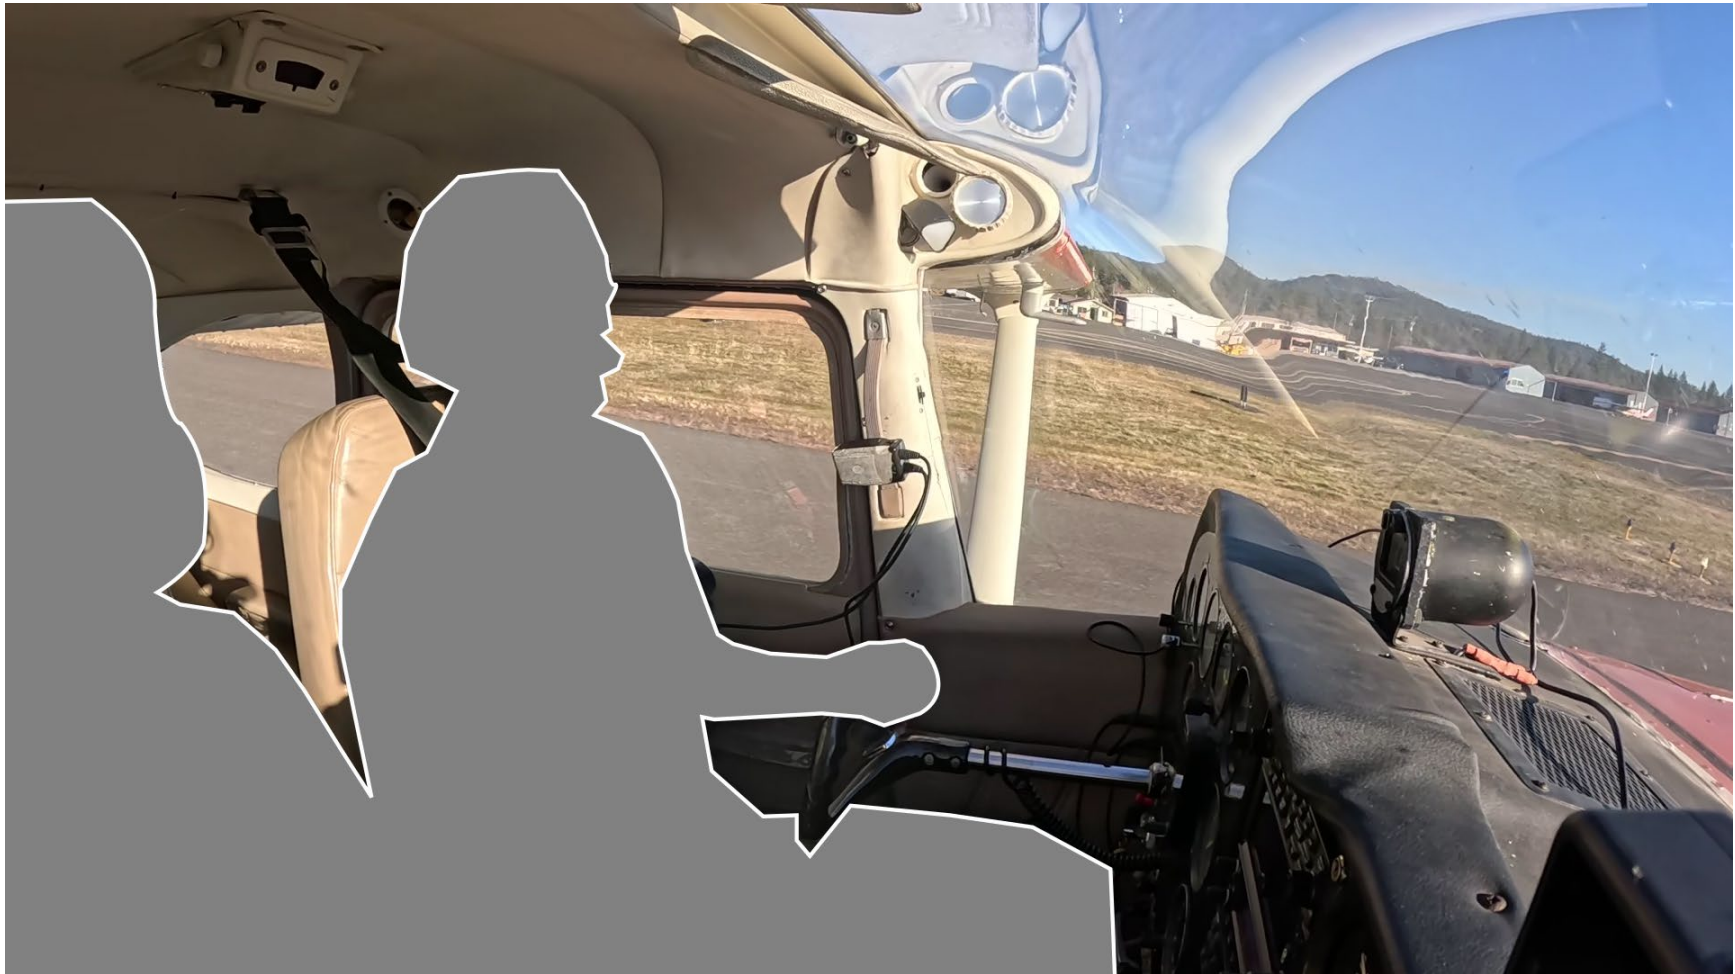
| <b>Video Elapsed Time (MM:SS)</b> | <b>Observation</b> |
|---|---|
| <b>32:20</b> | Approximate time that the aircraft touched the runway. The aircraft was approximately 1,885 feet past runway 17's threshold (see figure 1). The throttle quadrant was obstructed. |

**Figure 1.** Approximate point of touchdown at O22 before go-around initiation.

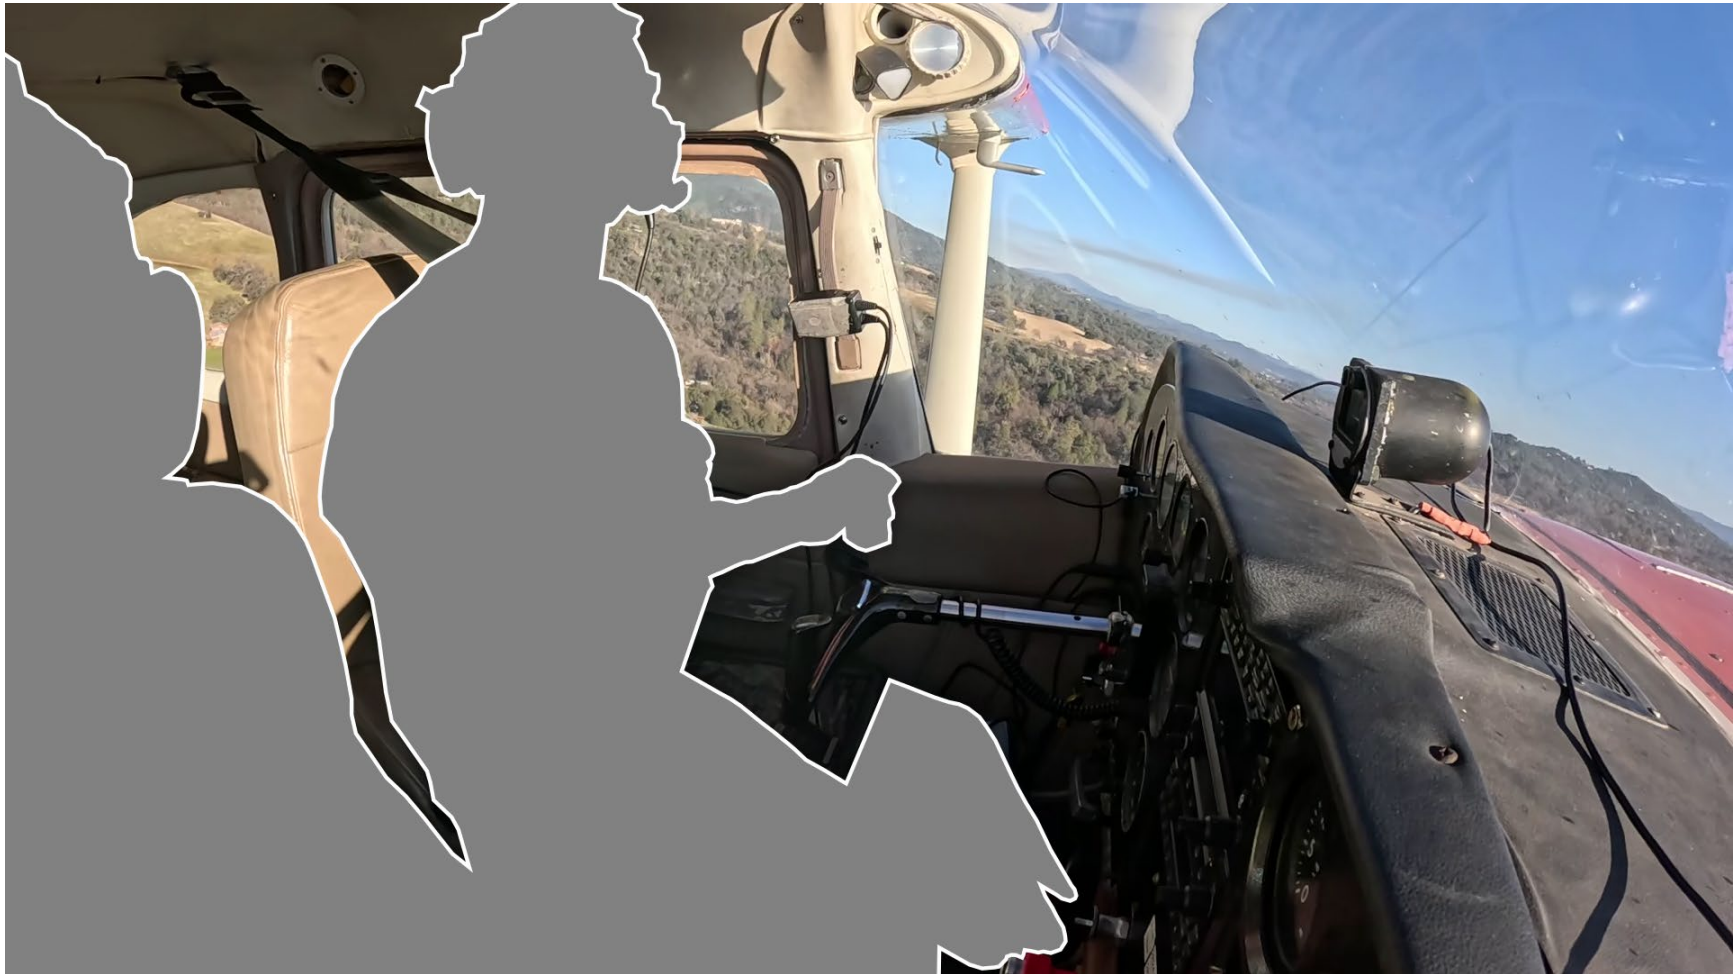
| <b>Video Elapsed Time (MM:SS)</b> | <b>Observation</b> |
|---|---|
| <b>34:58 - 35:42</b> | The pilot initiated and leveled out from a 180-degree turn back to O22. At the initiation of the turn, the aircraft was approximately 2.55 miles from the displaced threshold of runway 35 at O22. During the turn, the throttle quadrant was visible (see figure 2). |

**Figure 2.** Approximate position where the aircraft began to turn back towards the airport.

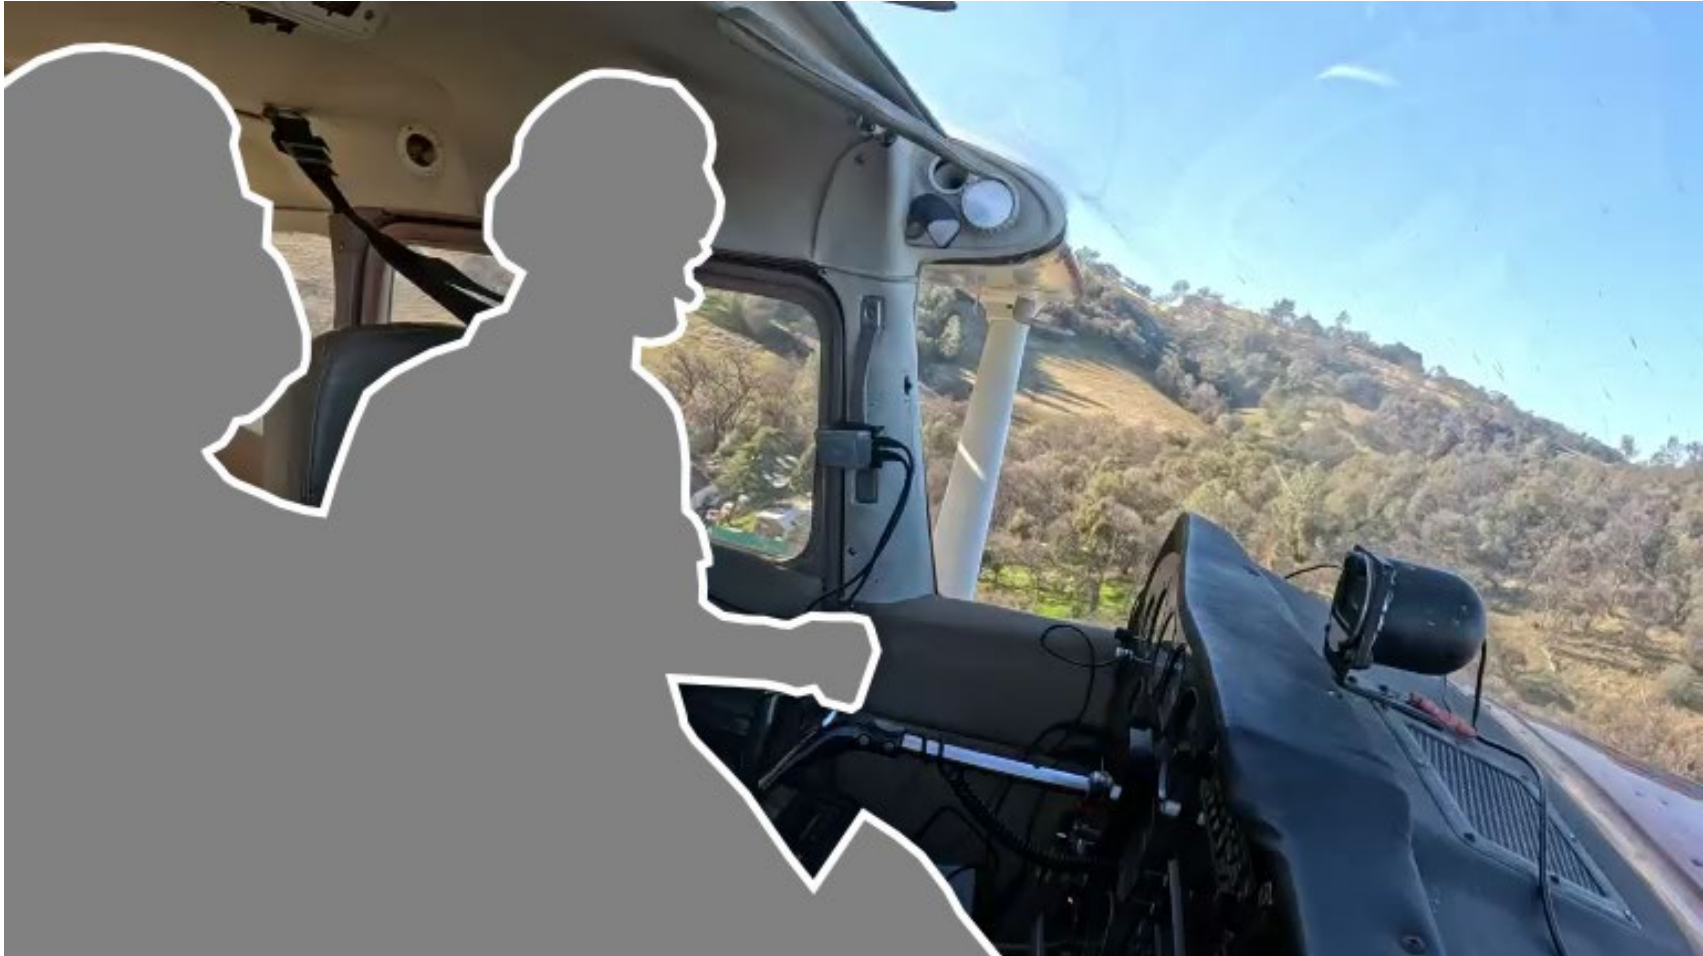
| <b>Video Elapsed Time (MM:SS)</b> | <b>Observation</b> |
|---|---|
| <b>37:11</b> | End of recording. The aircraft was still flying. The aircraft was getting closer to terrain (see figure 3). From this approximate position, the aircraft was 1,592 feet from the reported wreckage location. |

**Figure 3.** Final still image of the recording.

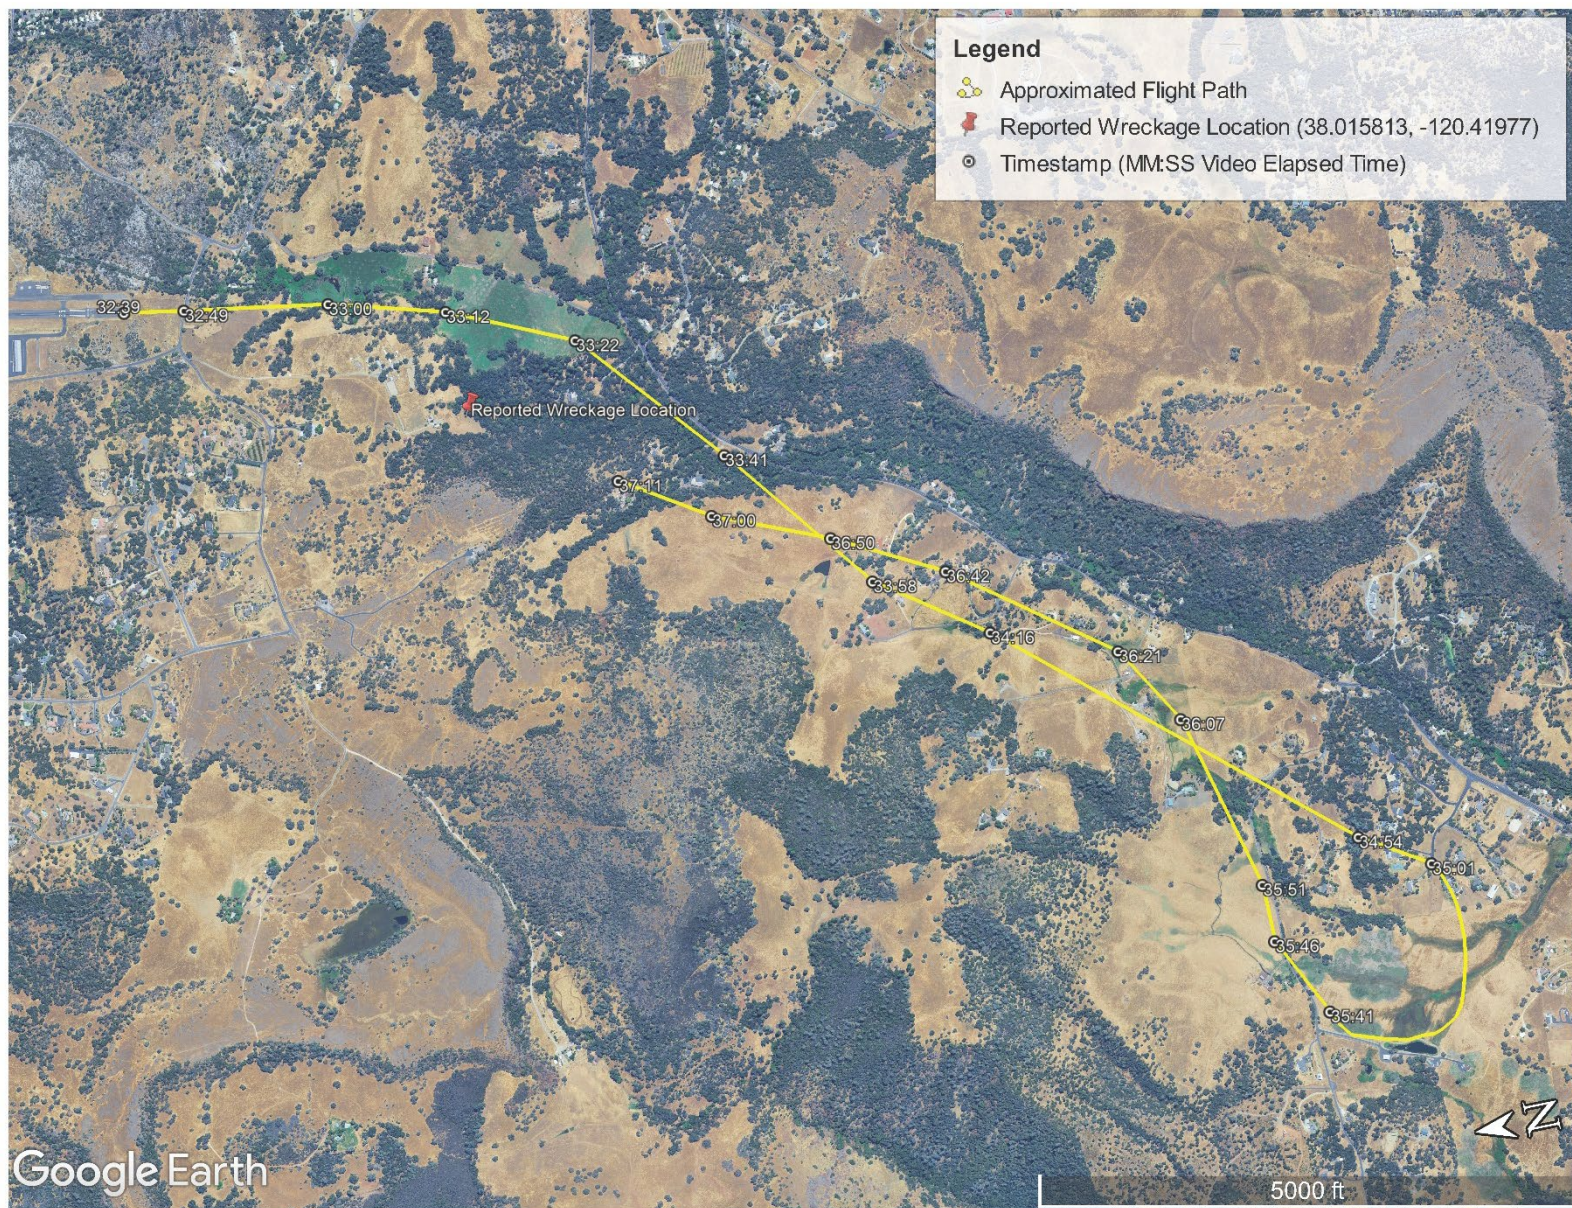
Figure 4 shows the approximated flight path of the aircraft. The weather and lighting conditions in Google Earth are not necessarily representative of the weather and lighting conditions present at the time of the recording. Note that the flight path isn't exact, and that the timestamp presented reflect an estimated location based on the video footage and comparison to Google Earth.

**Figure 4.** ADS-B recreation after the go-around.
