WPR25LA086

## INVESTIGATION PHOTOGRAPHS

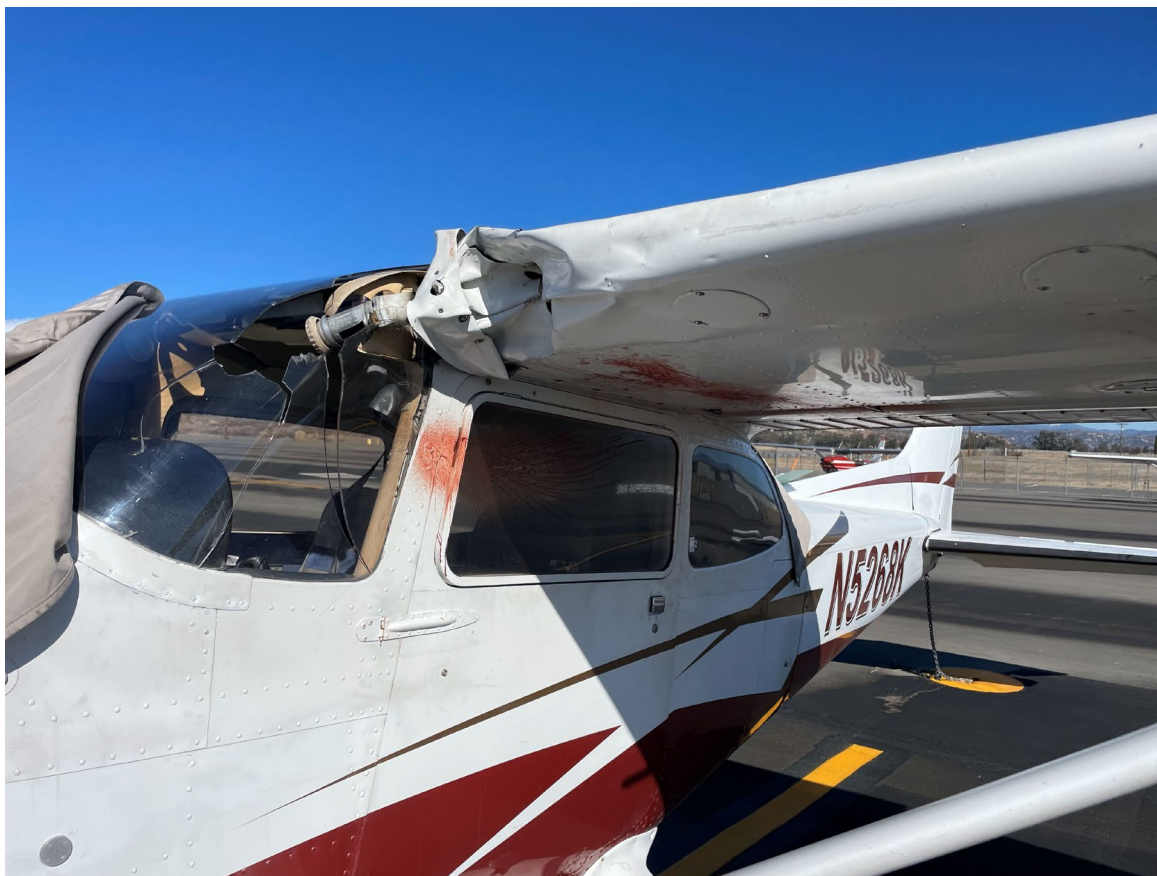
**Photograph 1 - N5268K, showing substantial damage to the left wing. Source airport operations.**
