# National Transportation Safety Board

WPR25LA096

## **MATERIALS LABORATORY**

Factual Report 25-036

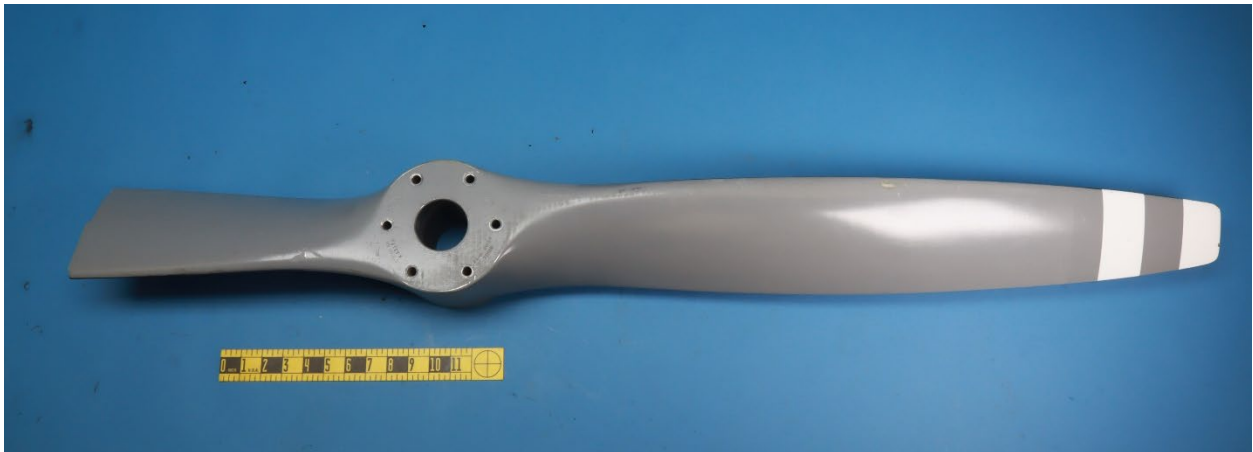
Portion of a Sensenich propeller Model: M74DM-0-58, SN: K13773 (Figure 1)

**Figure 1.** Portion of the propeller as received.

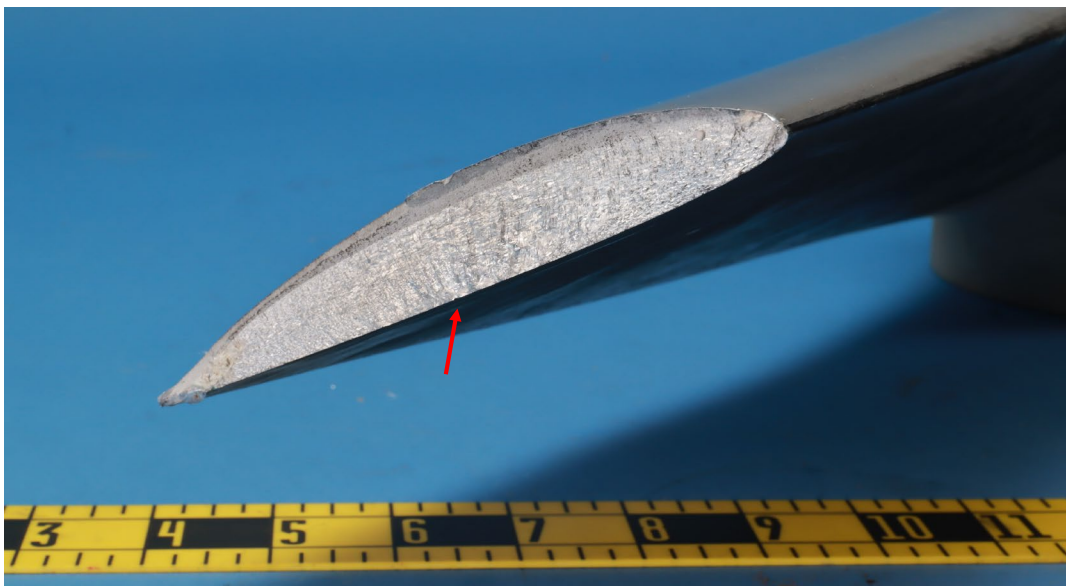
The propeller examined was a fixed pitch propeller with a blade fracture approximately 17 inches from the hub. The fracture surface was a flat fracture perpendicular to the blade's length and exhibited a narrow slant fracture region along the blade back (Figure 2). The fracture features were consistent with a fatigue crack. The fracture initiated in a location approximately in the middle of the blade face and progressed towards the blade back where the final separation was due to overstress of the reduced cross section. The fatigue crack extended over approximately 79% of the blade's cross section. Examination of the fatigue crack origin revealed a pit that had been painted over (Figure 3).

**Figure 2.** Fracture surface exhibiting a flat fracture and shear lip along the blade back. Fracture origin indicated by the red arrow.

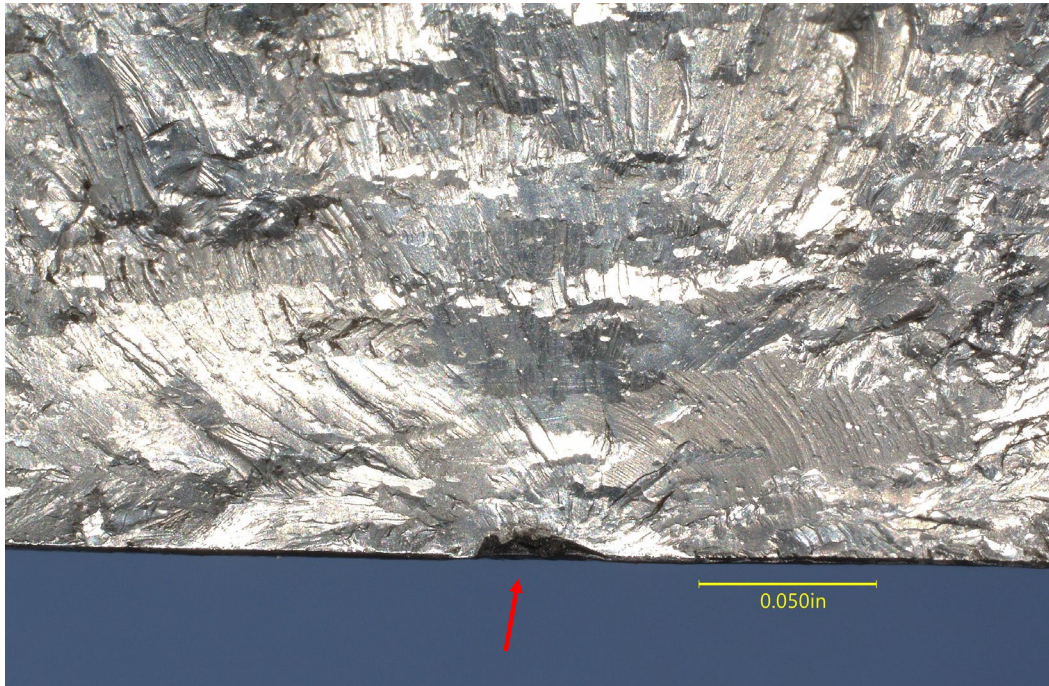
**Figure 3.** Closeup of the fatigue crack origin with a pit that had been painted over. Crack arrest fronts can also be seen emanating from the origin location.

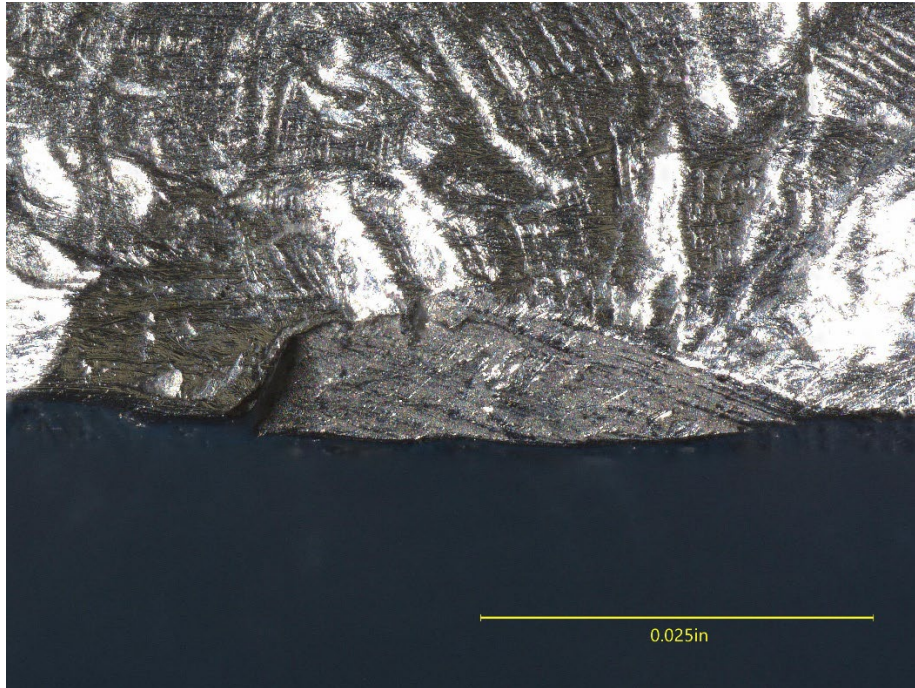
The propeller's paint was stripped along a section of the propeller face near the origin to examine the pit and the surrounding area. The origin pit exhibited material displacement which caused a raised edge along the periphery of the pit and linear scars in the pit. The features of the origin pit were consistent a gouge caused by particle impact (Figure 4, 5). The paint stripped area of the blade face was examined and found to have multiple pits and gouge marks (Figure 6). Examination of the highlighted pits revealed features consistent with particle impact (Figures 7 - 11).

**Figure 4.** Fatigue crack origin pit with paint removed. View perpendicular to fracture surface.

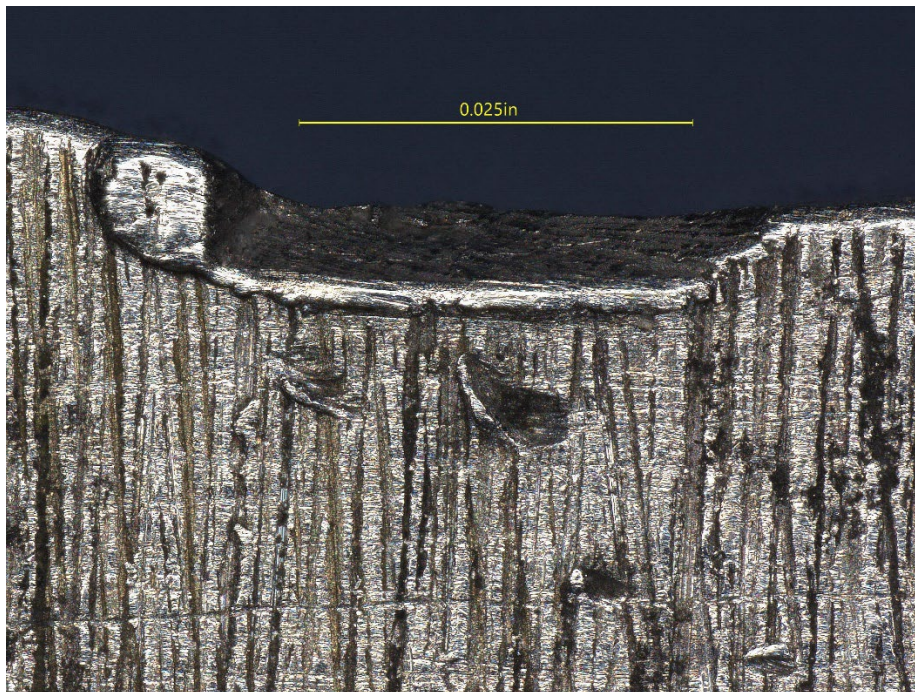
**Figure 5.** Fatigue crack origin pit with paint removed. View perpendicular to blade face.

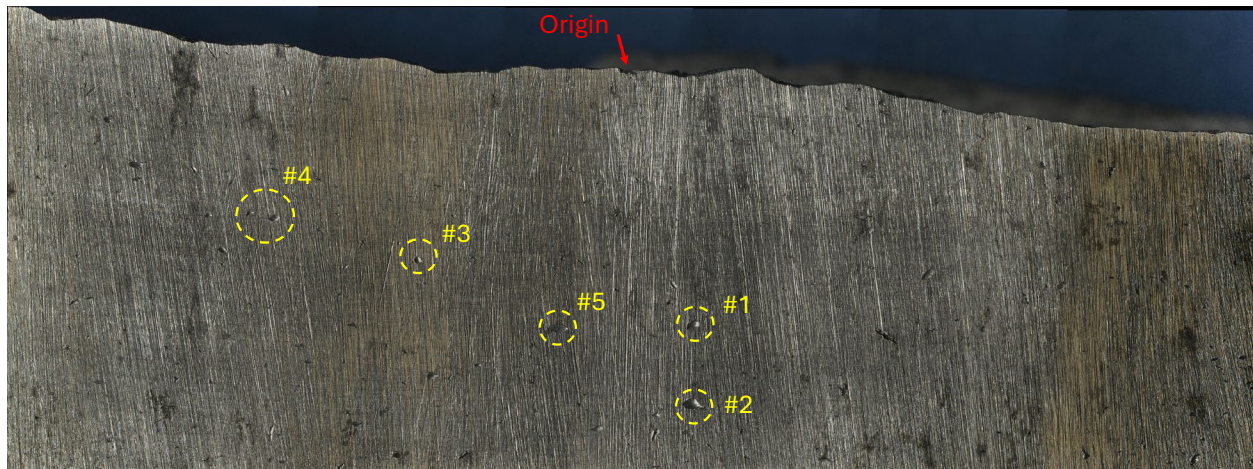
**Figure 6.** Blade face near origin exhibiting multiple pits.
