WPR25LA096

## INVESTIGATION PHOTOGRAPHS

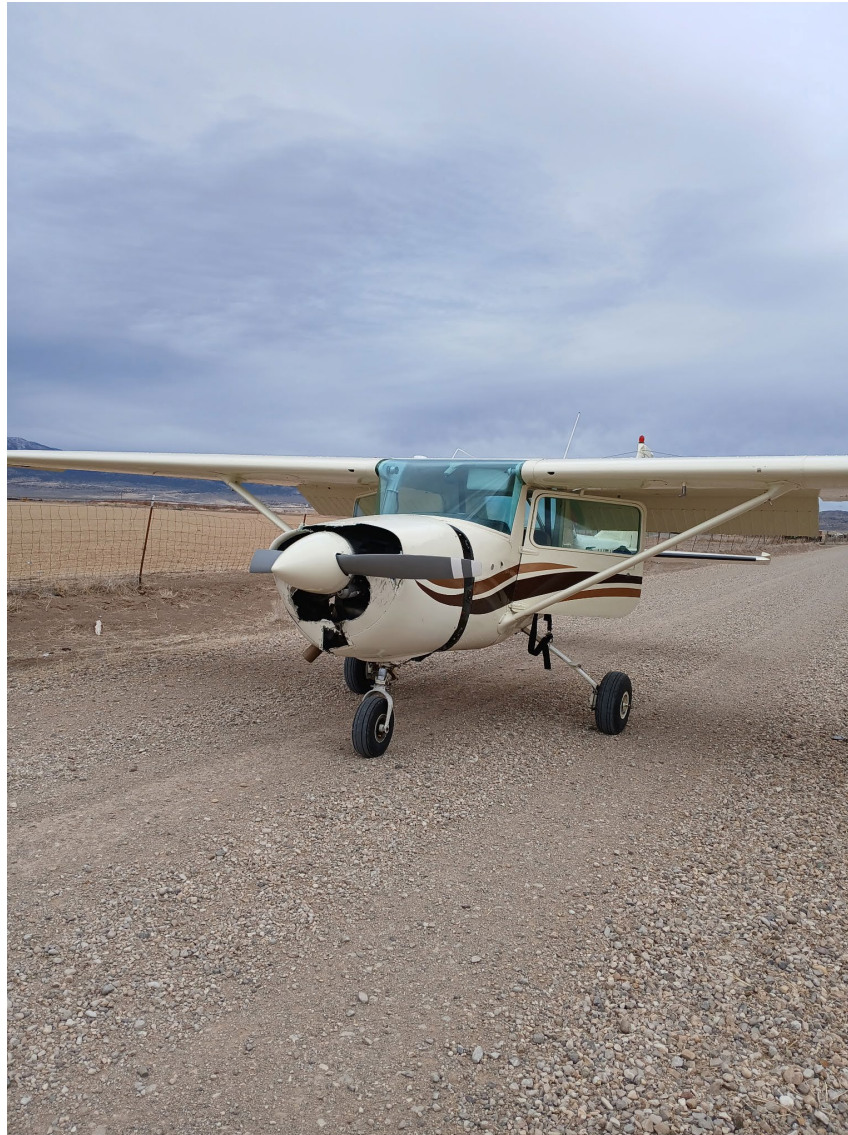
**Photograph 1 - A view of the airplane after completion of the forced landing. (Courtesy of the pilot.)**

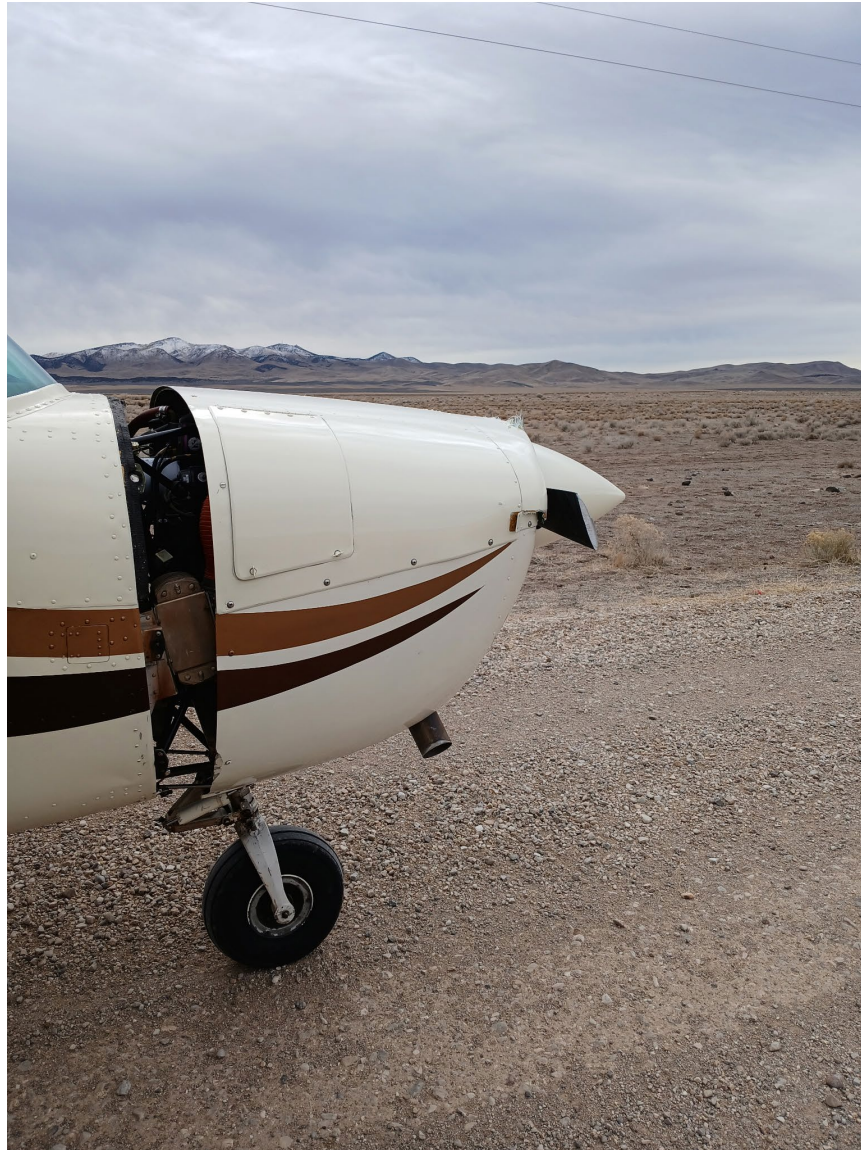
**Photograph 2 - A view of the fractured propeller blade and damaged engine cowlings.  
(Courtesy of the pilot.)**

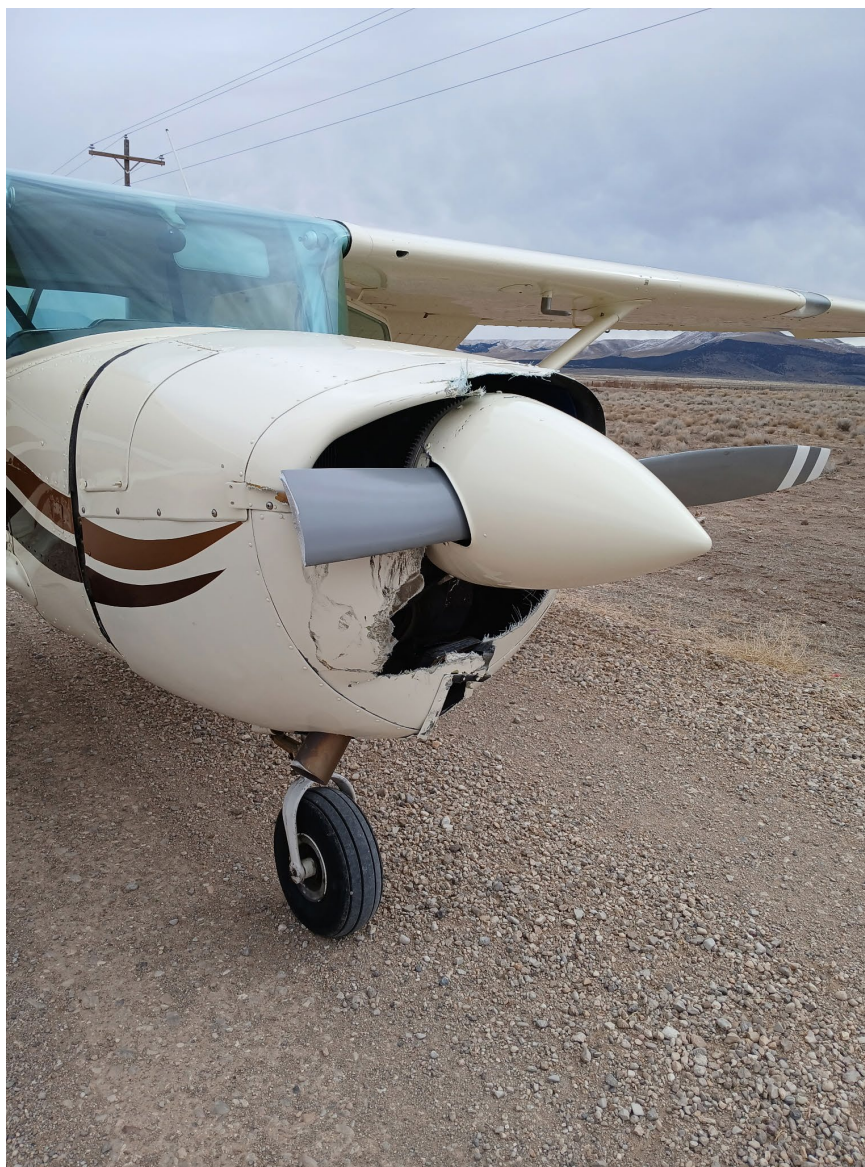
**Photograph 3 - A view of the fractured propeller blade. (Courtesy of the pilot.)**

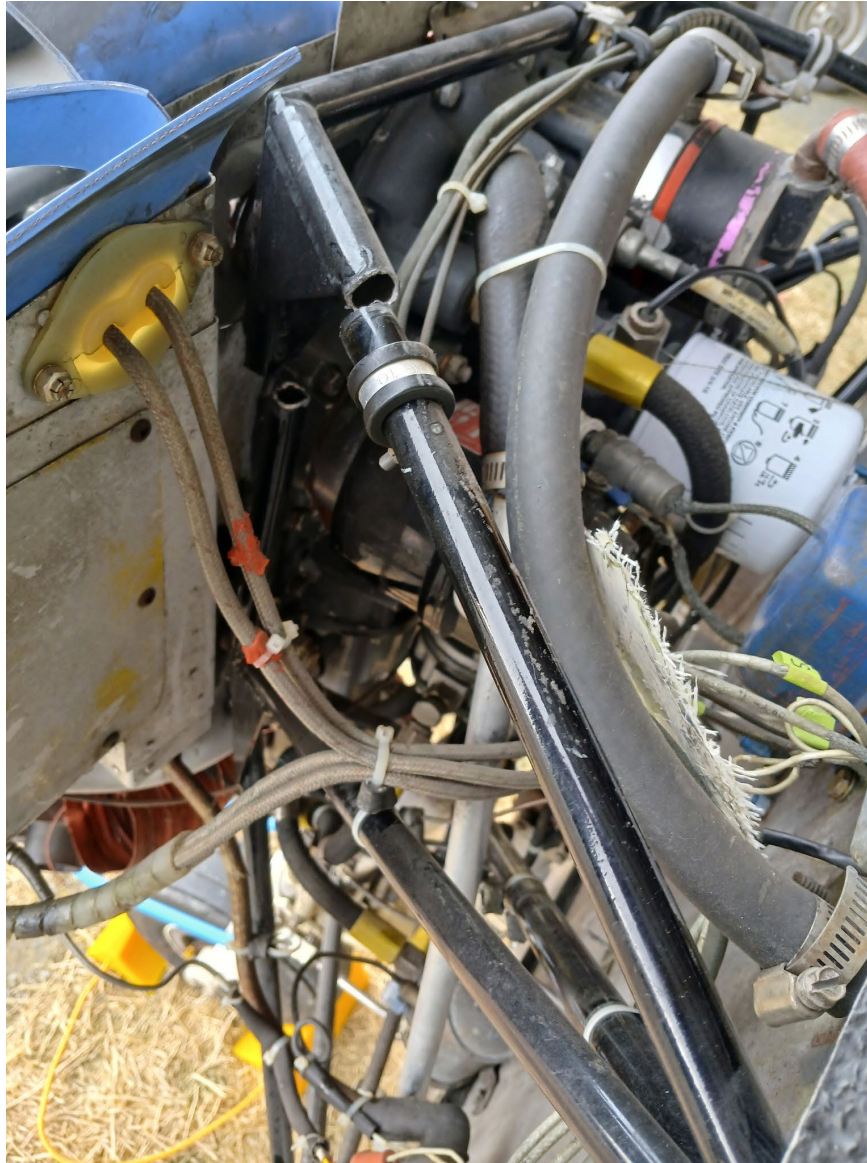
**Photograph 4 - A view of the substantial damage to the engine mount. (Courtesy of the pilot.)**

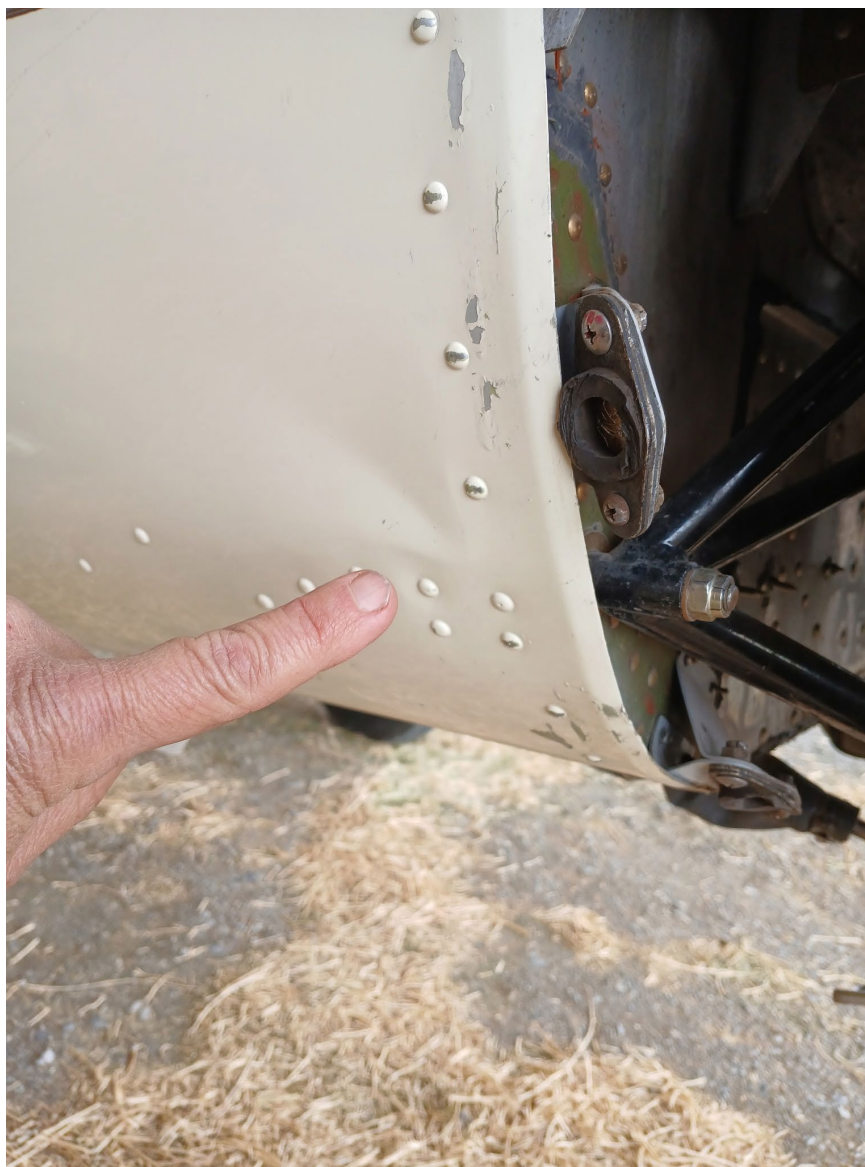
**Photograph 5 - A view of the substantial damage to the fuselage. (Courtesy of the pilot.)**
