WPR25LA105

## INVESTIGATION PHOTOGRAPHS

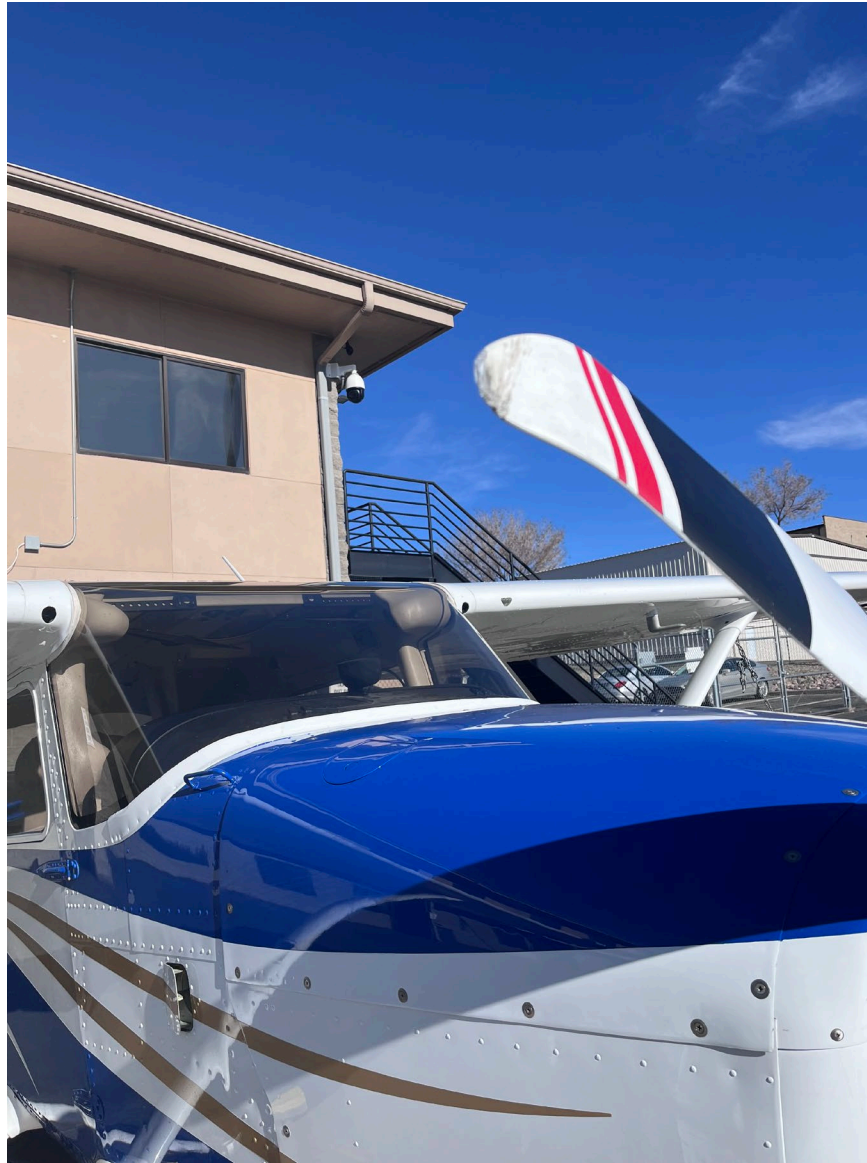
**Photograph 1 - Propeller blade damage (Courtesy of ERAU)**

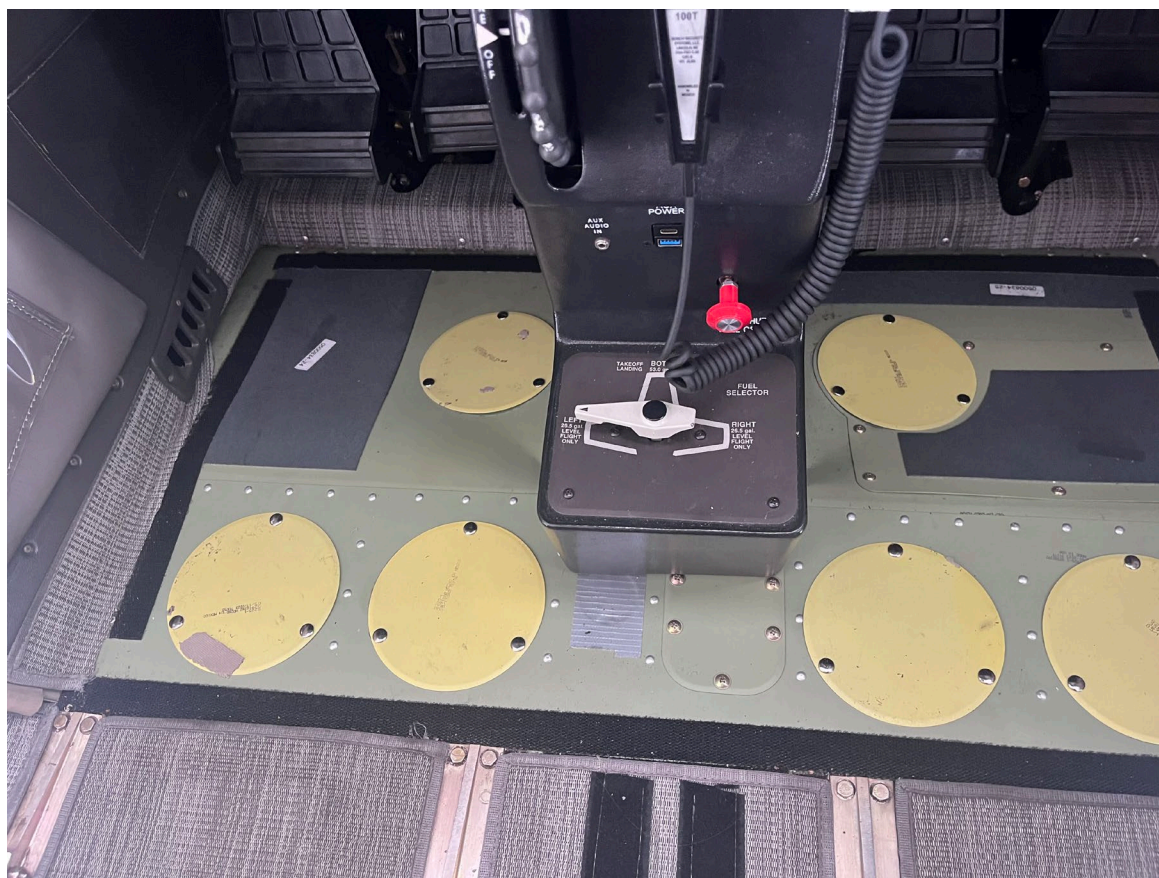
**Photograph 2 - Floor damage (Courtesy of ERAU)**

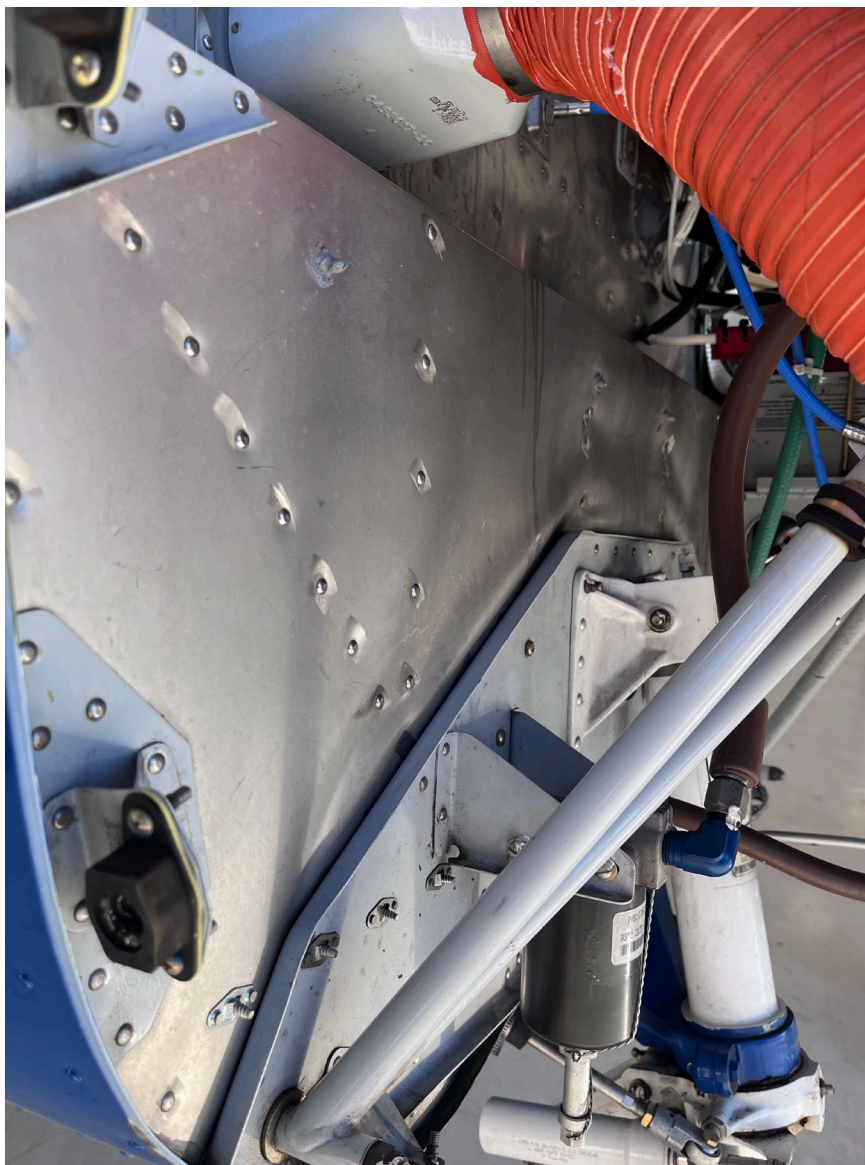
**Photograph 3 - Firewall damage (Courtesy of ERAU)**
