WPR25LA115

## INVESTIGATION PHOTOGRAPHS

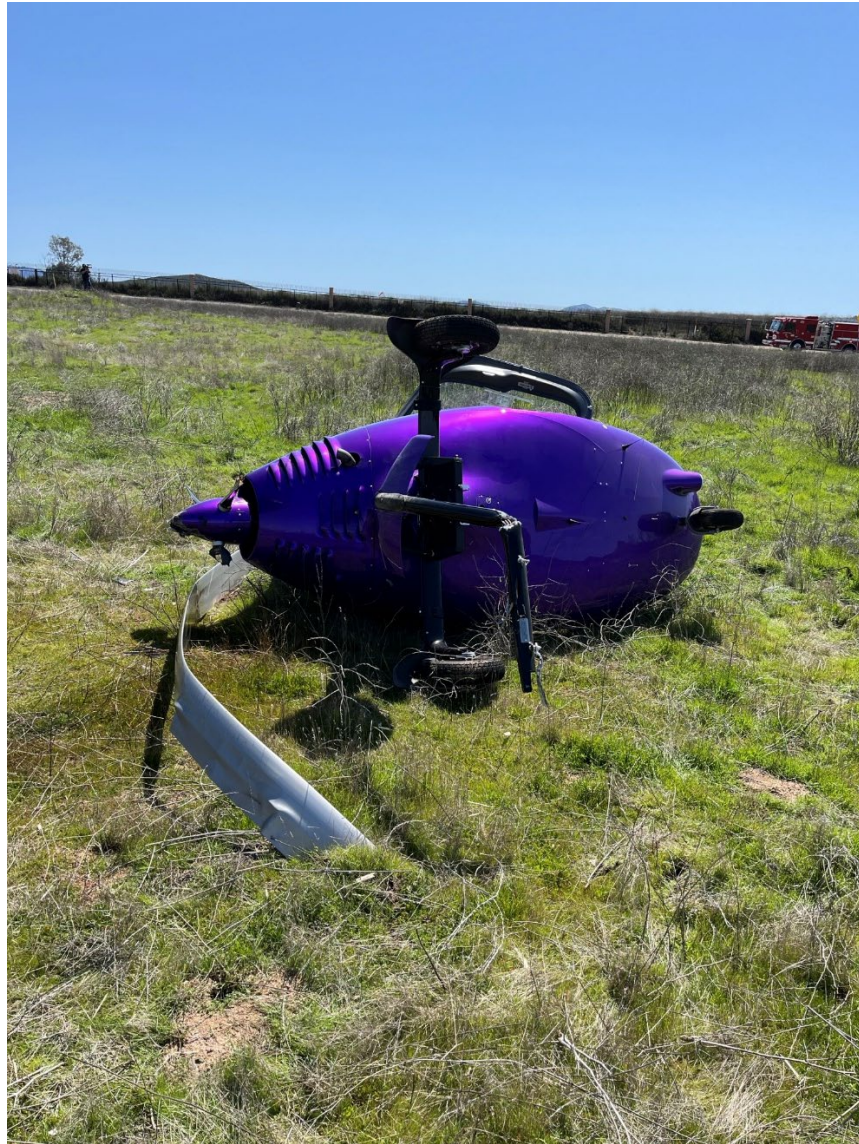
**Photograph 1 - View of damage to keel and main rotor blade (Courtesy of LEO)**

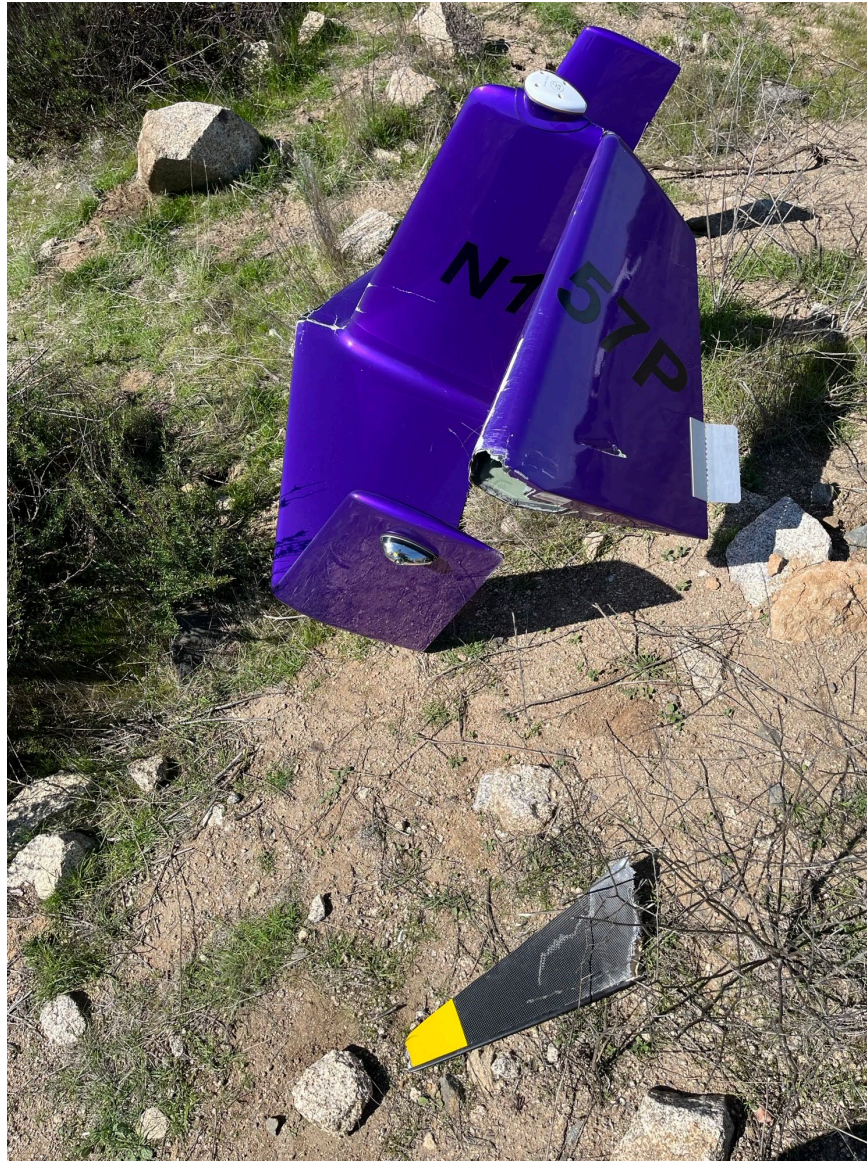
**Photograph 2 - View of damage to the rudder (Courtesy of LEO)**
