WPR25LA122

## INVESTIGATION PHOTOGRAPHS

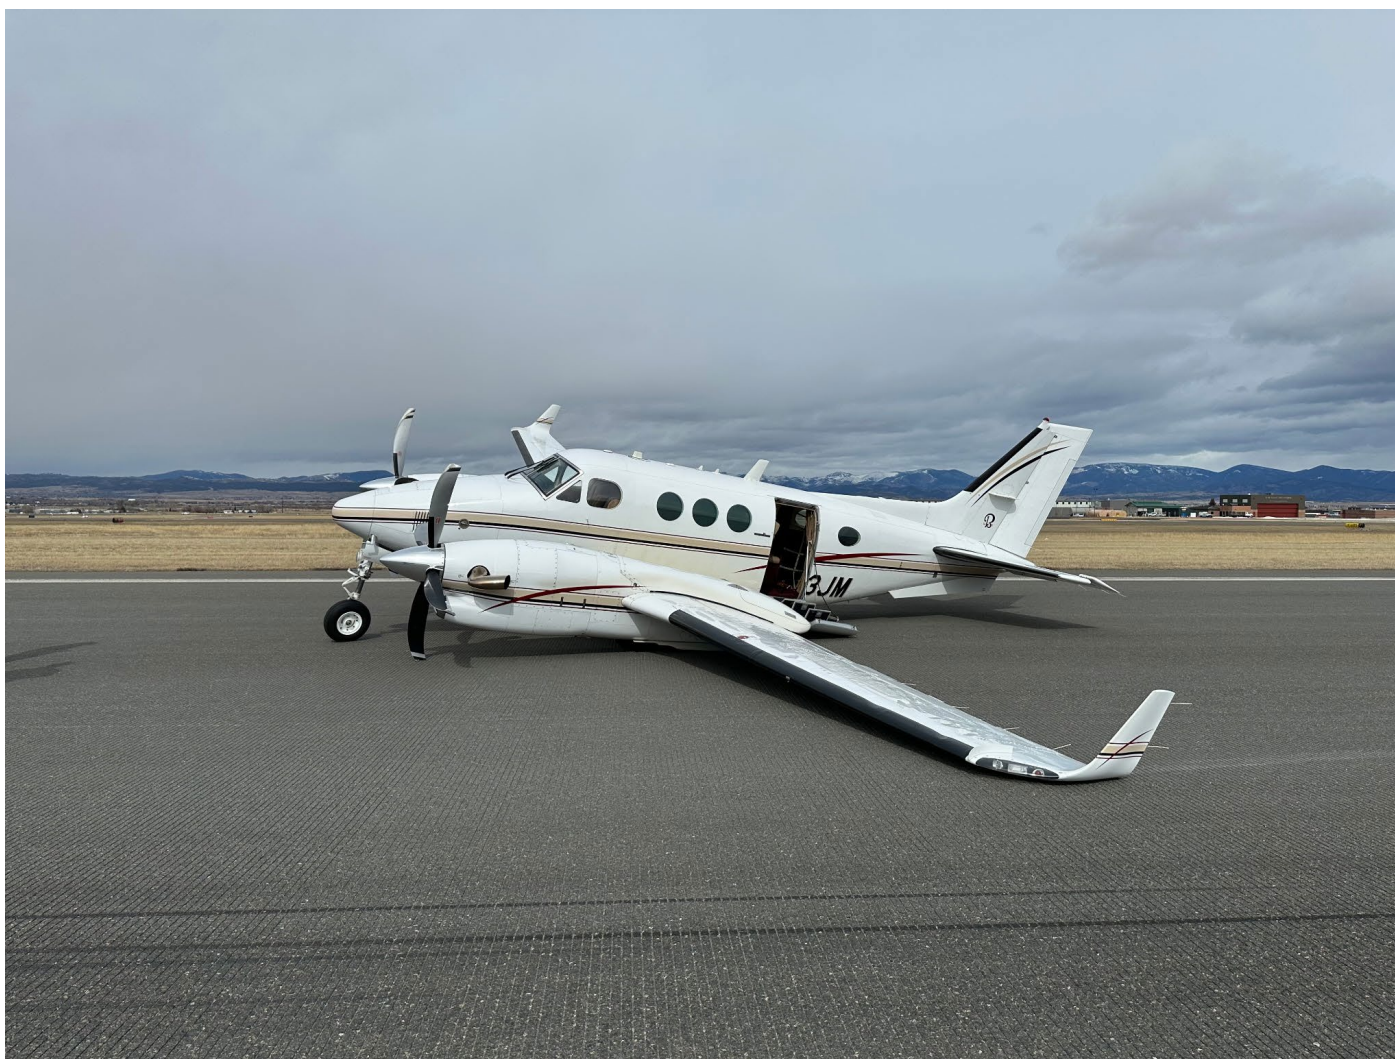
**Photograph 1 - The airplane on the runway prior to recovery. (Courtesy of airport operations).**

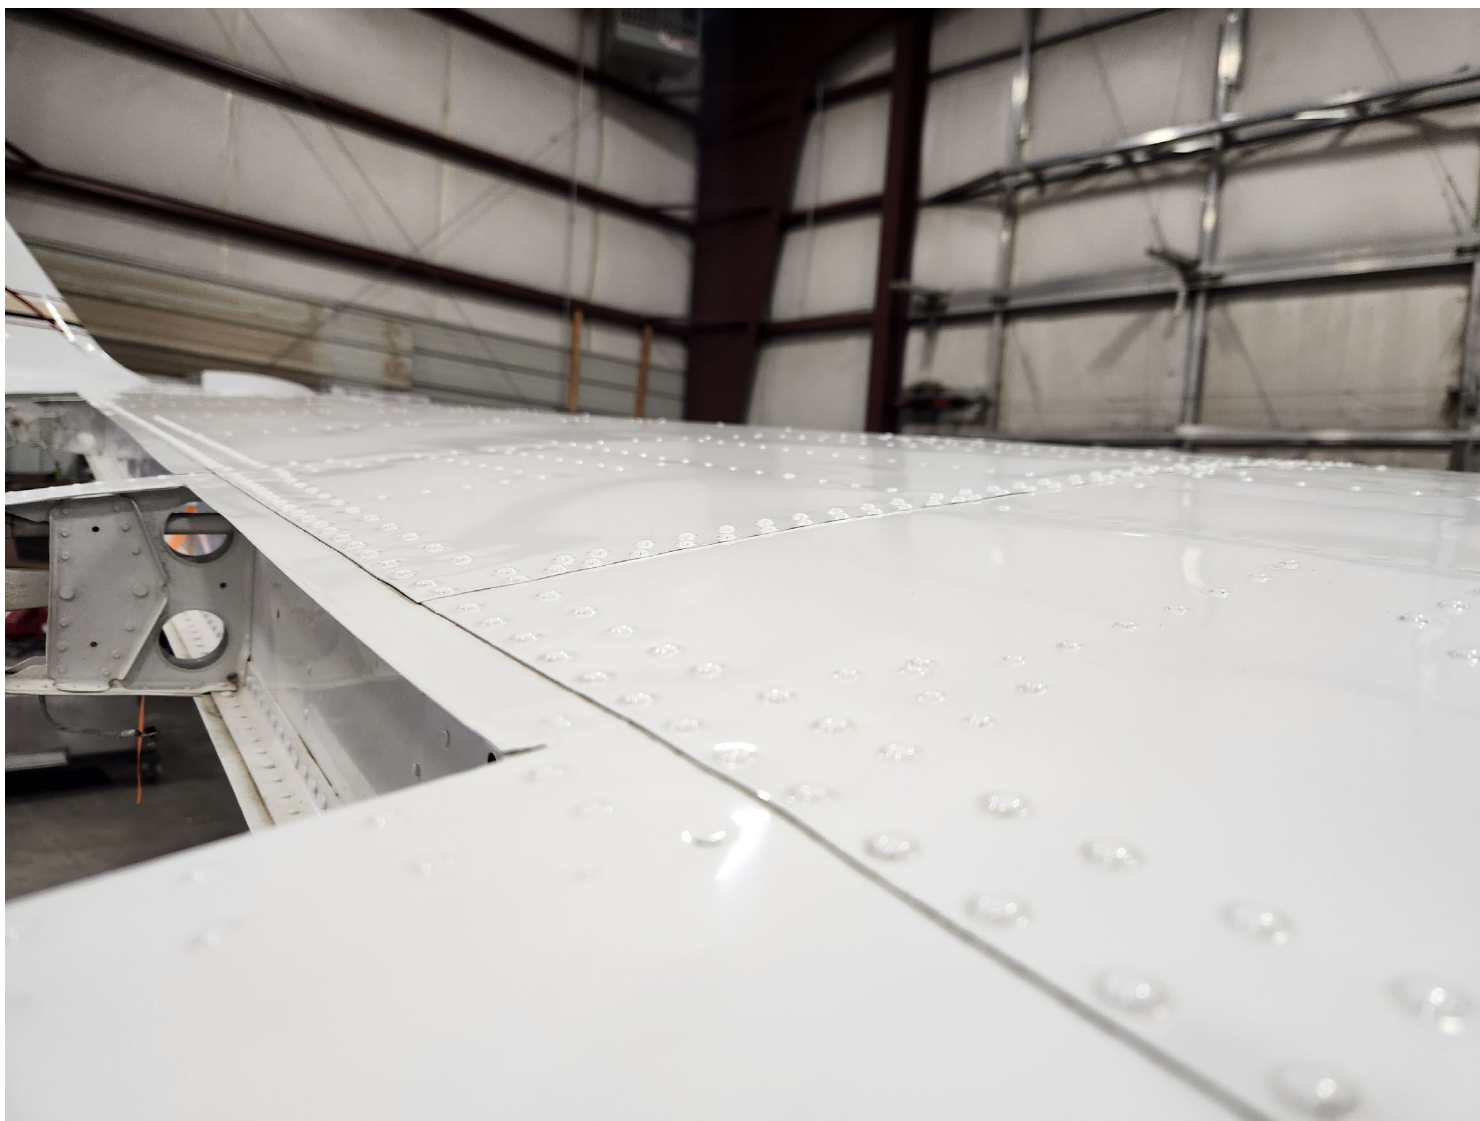
**Photograph 2 - View of substantial damage in the form of deformation of left wing upper skins.  
(Courtesy of the FAA).**

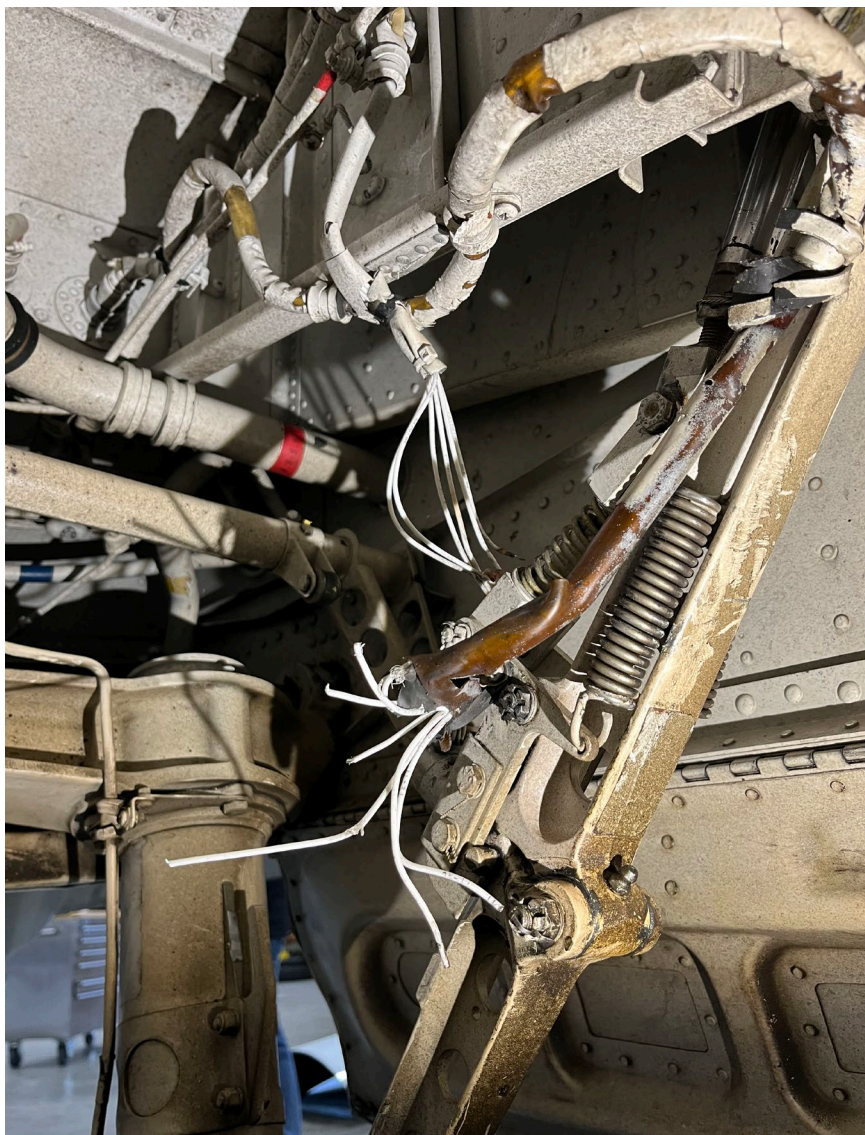
**Photograph 3 - The broken wires in the left main landing gear down lock switch wire bundle.  
(Courtesy of the FAA).**

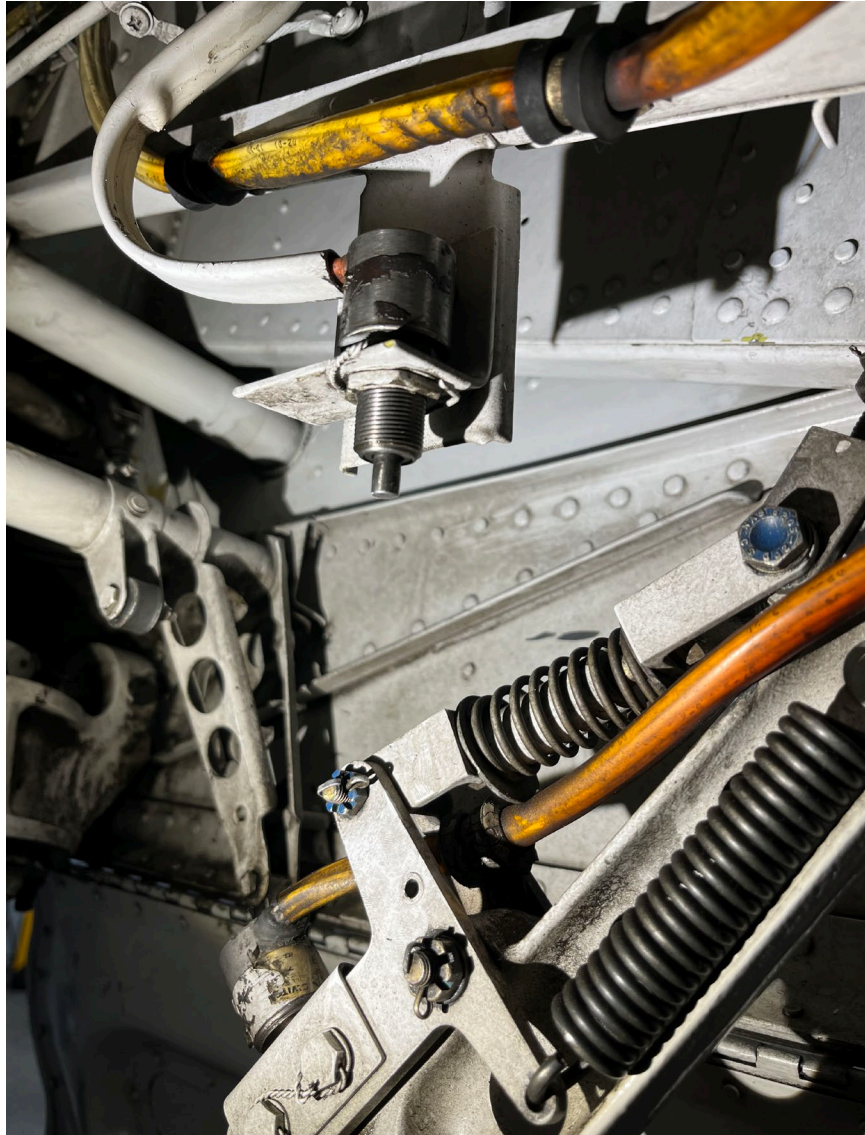
**Photograph 4 - The landing gear up limit and downlock switches on a different Beech C90A.  
(Courtesy of the FAA).**
