WPR25LA132

## INVESTIGATION PHOTOGRAPHS

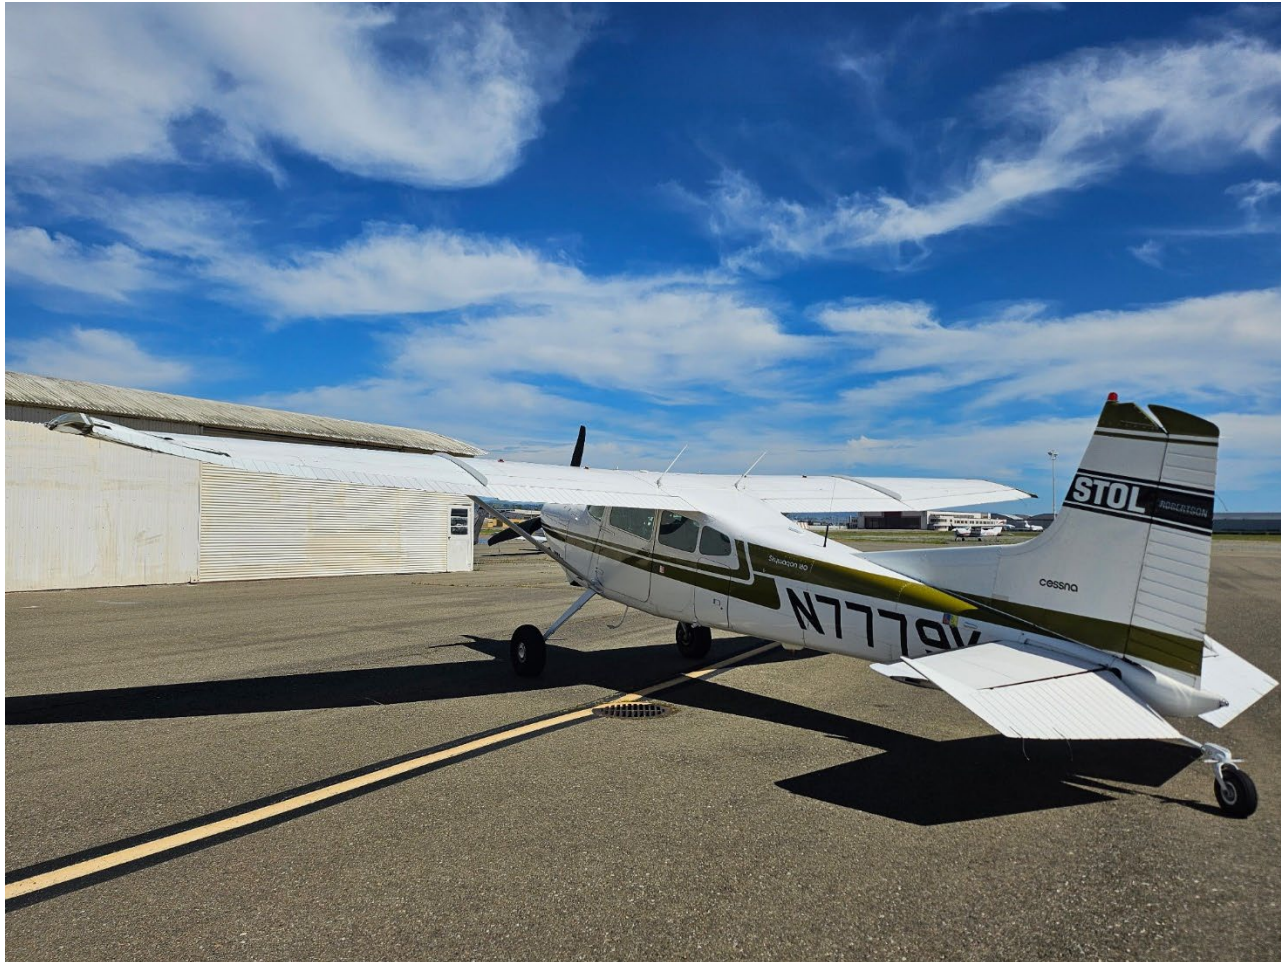
**Photograph 1 - View of damage to left wing (Courtesy of Airport Manager)**

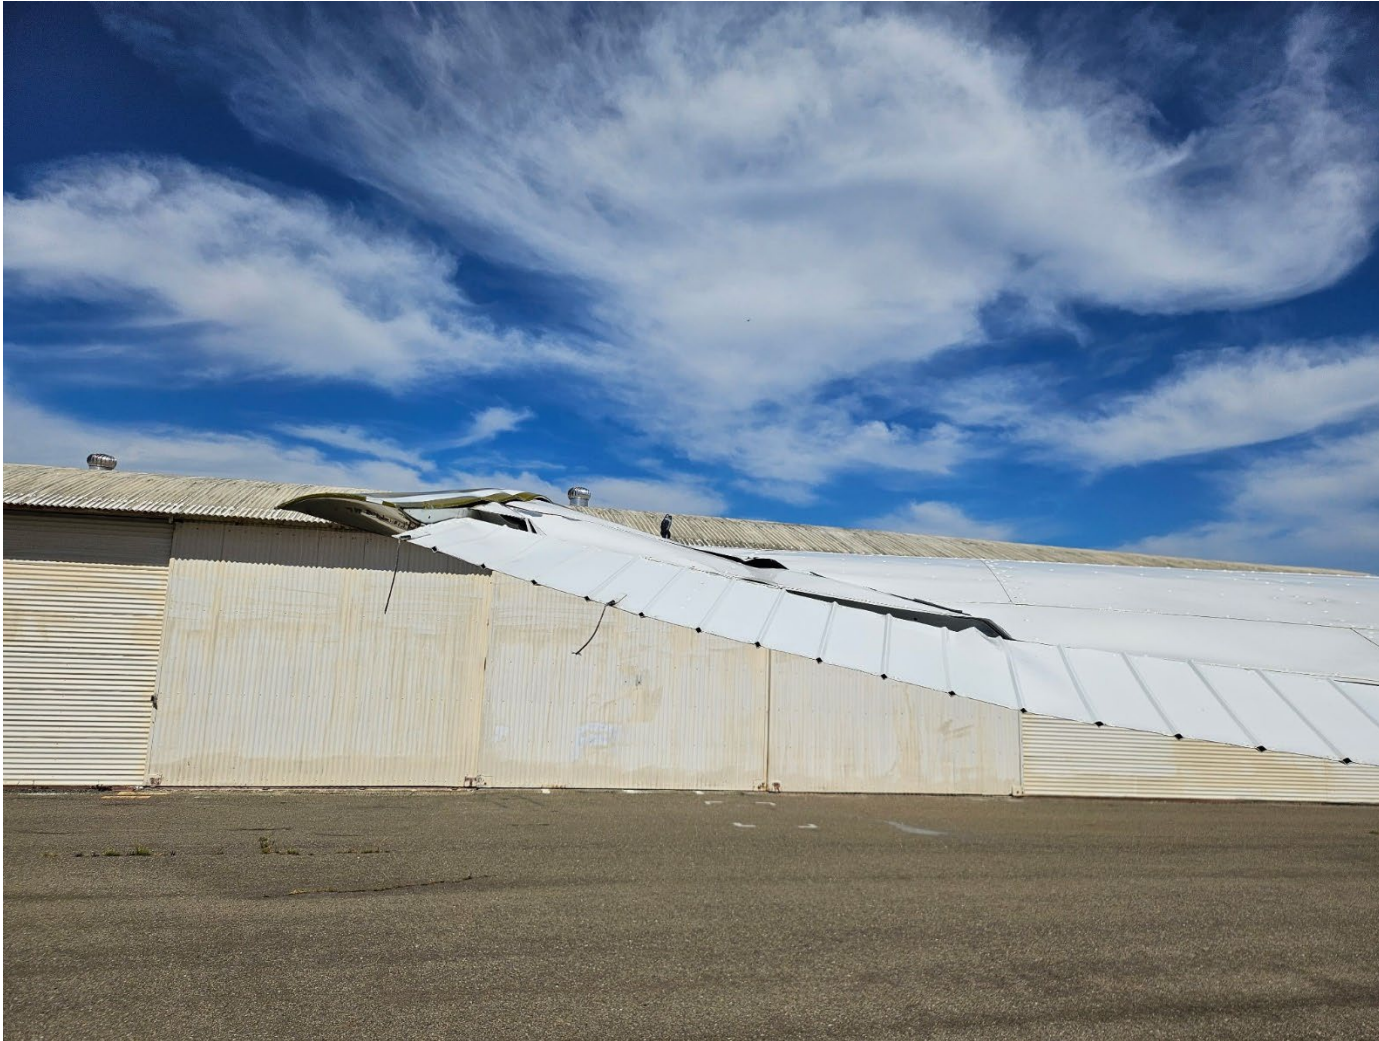
**Photograph 2 - View of damage to the left wing and aileron (Courtesy of Airport Manager)**
