WPR25LA139

## INVESTIGATION PHOTOGRAPHS

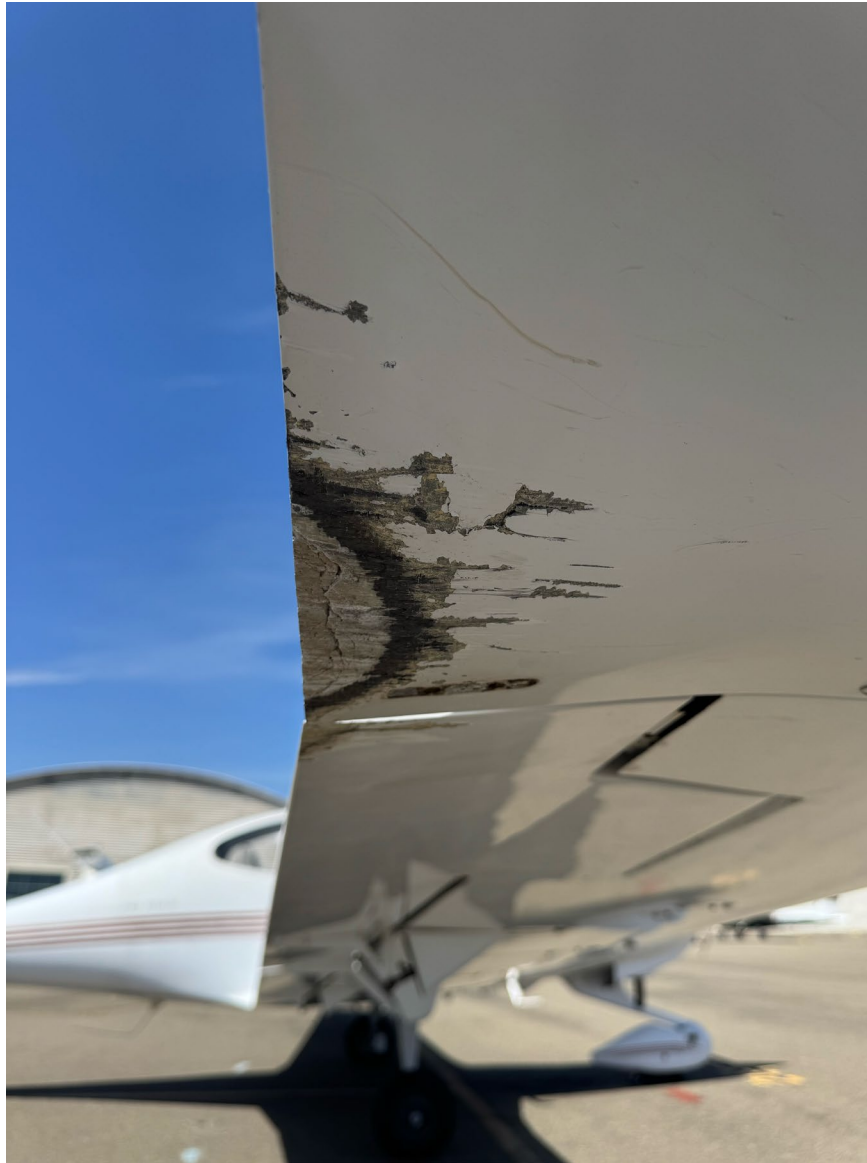
**Photograph 1 - Right Wing Damage (Courtesy of Operator)**

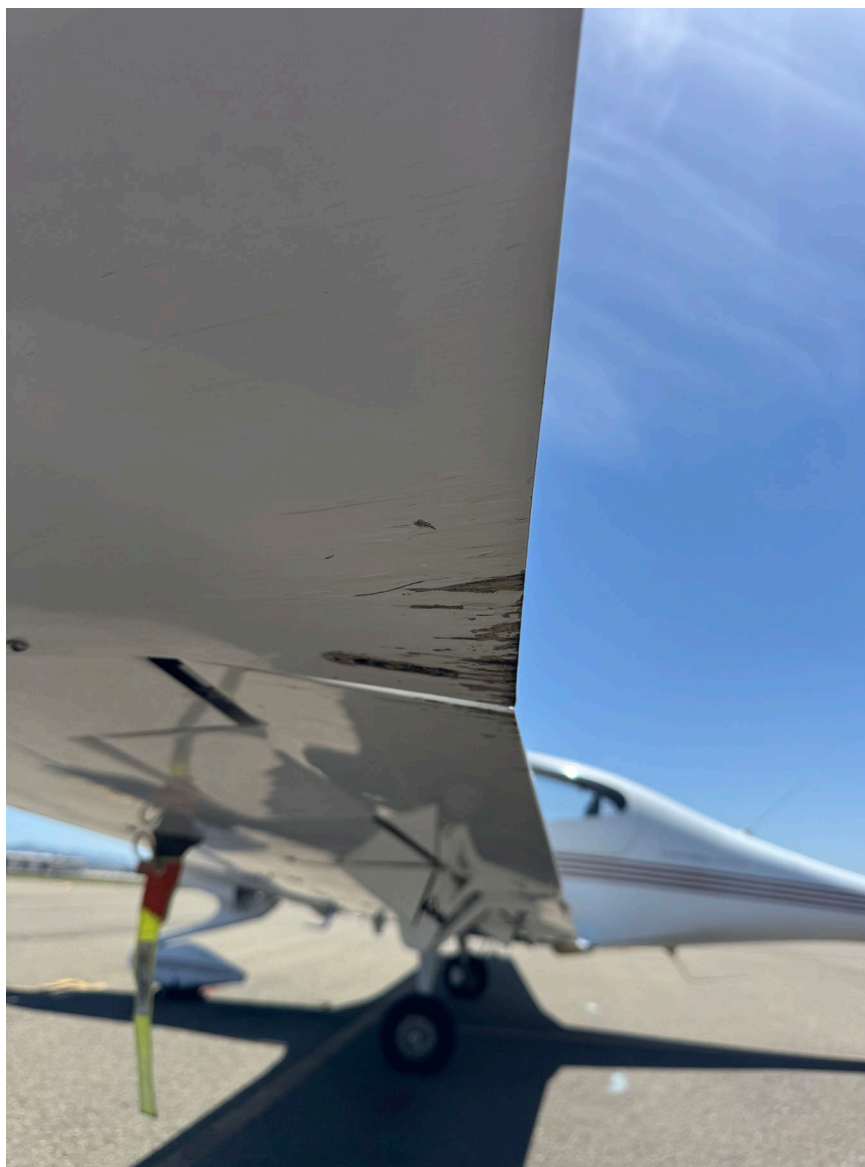
**Photograph 2 - Left Wing Damage (Courtesy of Operator)**

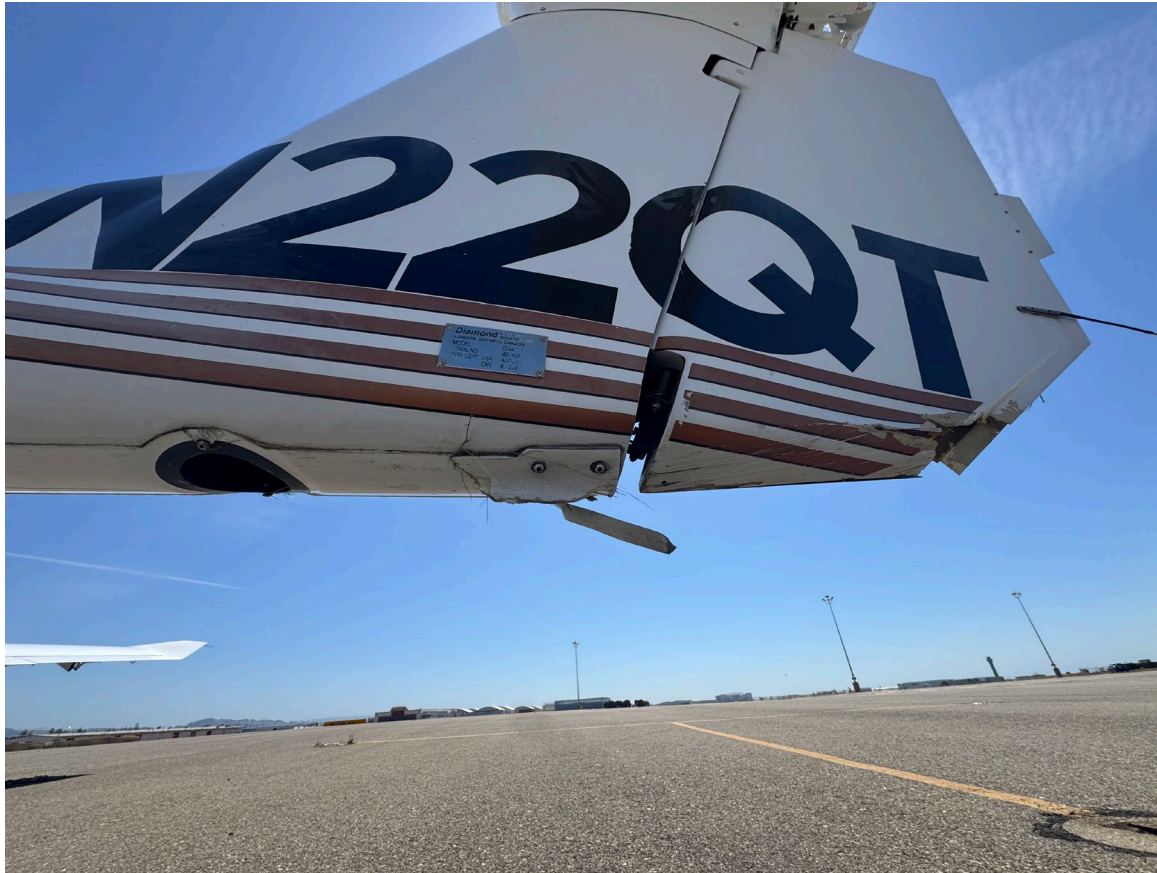
**Photograph 3 - Rudder Damage (Courtesy of Operator)**
