WPR25LA140

## INVESTIGATION PHOTOGRAPHS

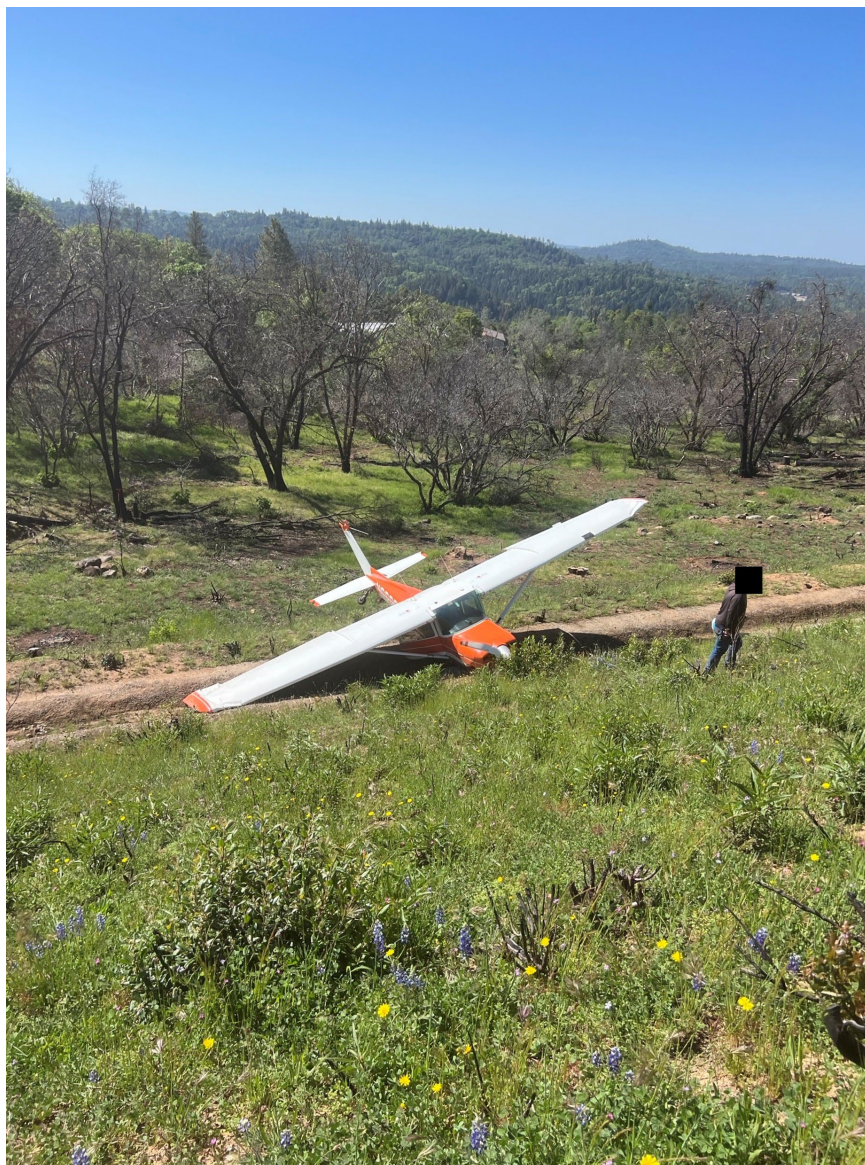
**Photograph 1 - N6682S at the accident site. (Courtesy of the pilot)**

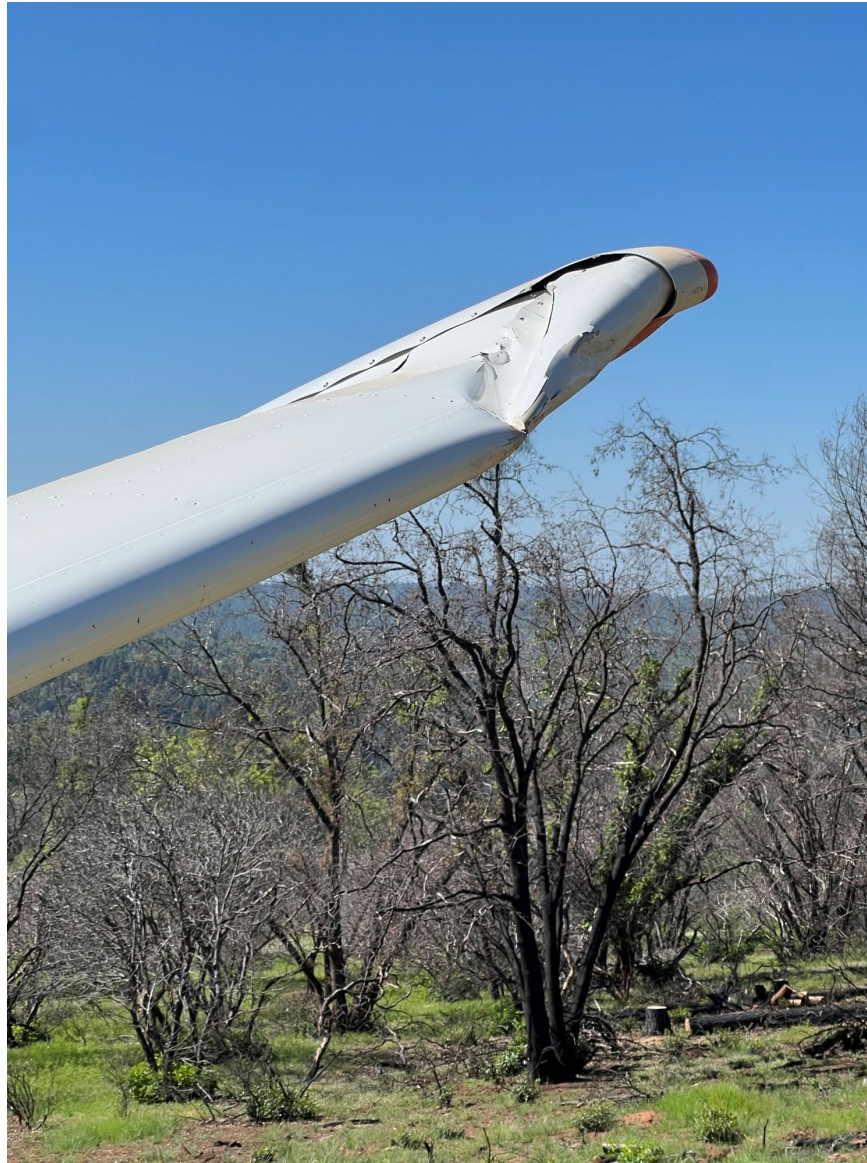
**Photograph 2 - Left wing damage. (Courtesy of the pilot)**

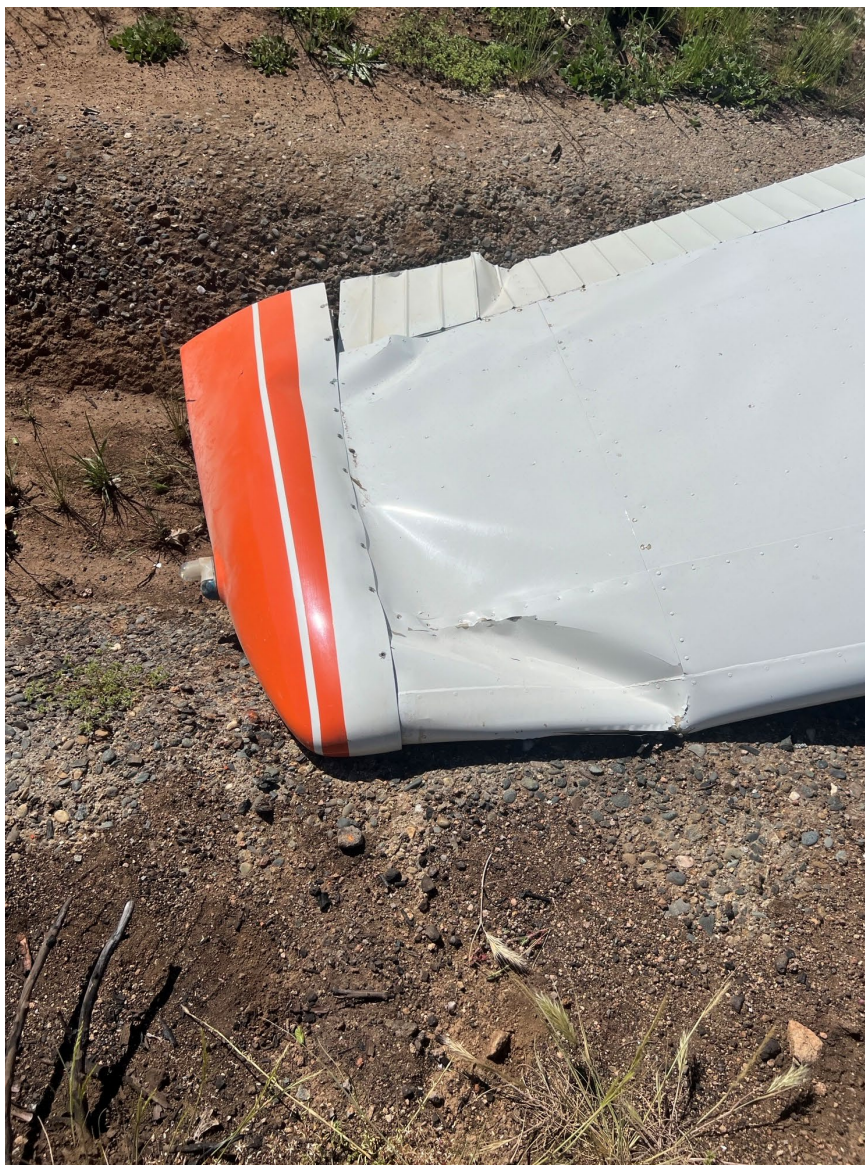
**Photograph 3 - Right wing and aileron damage. (Courtesy of the pilot)**
