WPR25LA141

## INVESTIGATION PHOTOGRAPHS

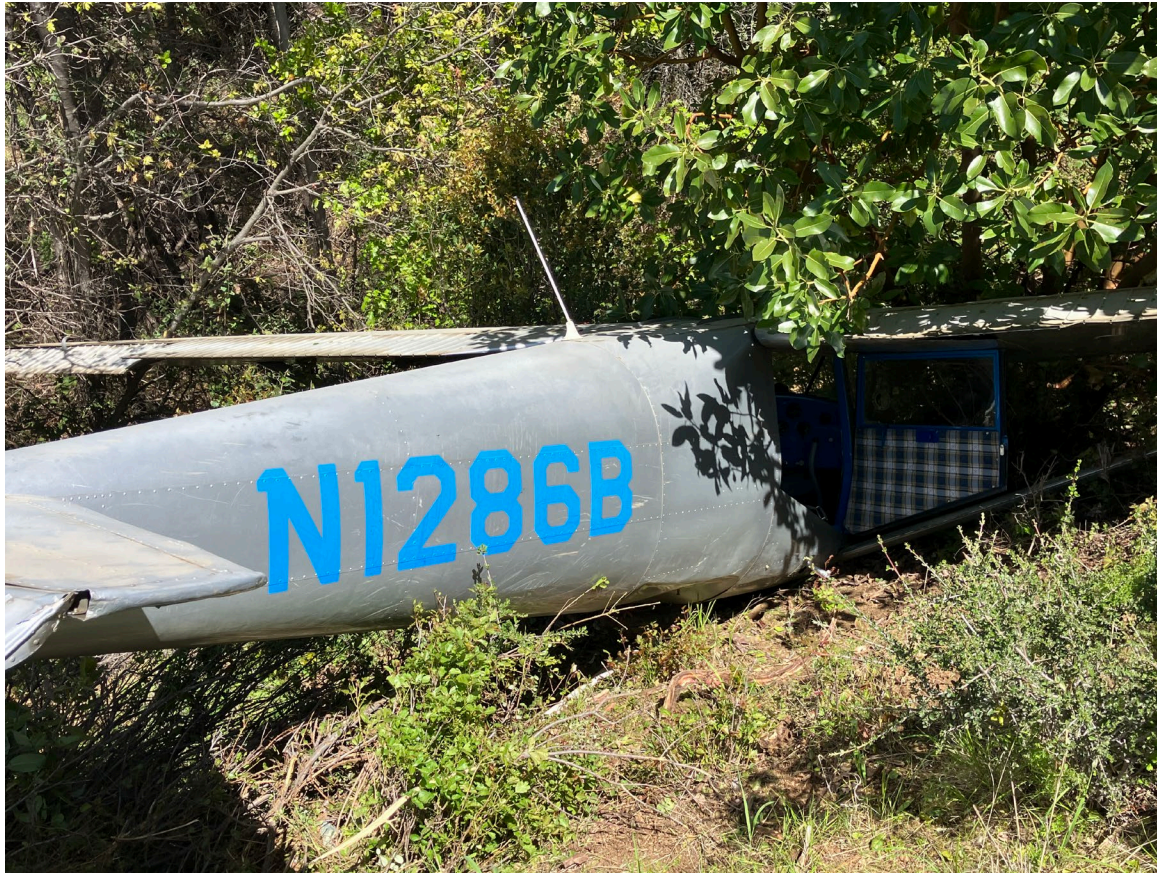
**Photograph 1 - View of damage to lower fuselage (Courtesy of pilot)**

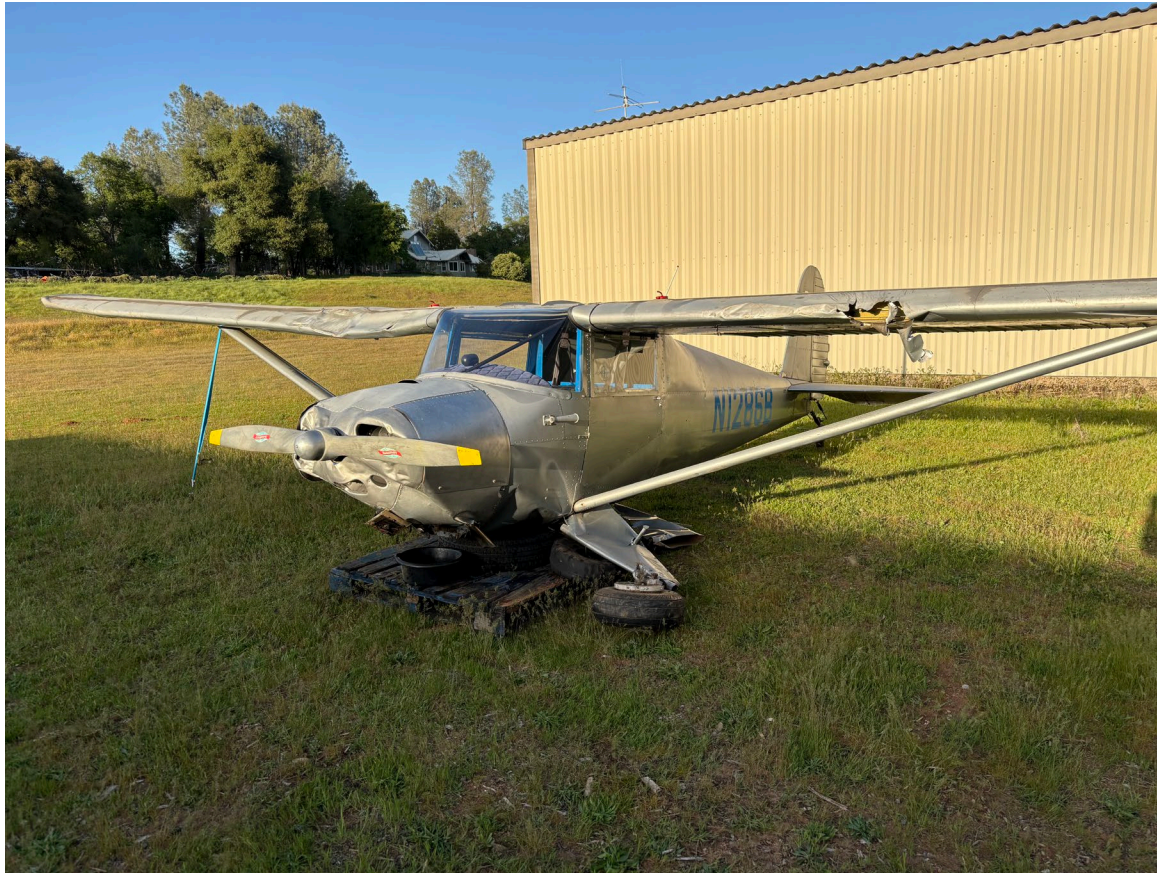
**Photograph 2 - View of damage to wings (Courtesy of pilot)**
