# National Transportation Safety Board

WPR25LA175

## **WRECKAGE EXAMINATION**

Location: Hyampom, California  
Date: June 13, 2025  
Time: 10:30 Pacific daylight time  
Airplane: Cessna 182P, N78720

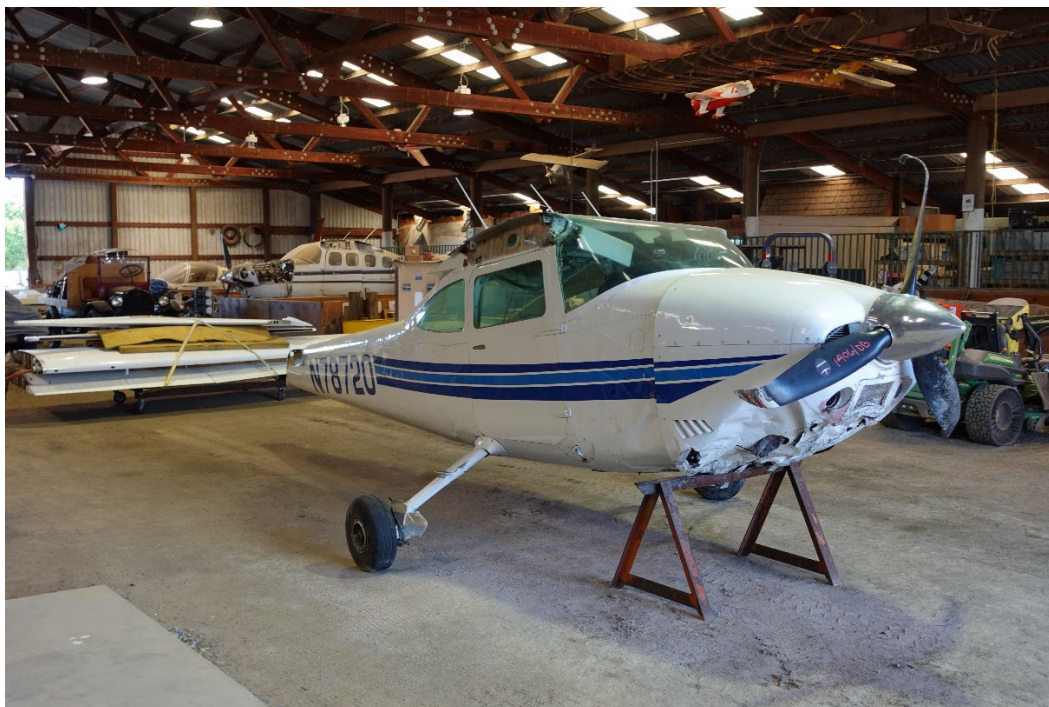
Examination of the recovered wreckage revealed that recovery personnel had removed both wings, vertical stabilizer, horizontal stabilizer, both elevators and rudder for transport. The engine, engine mount, firewall, main landing gear, instrument panel and flight controls remained attached. The nose landing gear had impact separated. Damage to the lower engine cowling was observed.

**Figure 1: View of accident airplane during examination.**

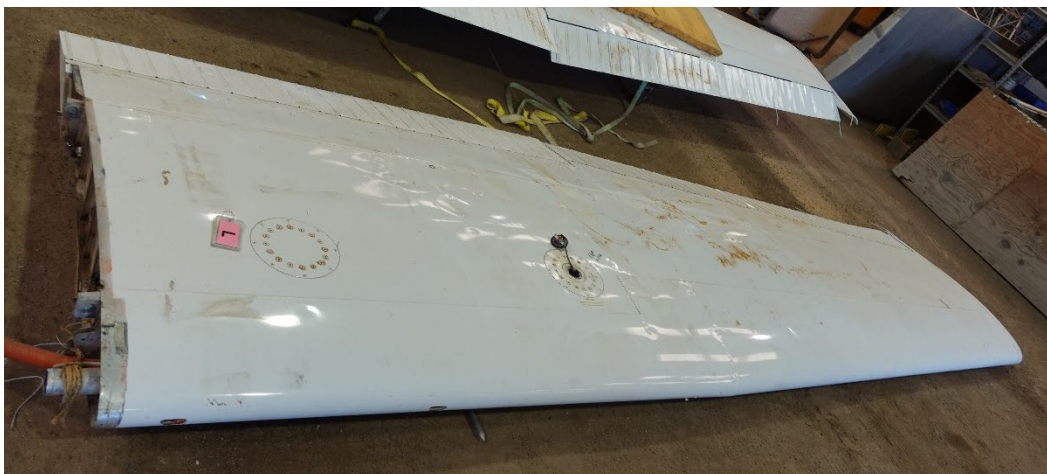
The left wing was separated from the fuselage at the wing root. No visible damage was observed to the left wing. The left wing aileron and flap remained attached to its respective attachment points. The wing tank was examined internally using a lighted borescope, no obstructions or debris were observed. No anomalies were observed to the fuel cap or filler port.

**Figure 2: View of left wing during the examination.**

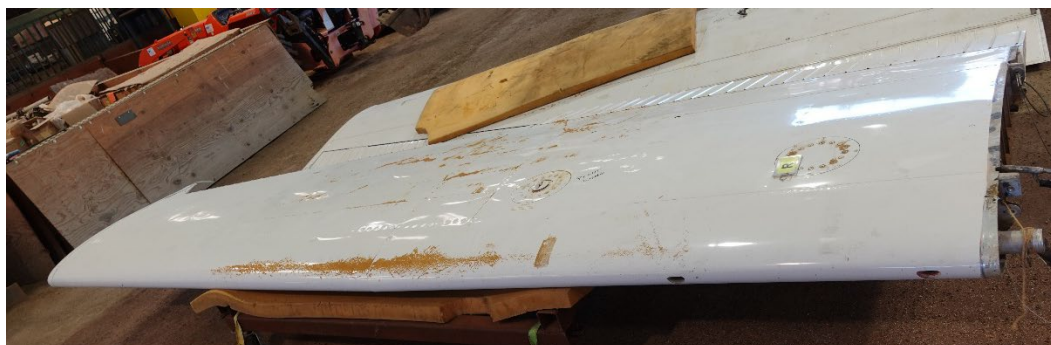
The right wing was separated from the fuselage at the wing root. No visible damage was observed to the right wing. The right wing aileron and flap remained attached to its respective attachment points. The wing tank was examined internally using a lighted borescope, no obstructions or debris were observed. No anomalies were observed to the fuel cap or filler port.

**Figure 3: View of right wing during examination.**

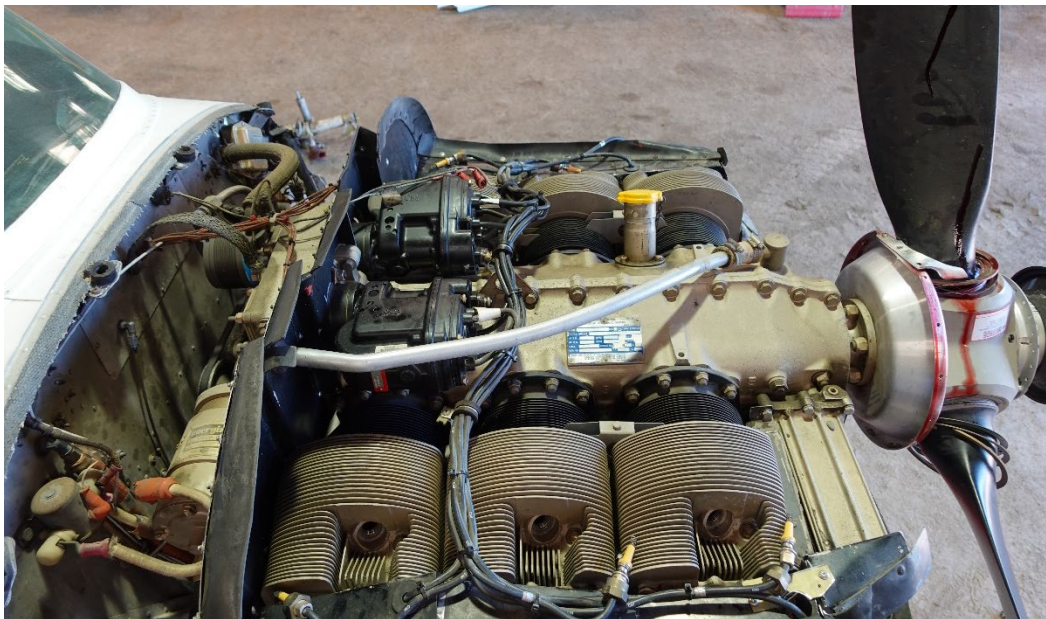
Examination of the recovered engine revealed that the engine remained attached to the airframe via the engine mounts. The lower left and right engine mount brackets were impact damaged. All six cylinders and all engine accessories remained attached. All fuel and oil lines that were removed were tight. No damage to the engine crankcase or cylinder was observed.

**Figure 4: View of engine during examination.**

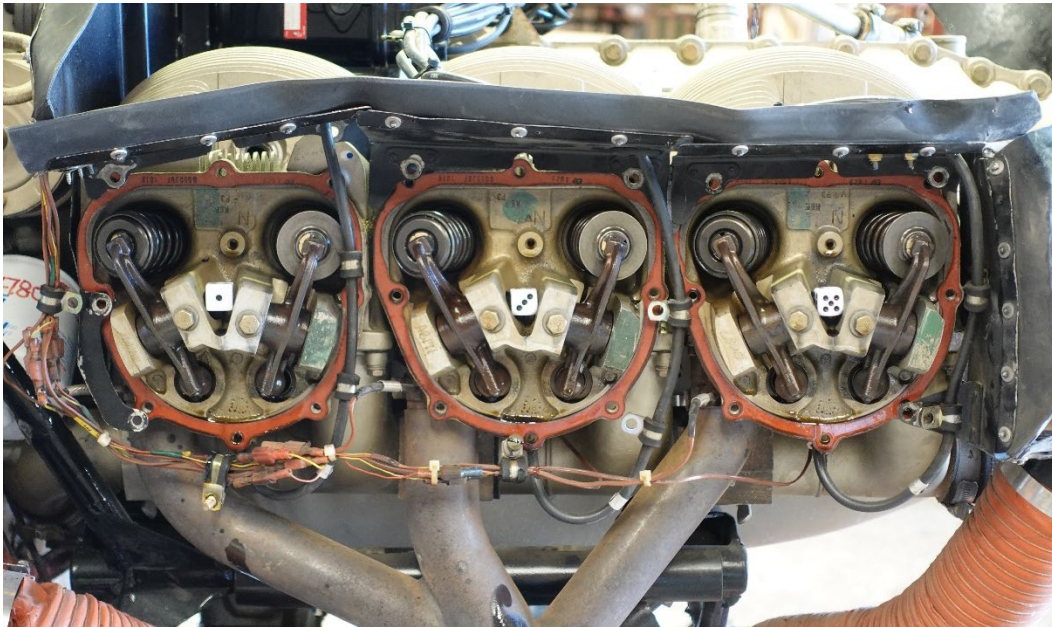
The rocker box covers were removed. The intake and exhaust rocker arms were intact, and oil coated on all cylinders. All intake and exhaust valve springs were in place and visually appeared to be undamaged. The upper spark plugs were removed, and all six cylinders were examined internally using a lighted borescope. A normal amount of combustion deposits was observed within the combustion dome of each cylinder and piston face. All of the intake and exhaust valves were unremarkable. The crankshaft was rotated by hand using the propeller hub.

Rotational continuity was established throughout the engine and valve train. Thumb compression and suction was obtained on all six cylinders.

**Figure 5: View of right side engine cylinders.**

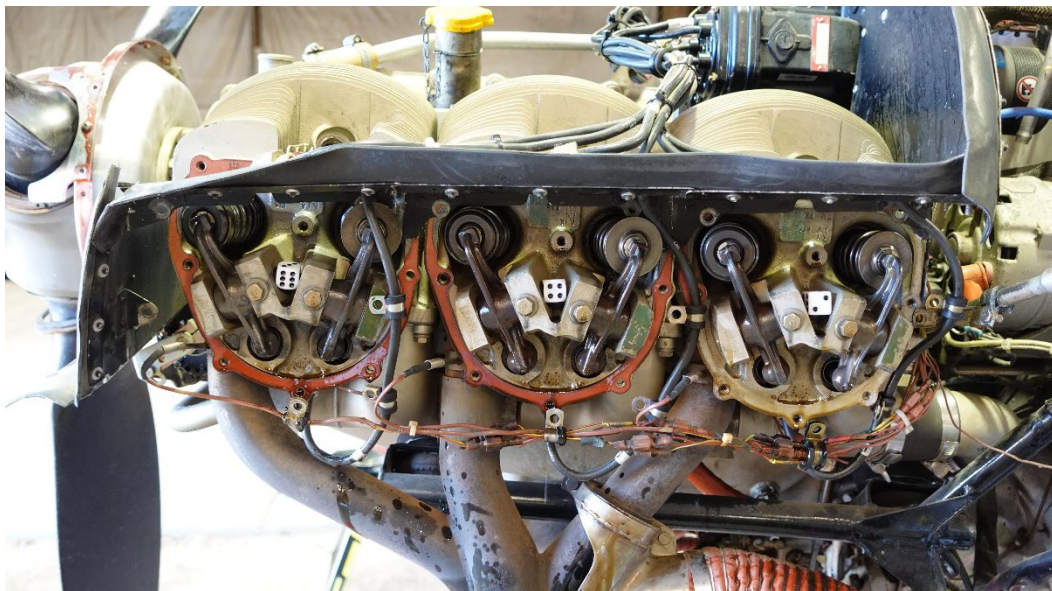
**Figure 6: View of left side engine cylinders.**

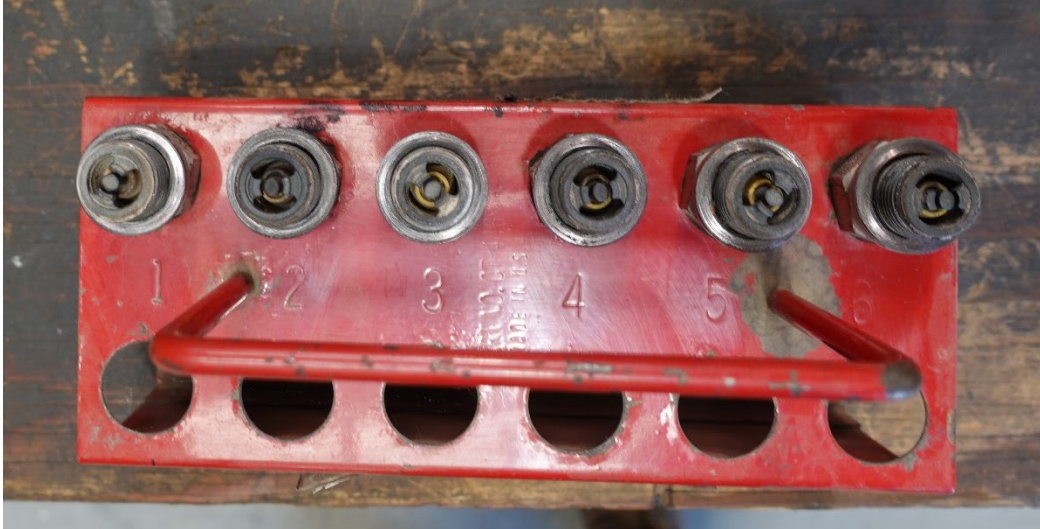
The top engine spark plugs were removed from the engine, and they were the fine-wire electrode type. All the spark plug exhibited light gray deposits within the electrode area. The spark plugs exhibited signatures consistent with WORN NORMAL when compared to the Champion Check-A-Plug comparison chart.

**Figure 7: View of top engine spark plugs.**

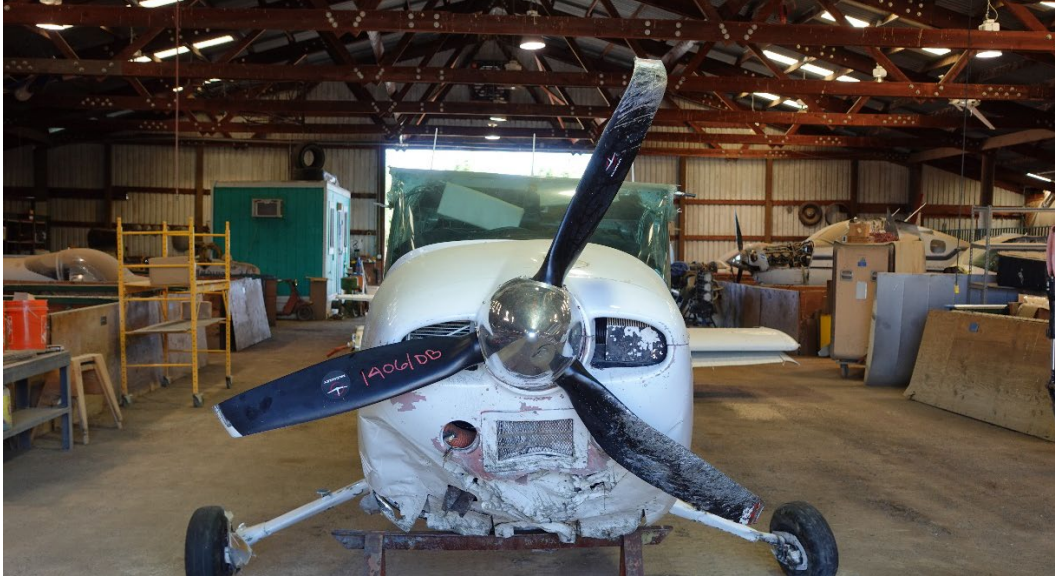
The airplane was equipped with a three blade Hertzell propeller; for the purposes of this report the propeller blades were labeled A, B, and C. All blades remained attached to the propeller hub. All the propeller blades exhibited aft bending about mid span, consistent with impact damage.

**Figure 8: Front view of propeller during examination.**

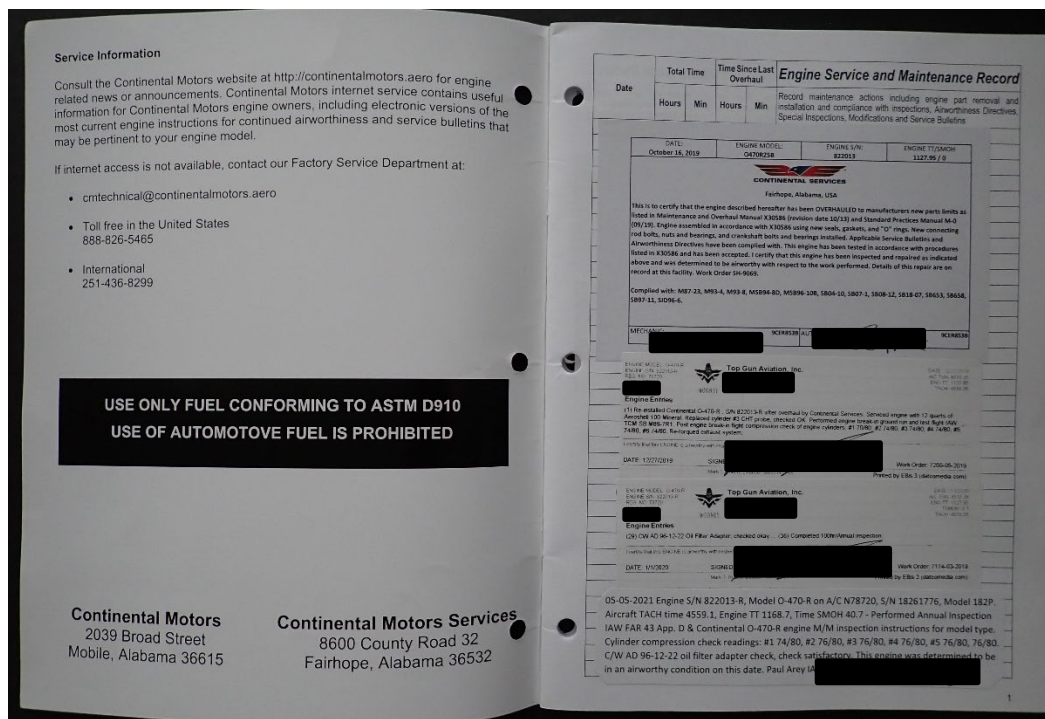
A review of the airplane logbooks revealed that, the most recent annual inspection was conducted on June 1, 2024. At the time of the exam the aircraft total time was 4714.7 hours. According to the engine logbook, the engine was overhauled to manufacture's new parts limits on October 16, 2019.

Figure 10: View of engine overhaul.
