WPR25LA176

## INVESTIGATION PHOTOGRAPHS

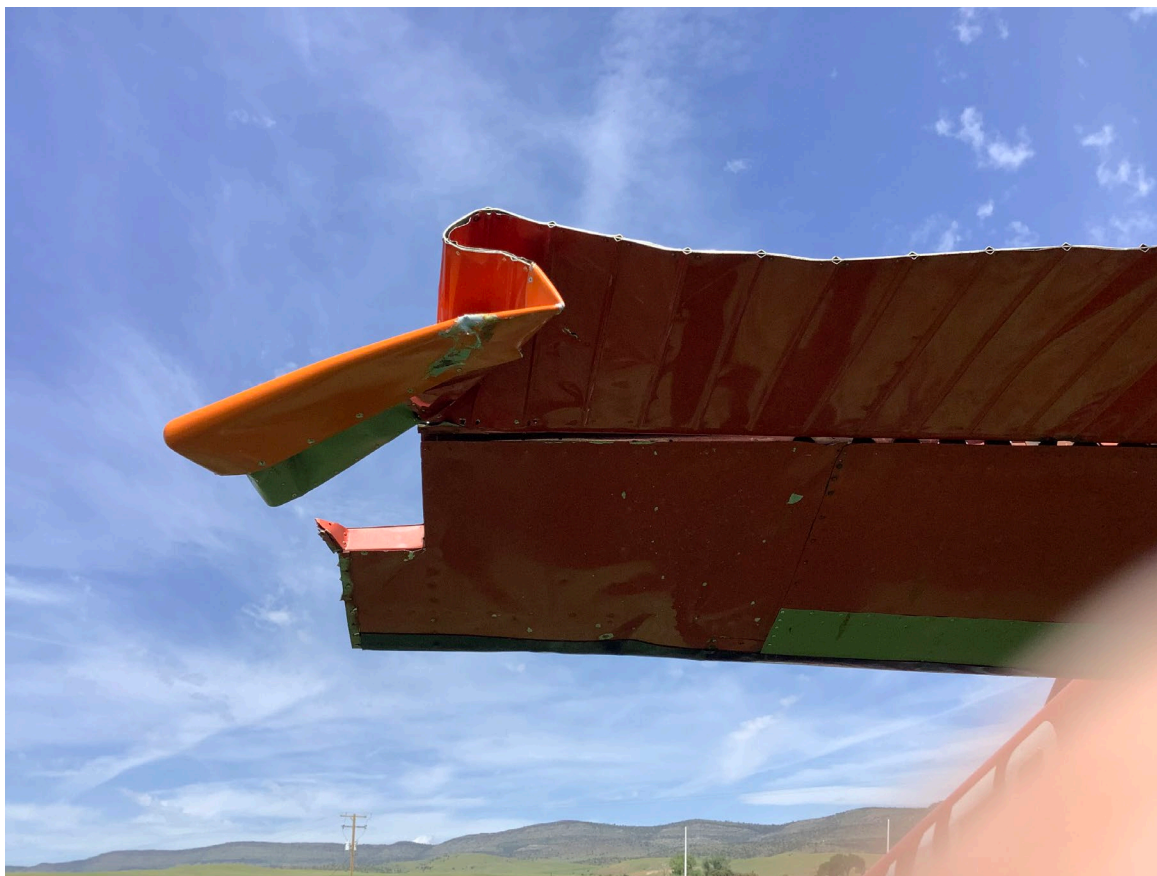
**Photograph 1 - View of damage to elevator and horizontal stabilizer. (Courtesy of pilot)**

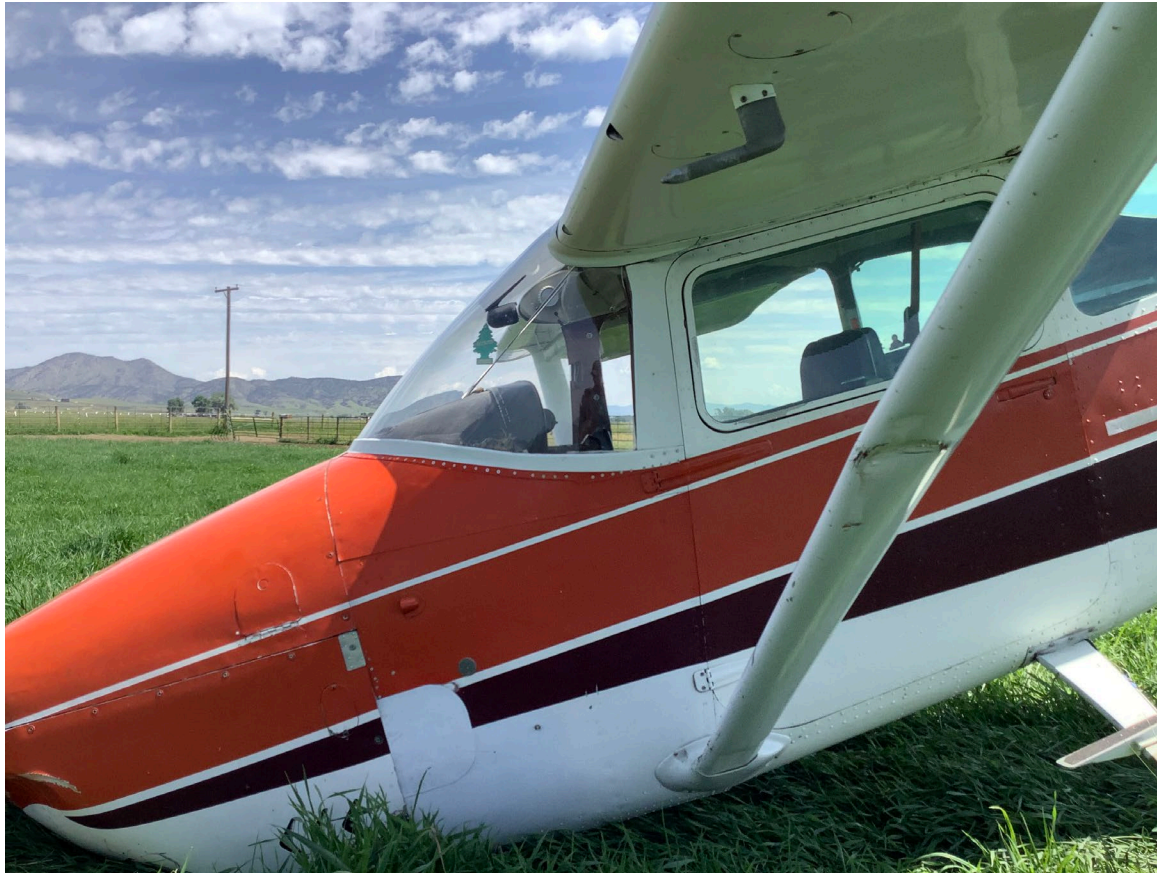
**Photograph 2 - View of damage to left wing lift strut. (Courtesy of pilot)**
