WPR25LA192

## INVESTIGATION PHOTOGRAPHS

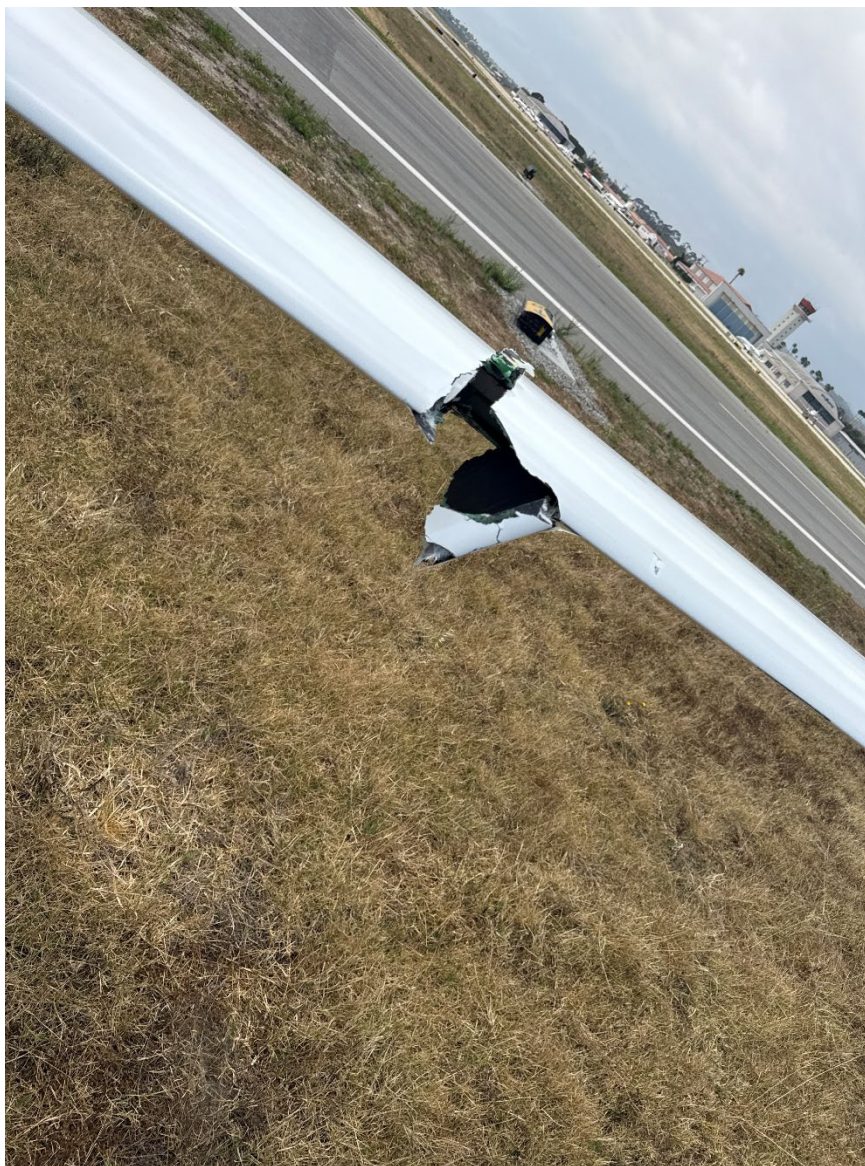
**Photograph 1 - View of left-wing damage (Courtesy of airport operations)**

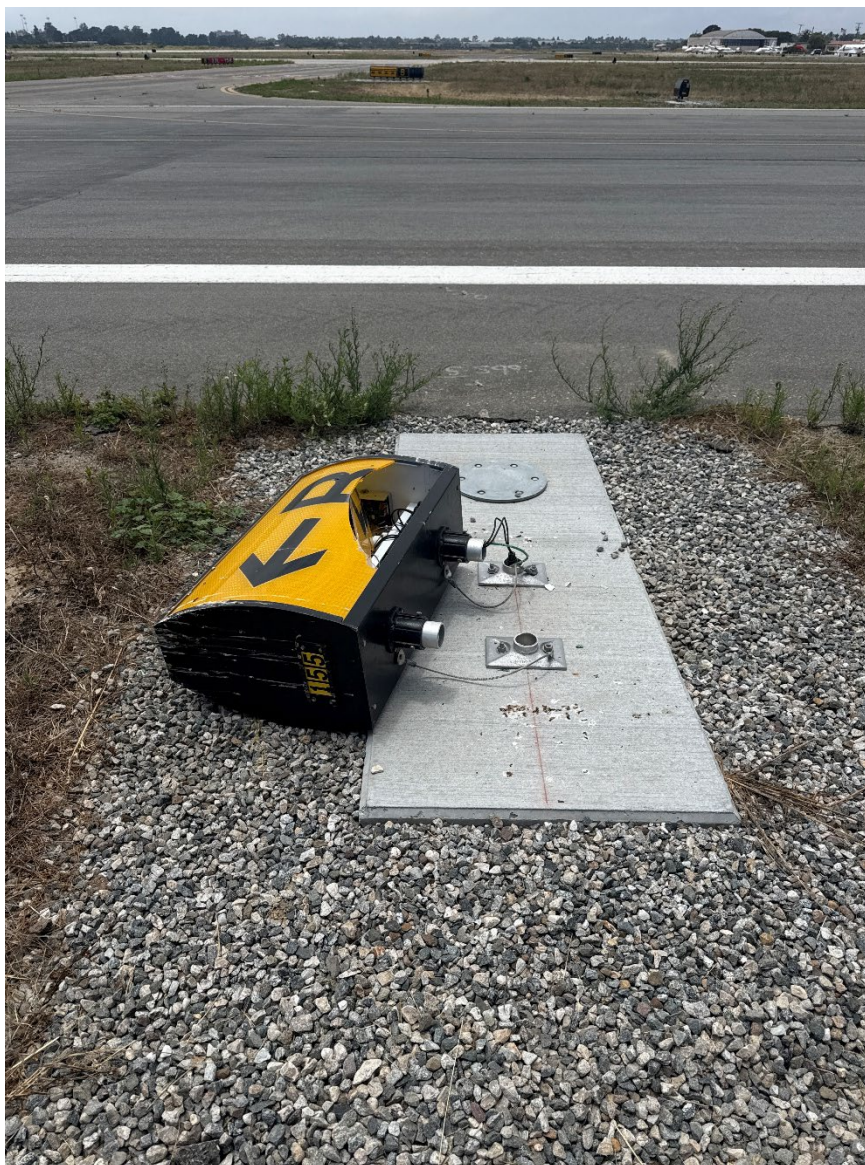
**Photograph 2 - View of damaged taxiway sign (Courtesy of airport operations)**
