WPR25LA193

## INVESTIGATION PHOTOGRAPHS

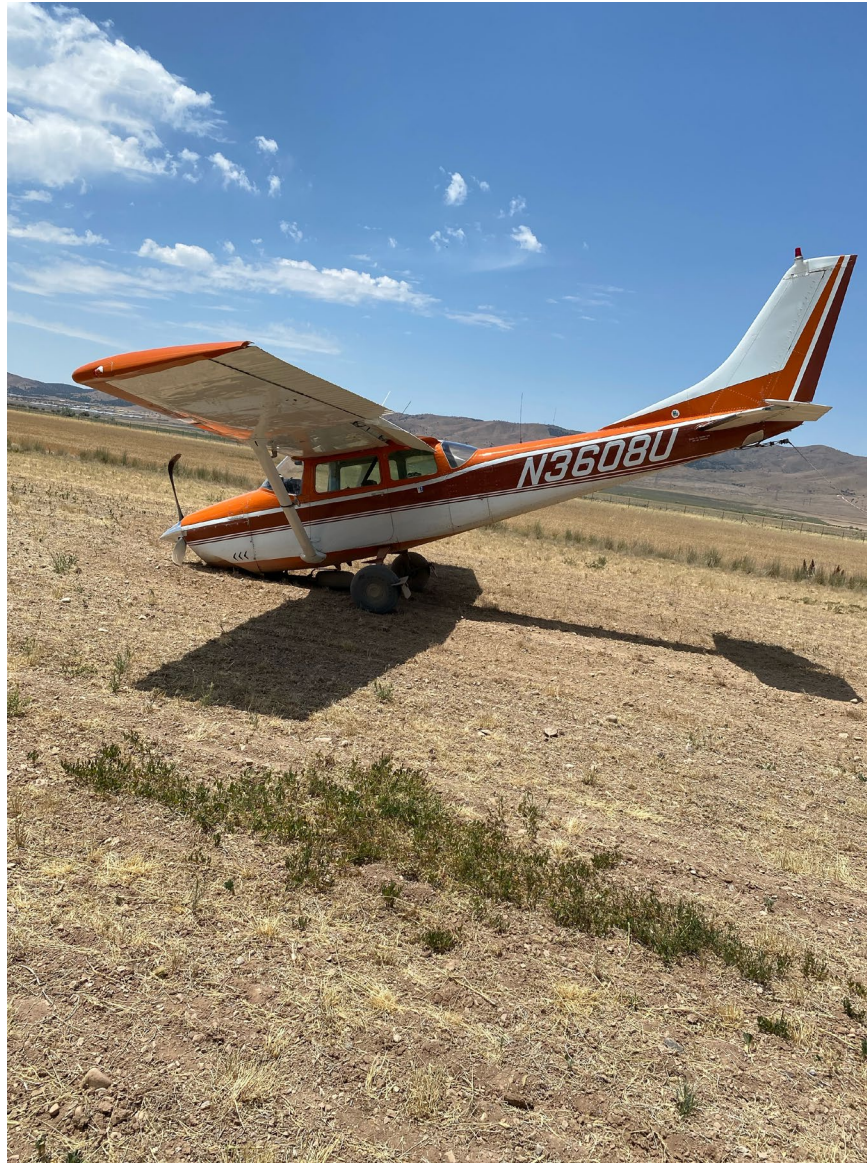
**Photograph 1 - Airplane at Accident Site (Courtesy of Pilot)**

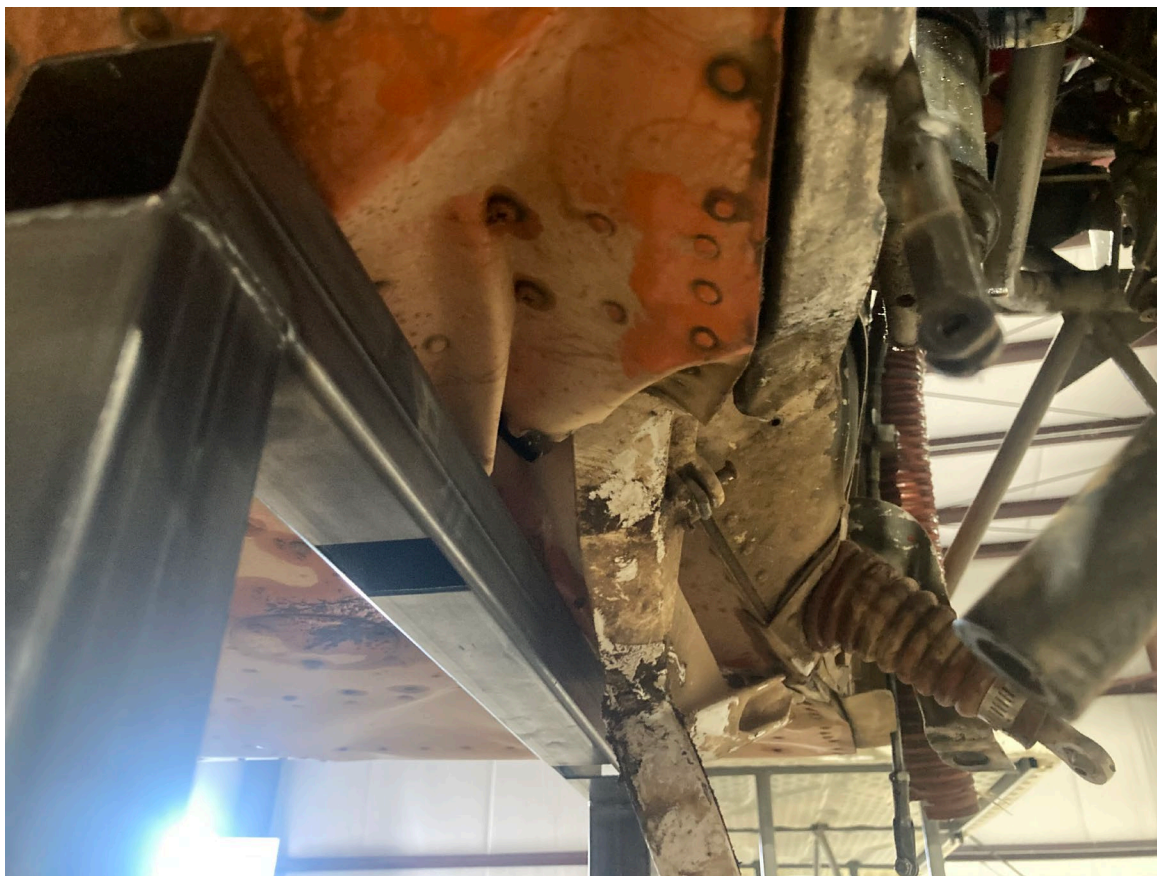
**Photograph 2 - Damaged Firewall, Fuselage, and Steering Shaft (Courtesy of Pilot)**

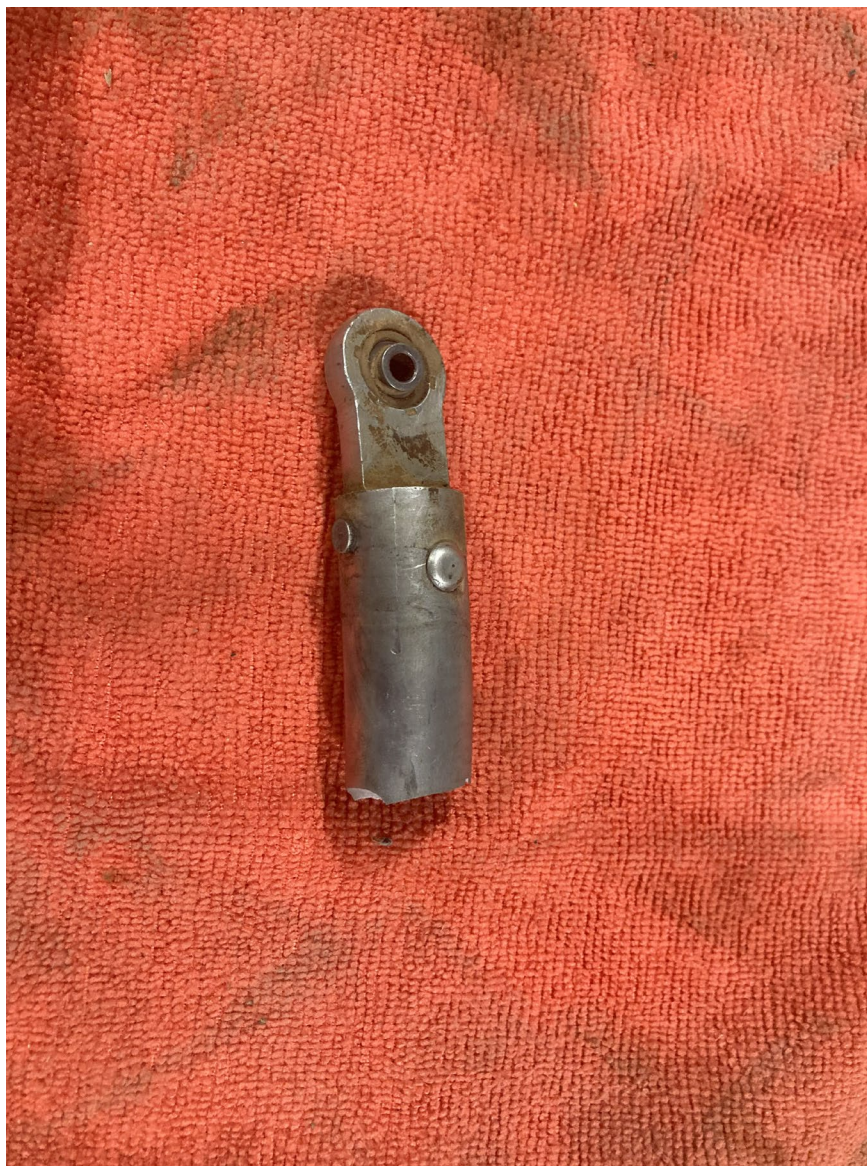
**Photograph 3 - Fractured Steering Shaft (Courtesy of Pilot)**
