WPR25LA199

## INVESTIGATION PHOTOGRAPHS

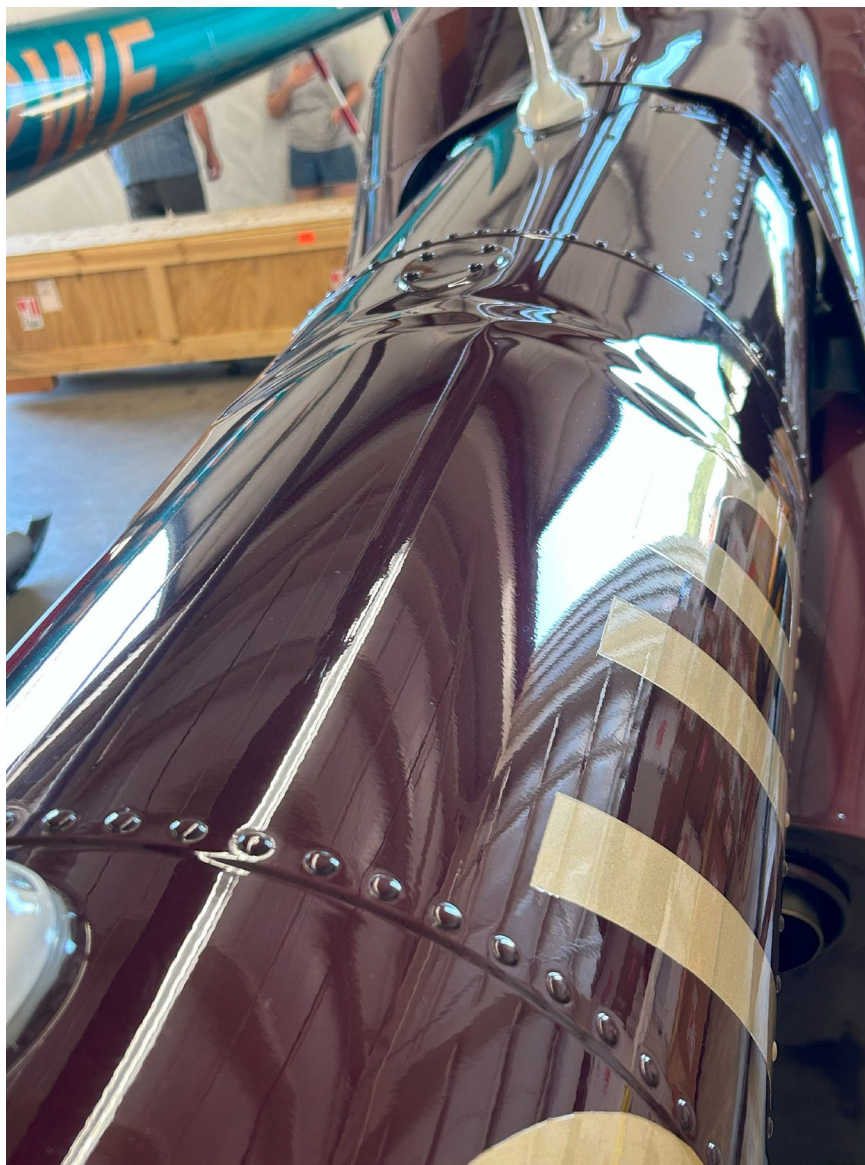
**Photograph 1 - View of substantial damage to the tailboom. (Courtesy of airport operations).**

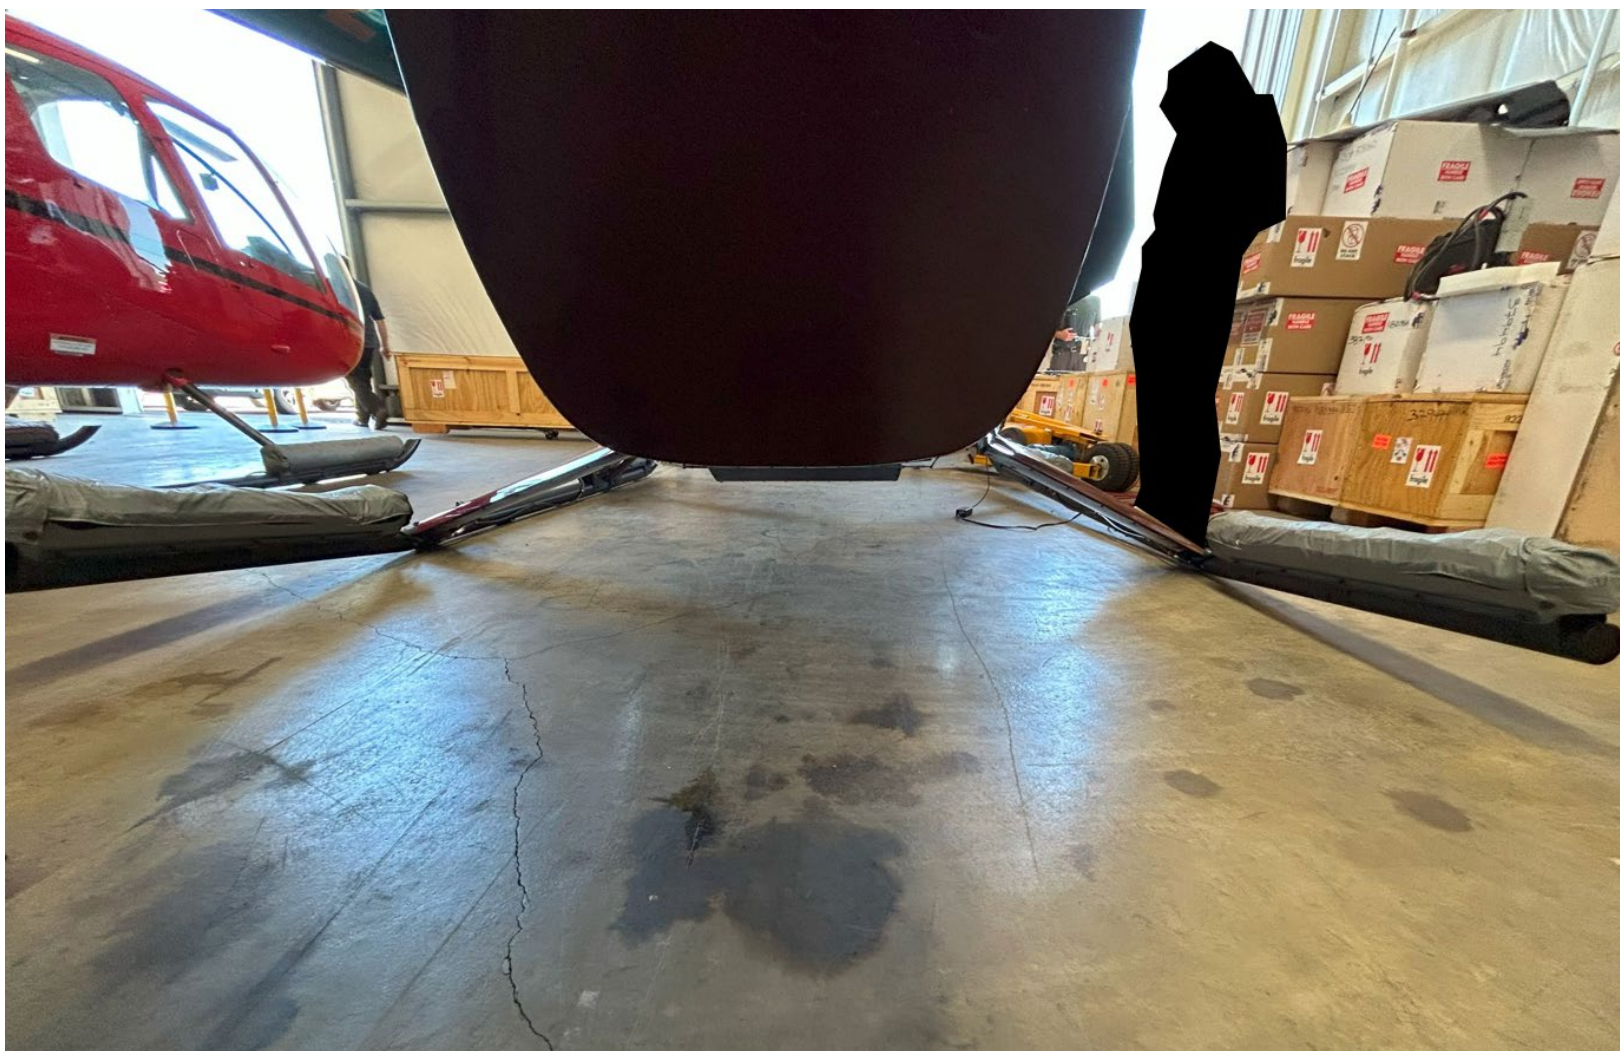
**Photograph 2 - Deformation of the helicopter skids. (Courtesy of airport operations).**

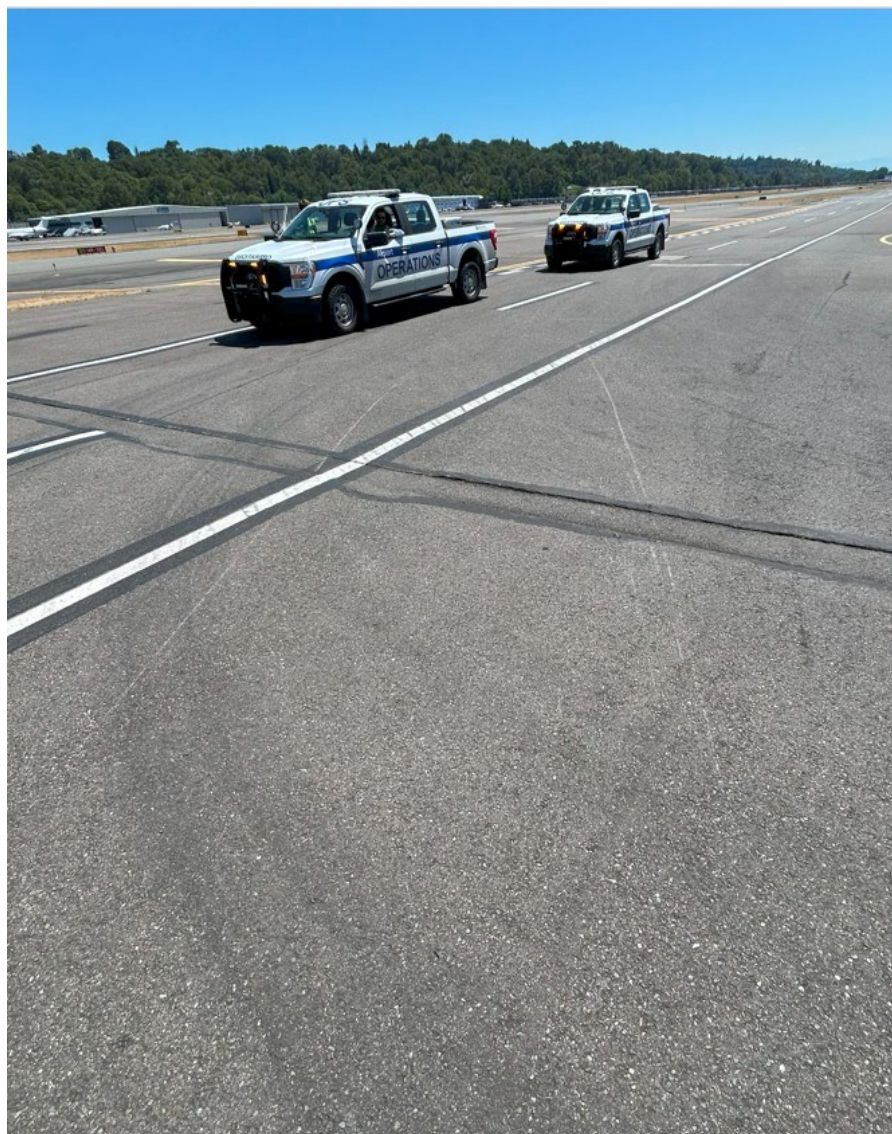
**Photograph 3 - Scrapes on ramp surface from helicopter impact. (Courtesy of airport operations).**
