WPR25LA231

**INVESTIGATION PHOTOGRAPH**

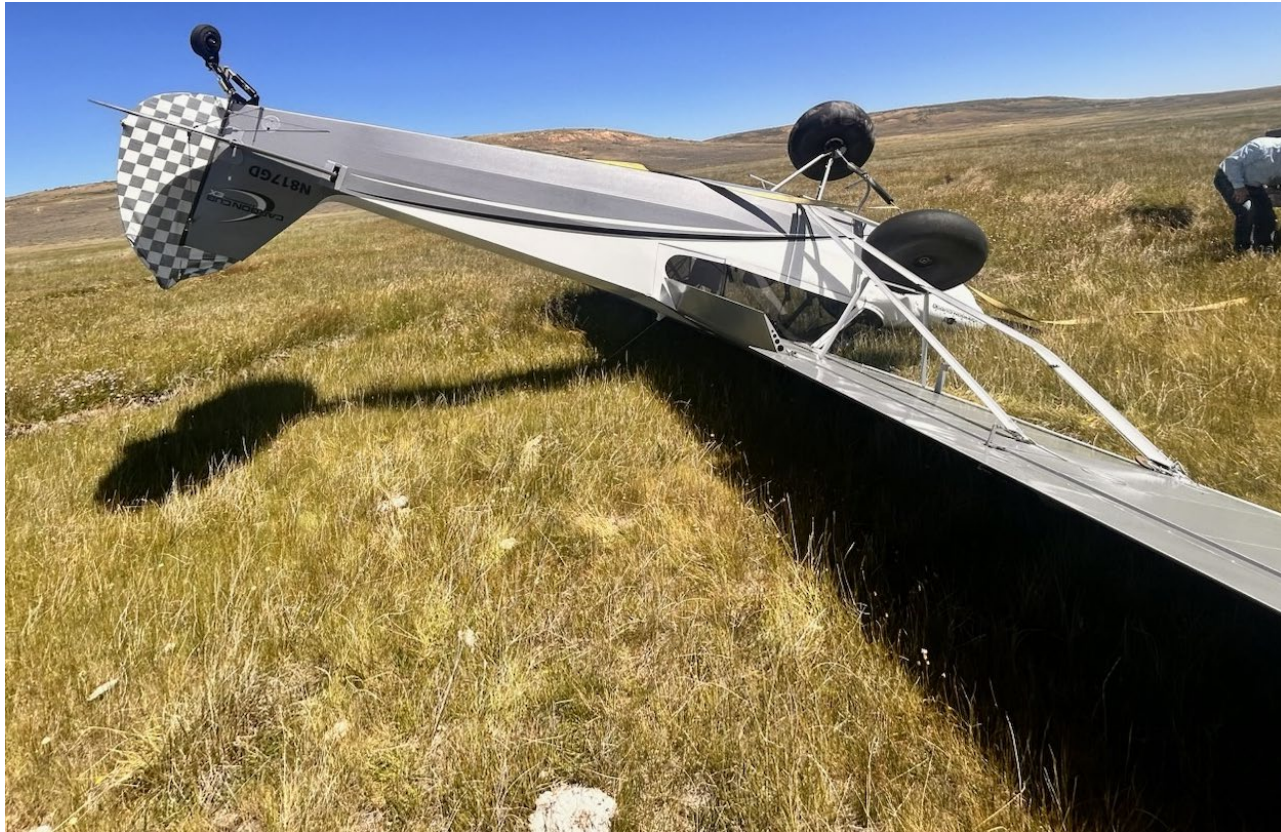
**Photograph 1 - View of damage to the left wing lift strut and rudder (Courtesy of Pilot)**
