WPR25LA234

## INVESTIGATION PHOTOGRAPHS

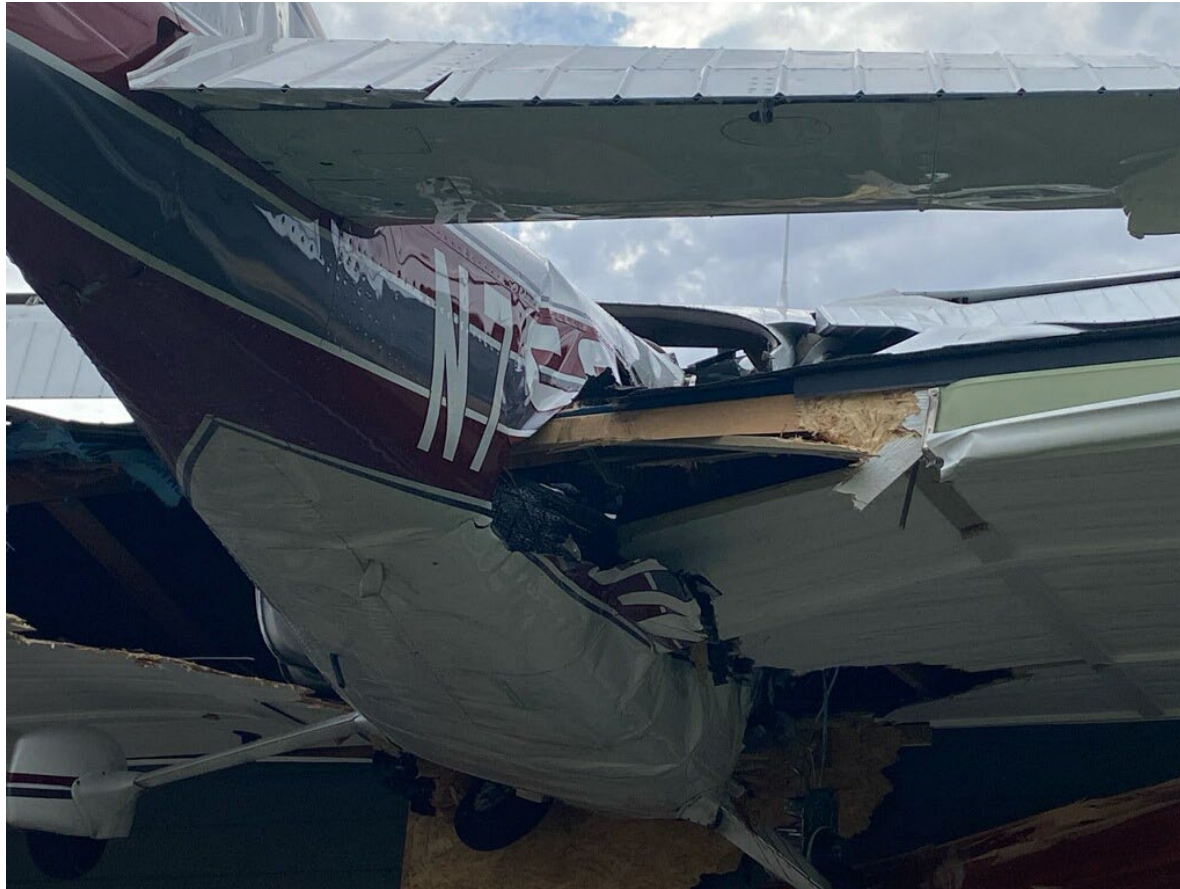
**Photograph 1 - View of damage to fuselage. (Courtesy of FAA)**

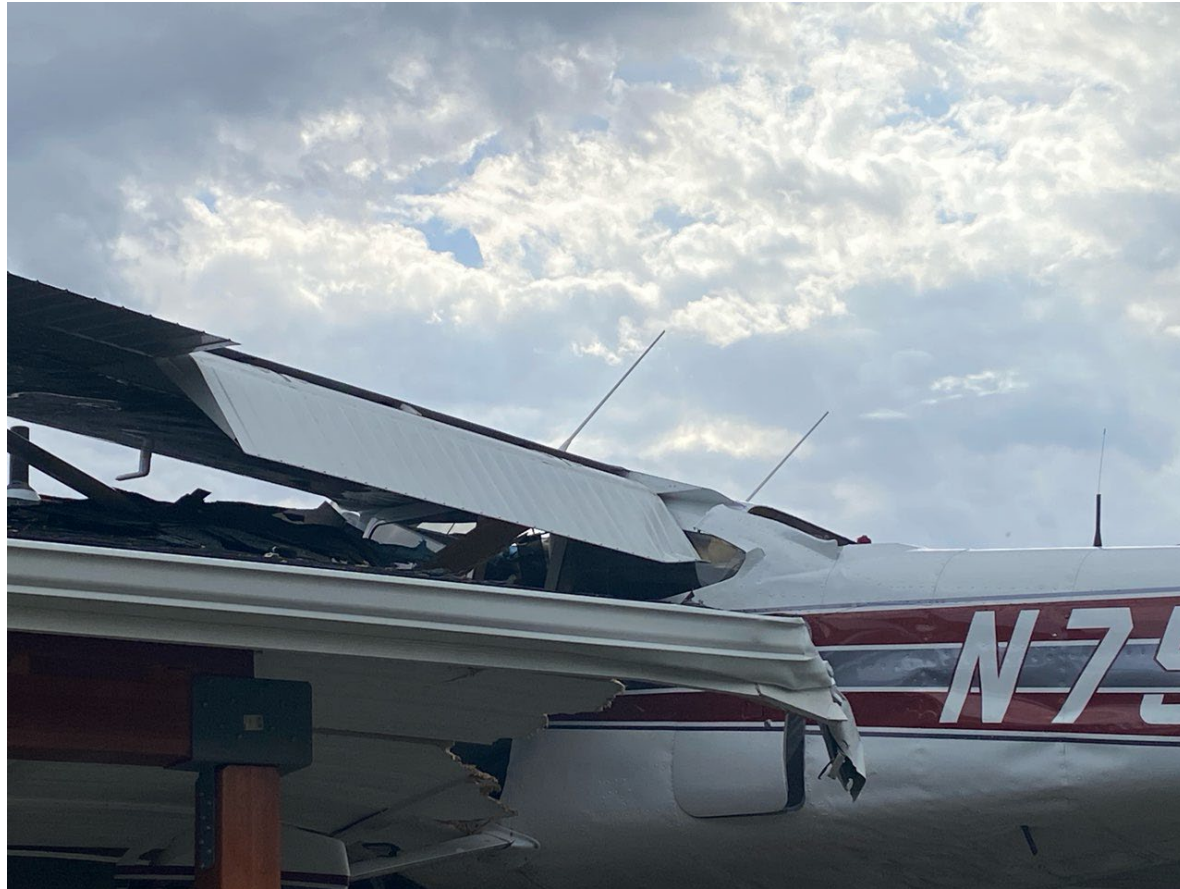
**Photograph 2 - View of damage to fuselage.  
(Courtesy of FAA)**

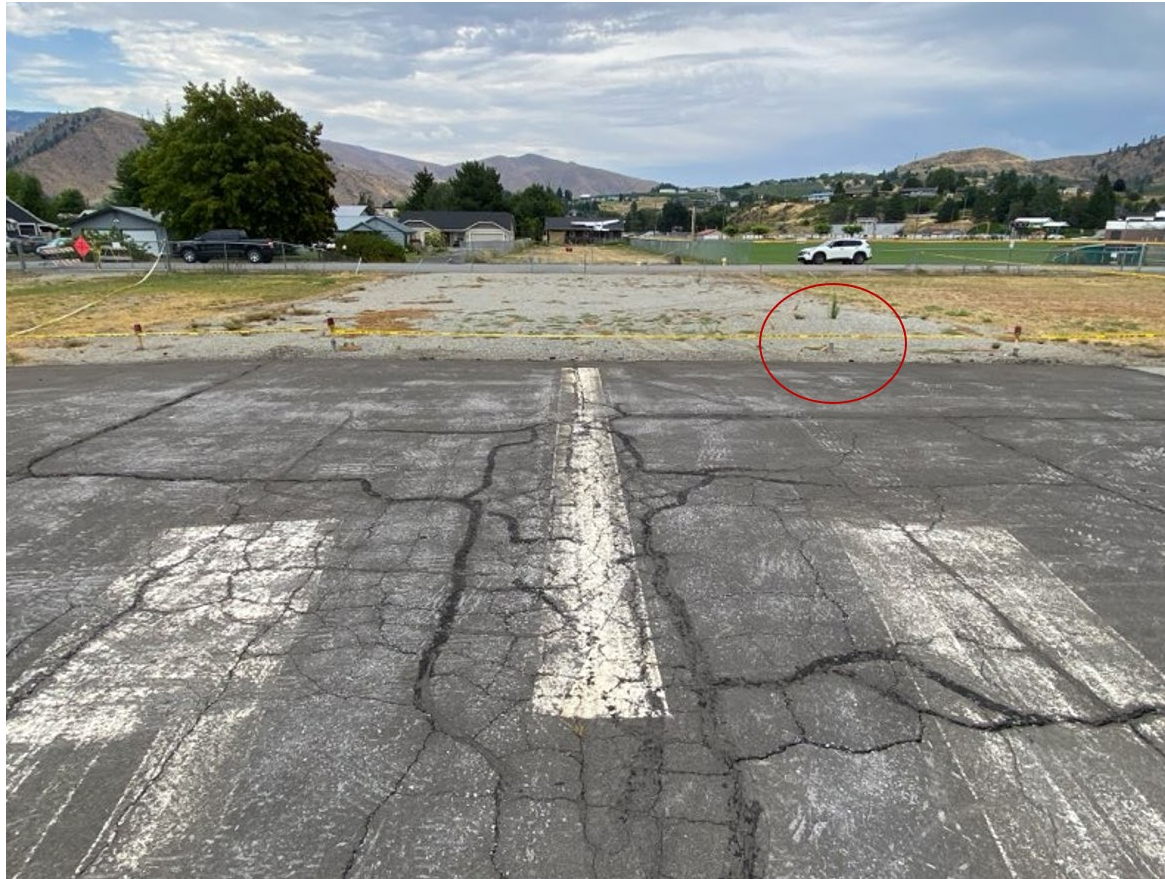
**Photograph 3 - Damaged runway end light circled.  
(Courtesy of FAA)**

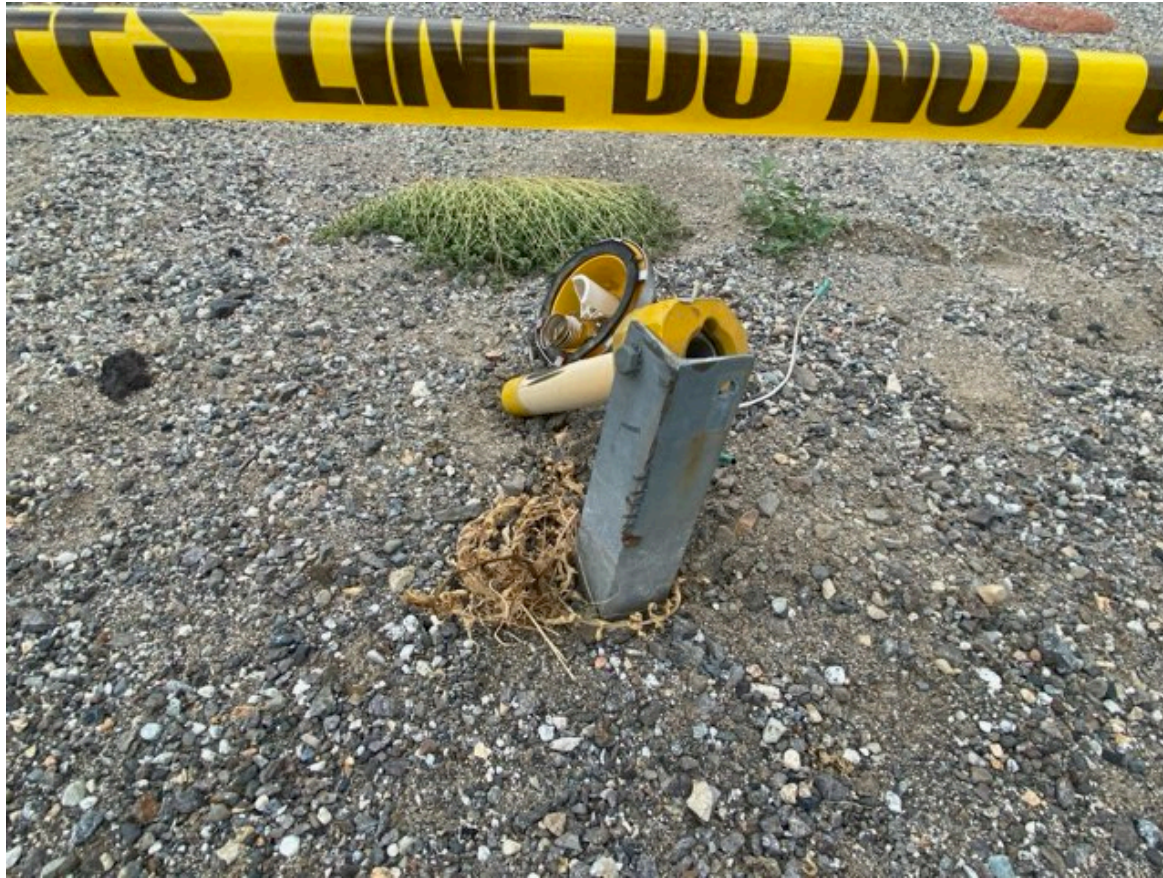
**Photograph 4 - Damaged runway end light.  
(Courtesy of FAA)**
