WPR25LA262

**INVESTIGATION PHOTOGRAPH**

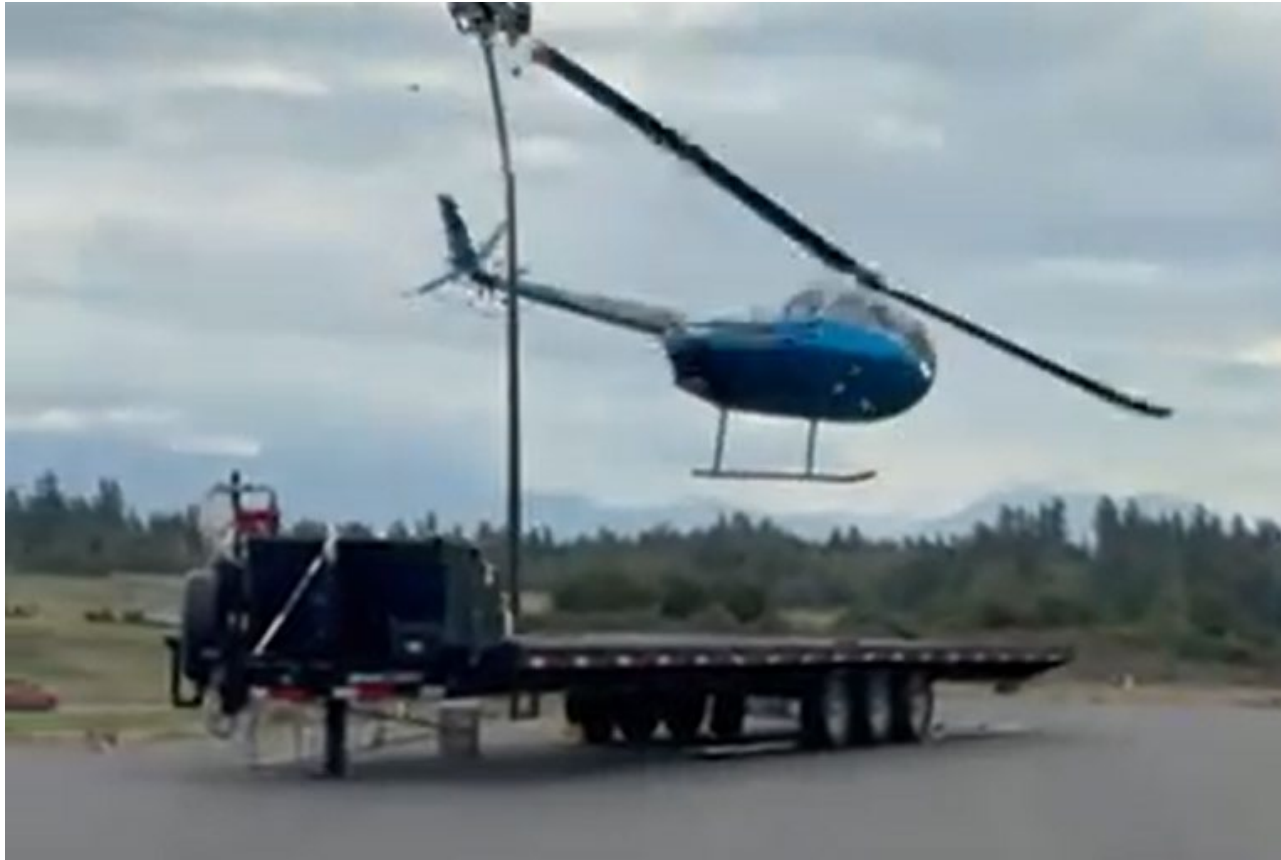
**Photo 1 - View of the helicopter's right side tailboom striking light pole (Courtesy of BVS Airport Operations)**

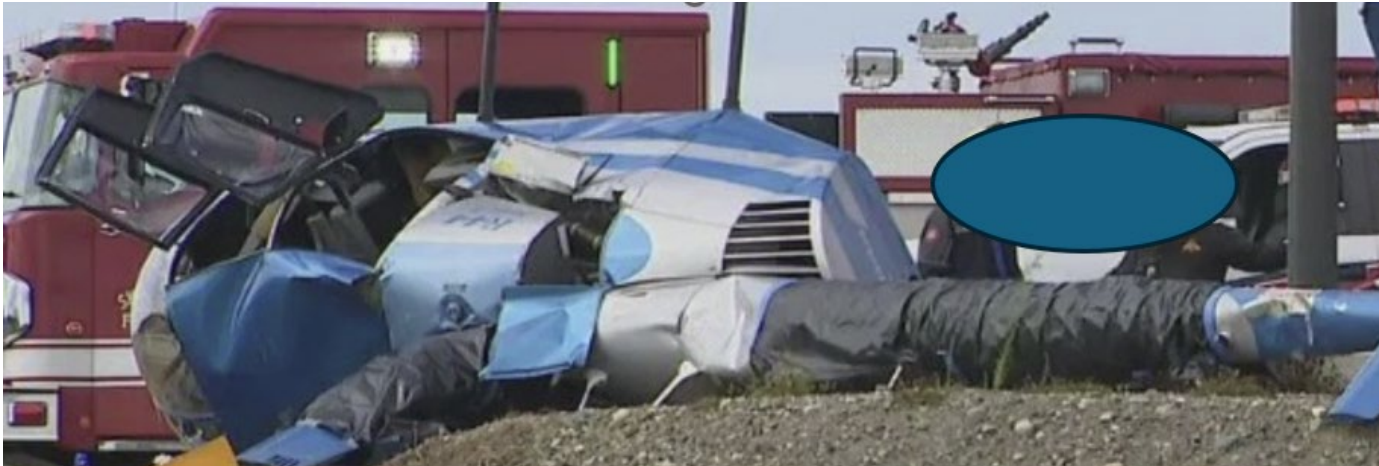
**Photo 2 - View of substantial damage to the tailboom and fuselage (Courtesy of Social Media)**
