WPR25LA270

## INVESTIGATION PHOTOGRAPHS

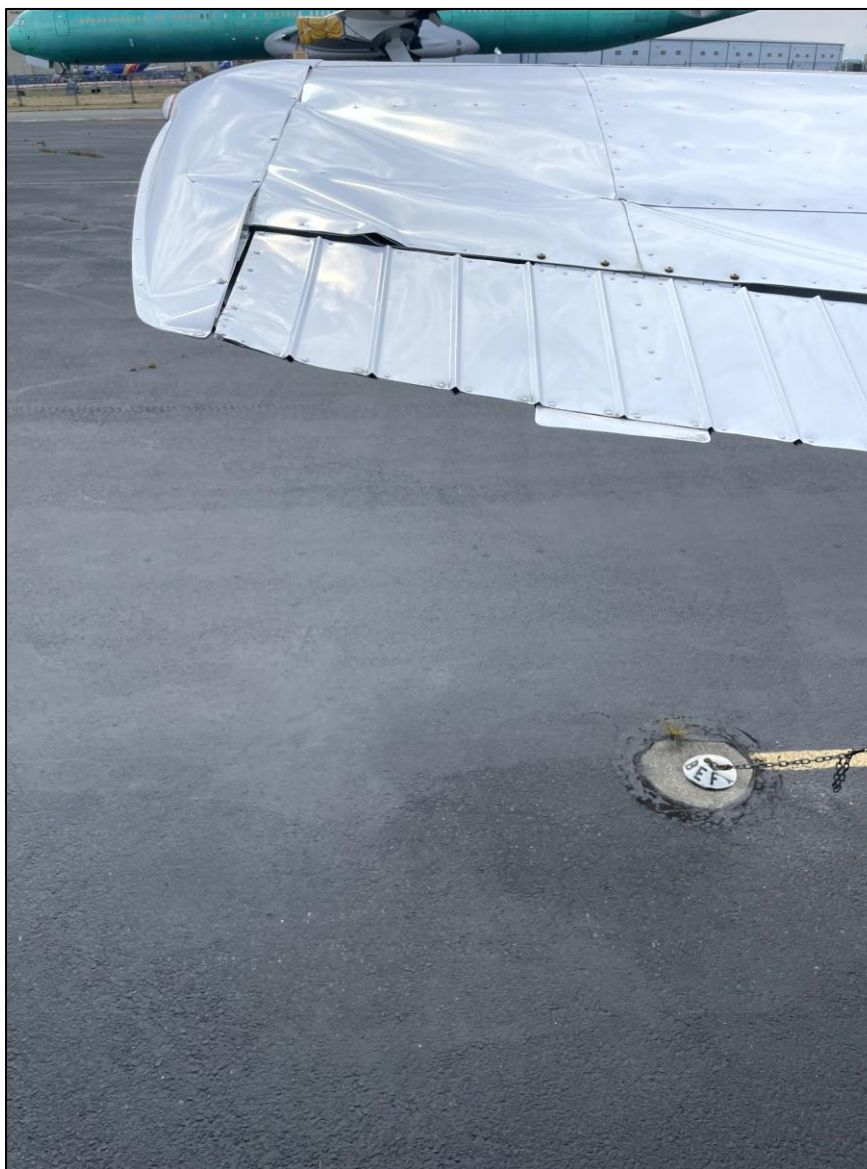
**Photograph 1 -Left horizontal stab and elevator damage. (Courtesy of the pilot.)**

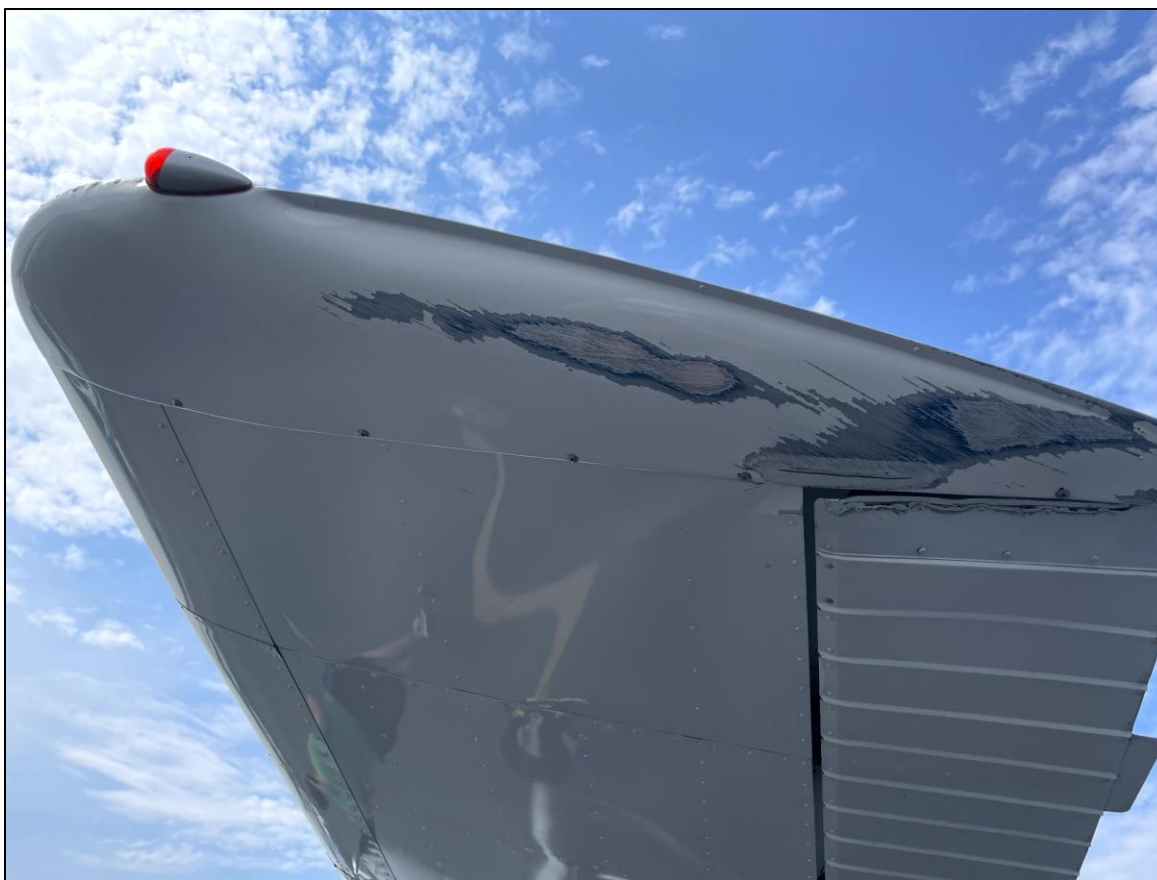
**Photograph 2 -Left wing tip fairing and aileron damage. (Courtesy of the pilot)**

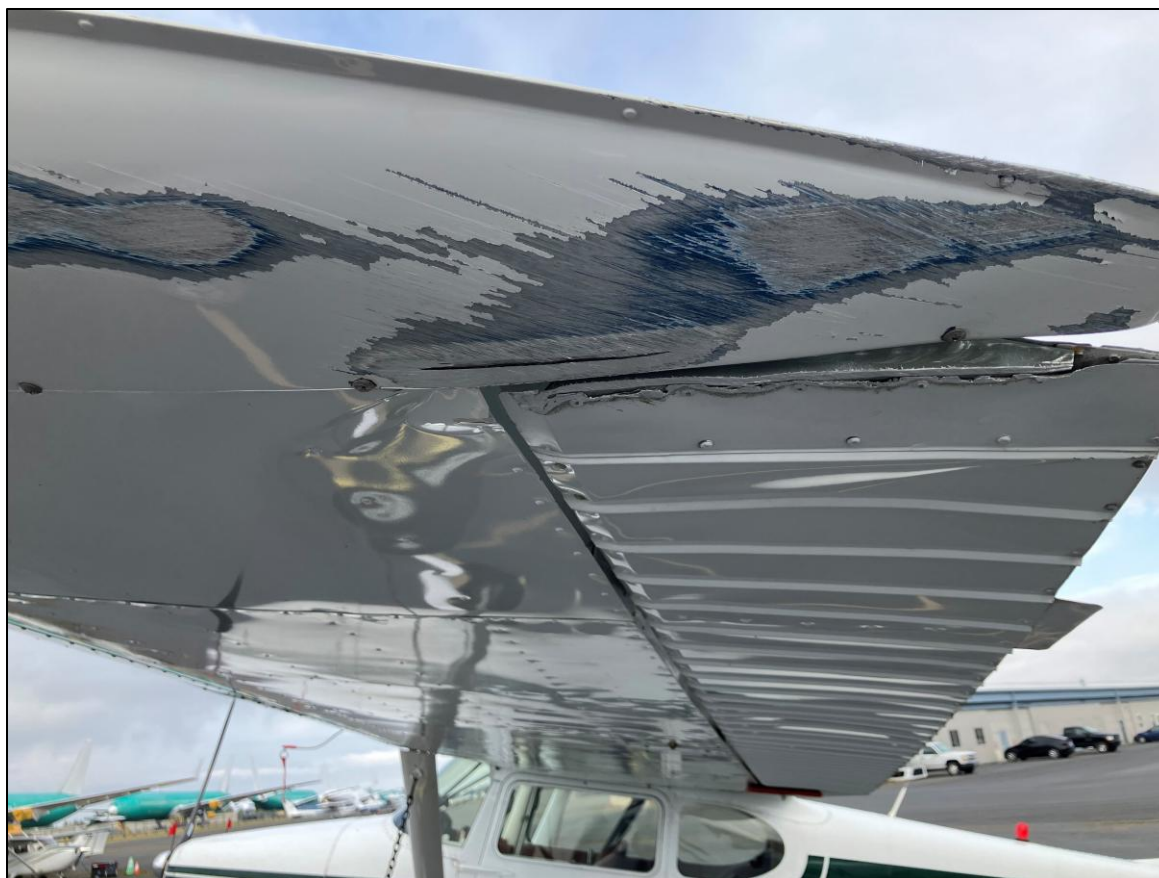
**Photograph 3 - Left wing tip fairing damage. (Courtesy of the FAA)**

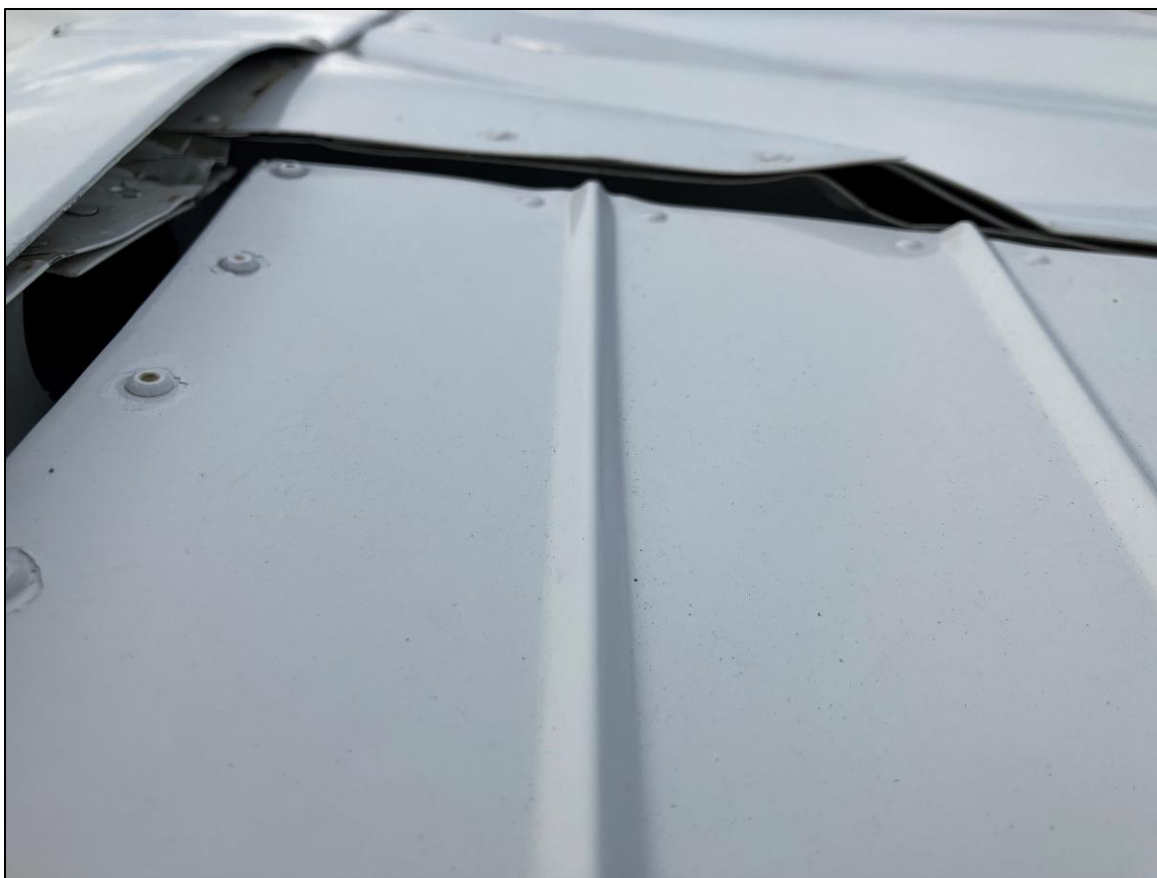
**Photograph 4 - Left outboard wing upper surface damage. (Courtesy of the FAA)**
