WPR26LA003

## INVESTIGATION PHOTOGRAPHS

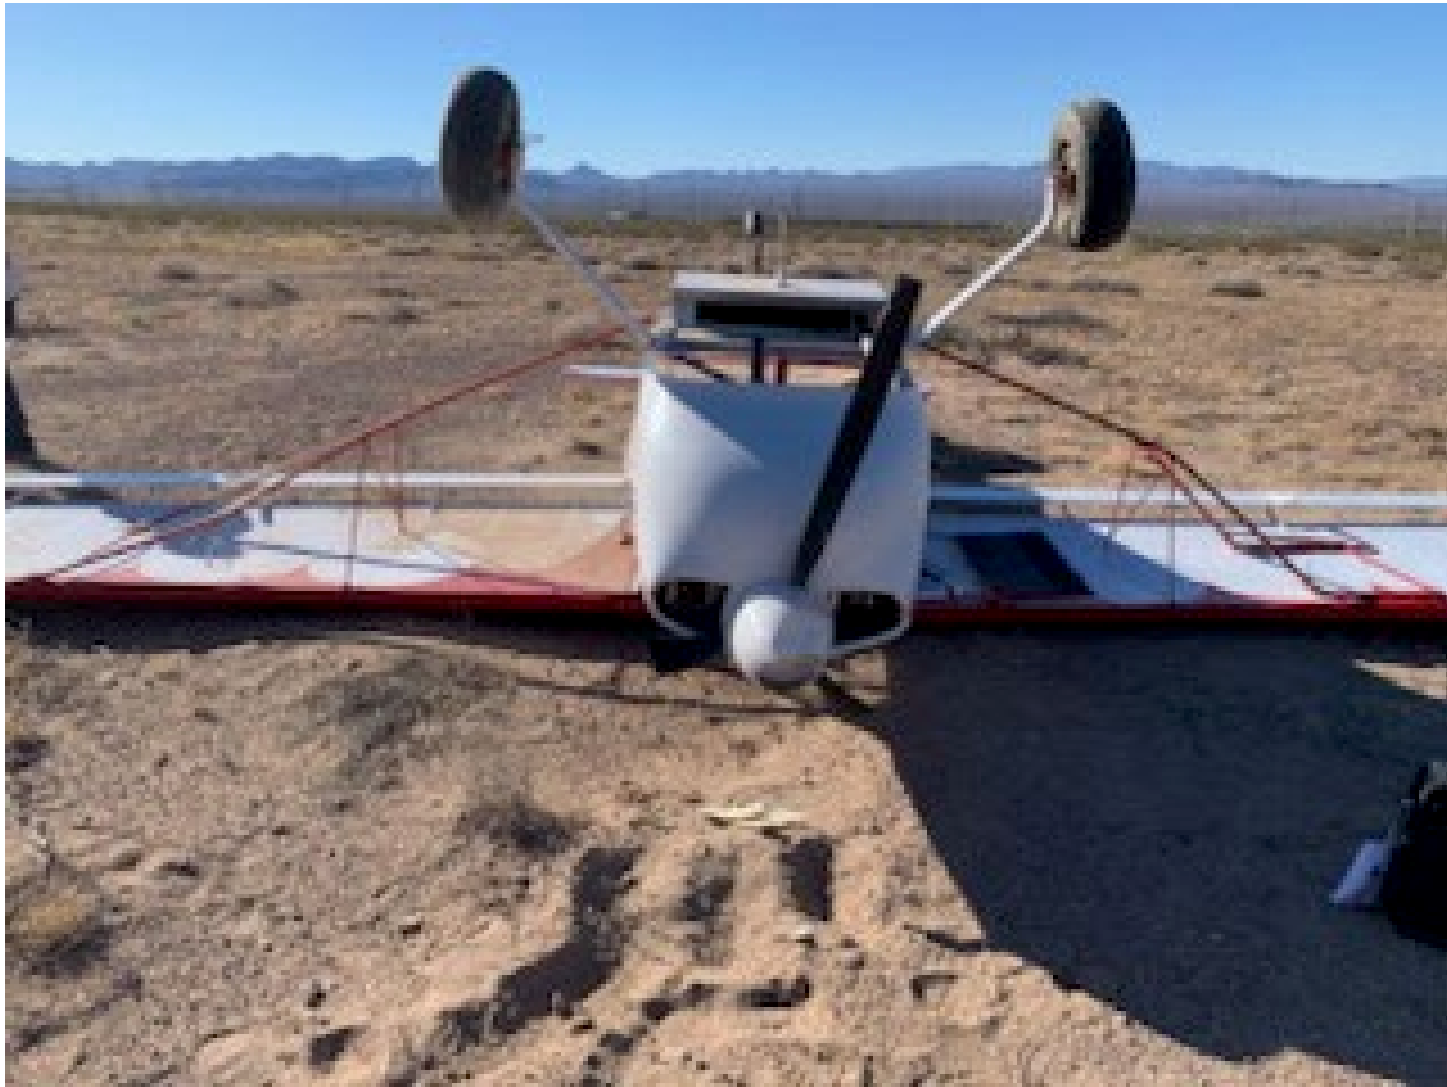
**Photograph 1 - Right wing strut damage (Courtesy of Pilot)**

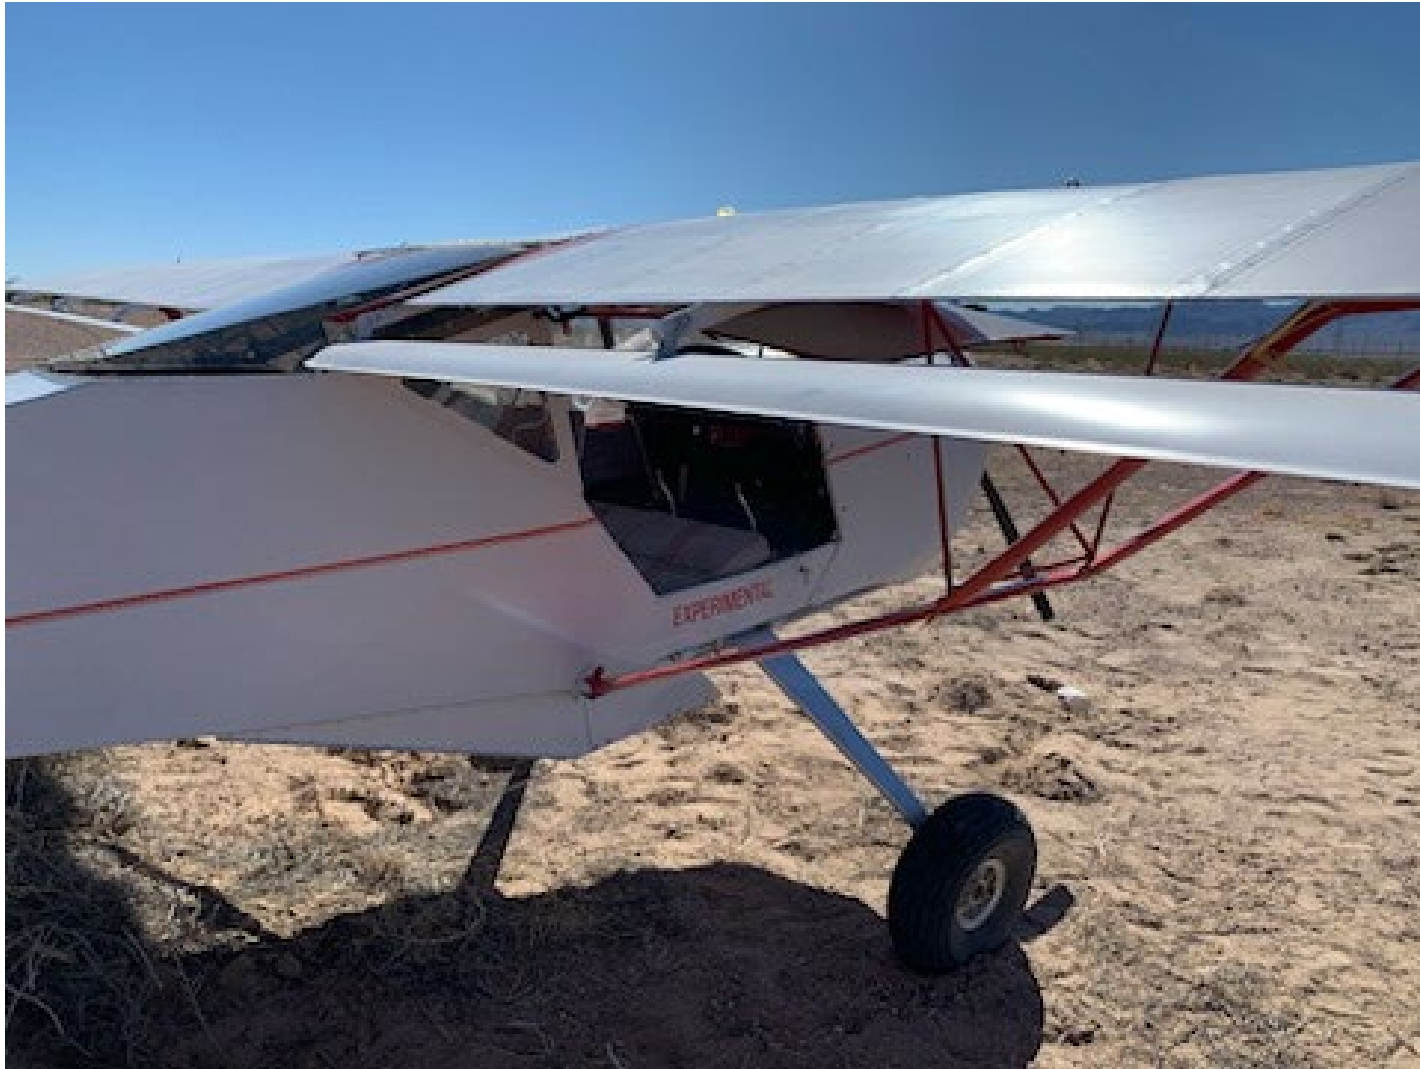
**Photograph 2 - Right wing strut damage (Courtesy of Pilot)**
