WPR26LA009

## INVESTIGATION PHOTOGRAPHS

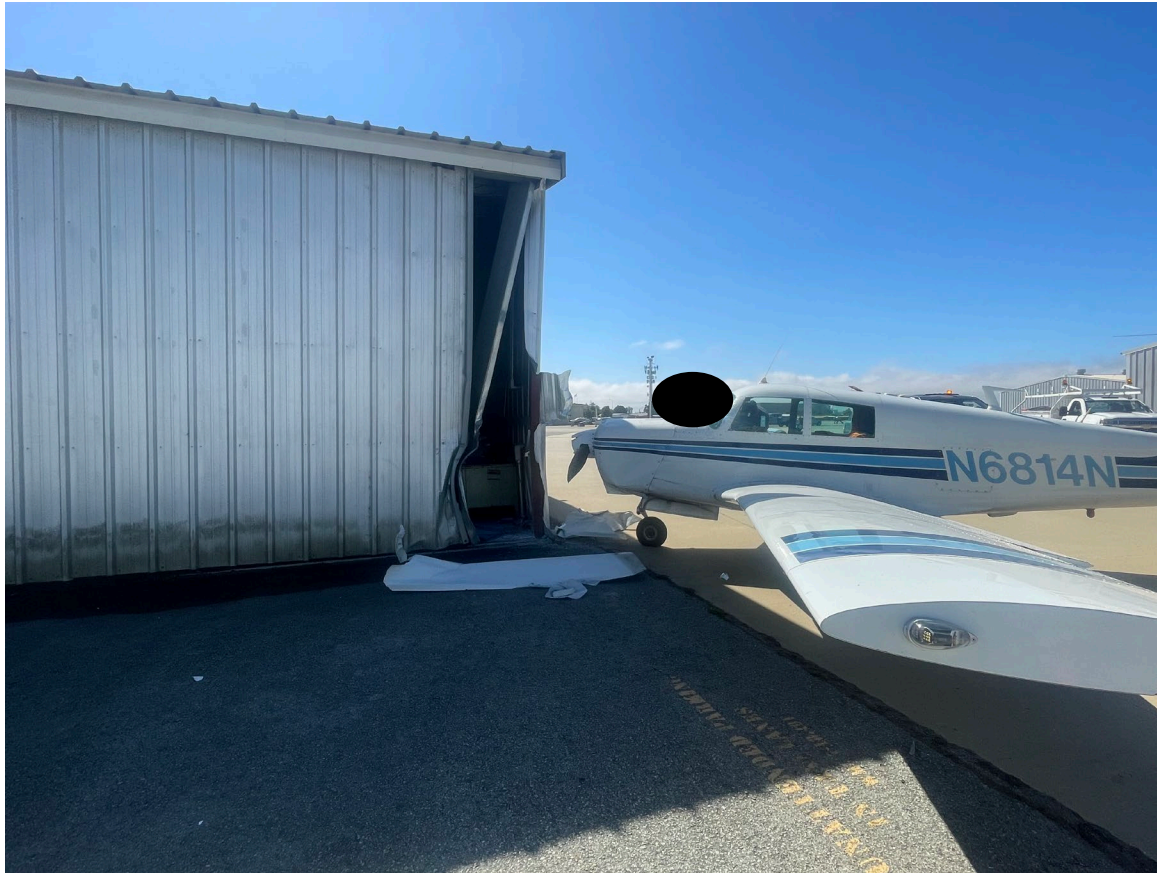
**Photograph 1 - View of accident airplane (Courtesy of Airport Operations)**

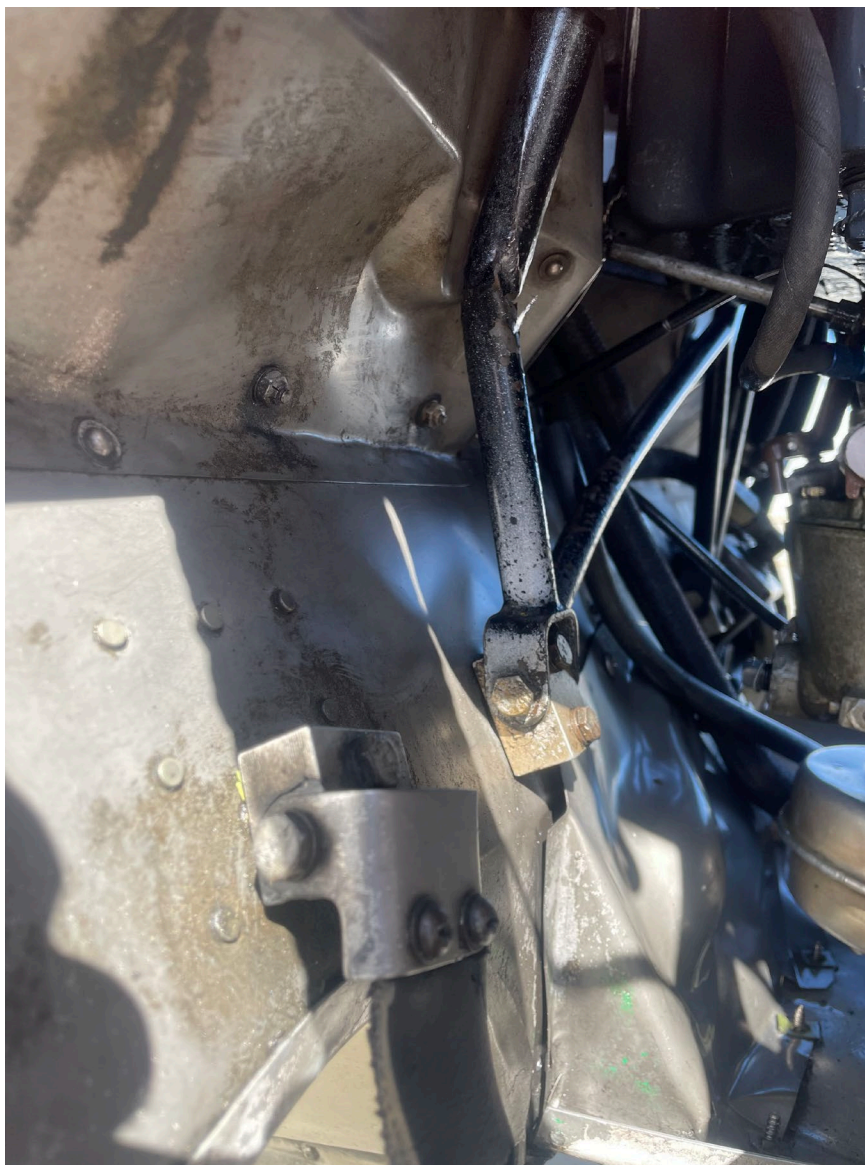
**Photograph 2 - View of engine mount damage (Courtesy of Airport Operations)**
