WPR26LA017

## INVESTIGATION PHOTOGRAPHS

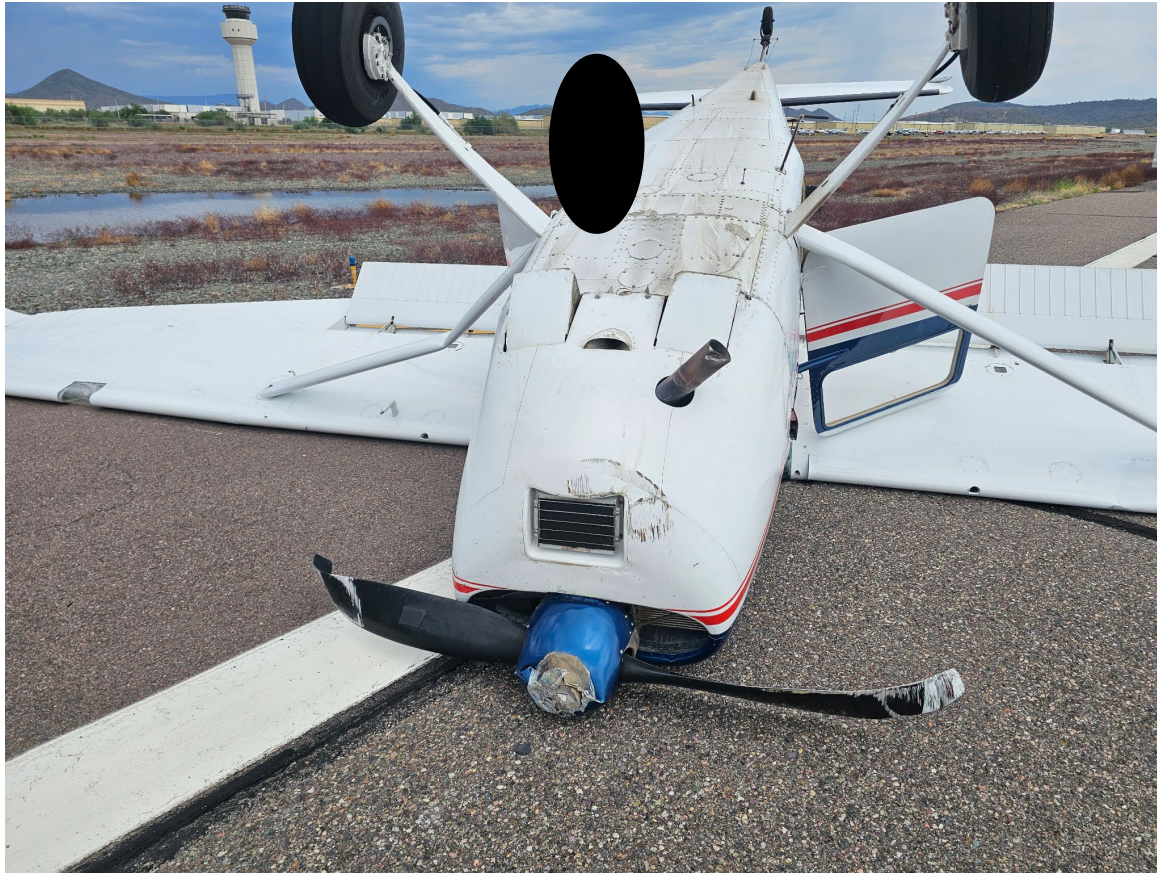
**Photograph 1 - View of left-wing lift strut damage (Courtesy of Pilot)**

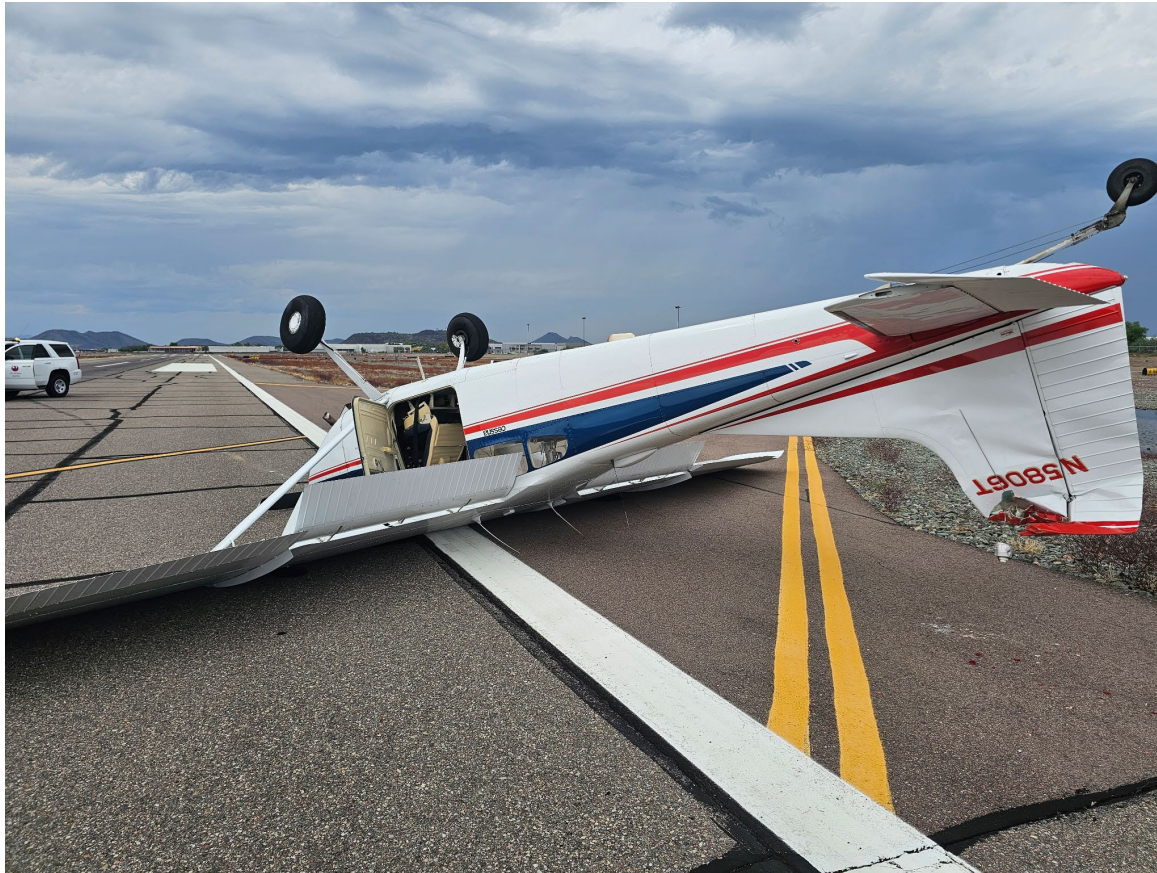
**Photograph 2 - View of vertical stabilizer damage (Courtesy of Pilot)**
