Zane Brown  
Aviation Accident Investigator  
AS-WPR

**Date:** 02/04/2026

**Subject:** WPR28LA028 / Tailwheel Assembly Examination

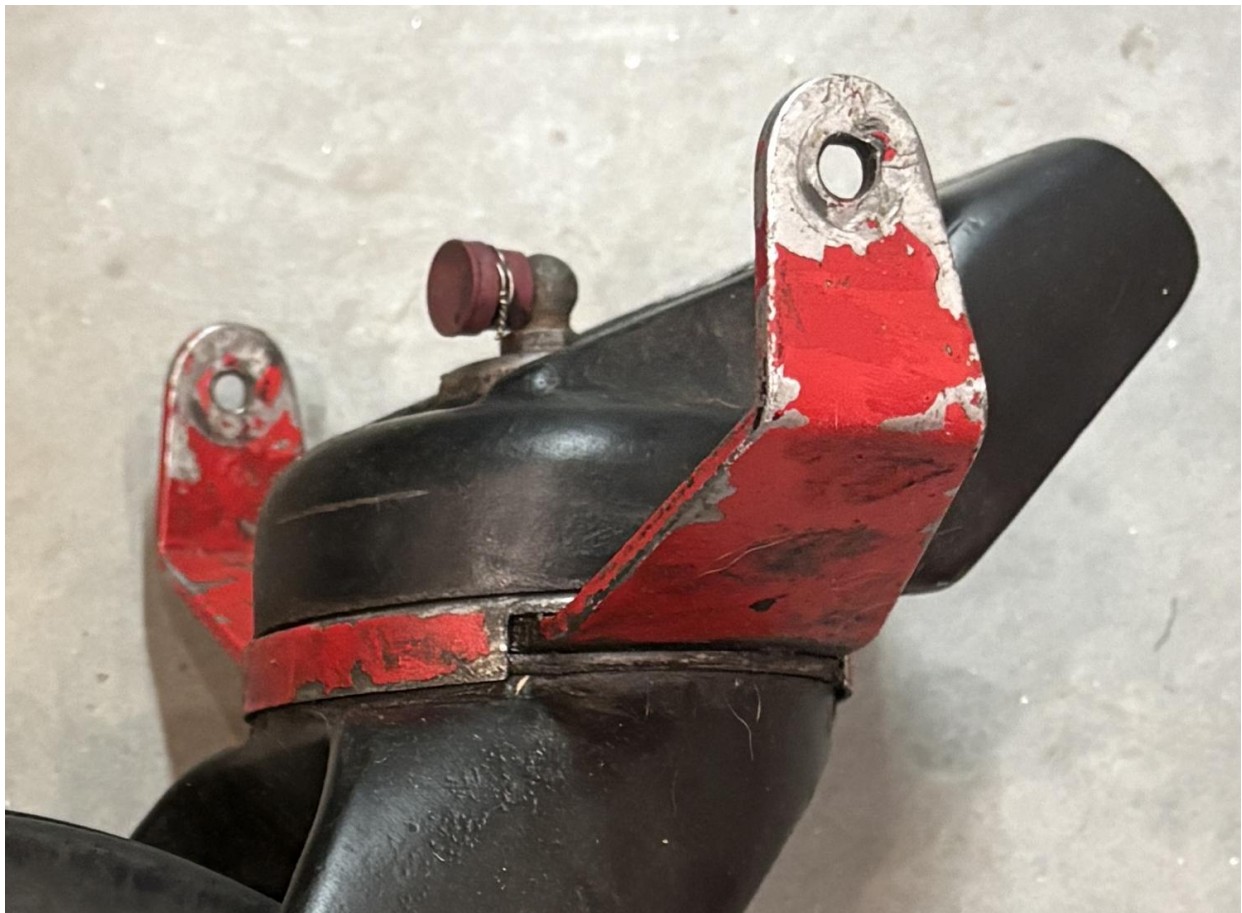
The tailwheel assembly was received packaged in a shipping box. The box was intact and sealed when opened by the investigator. When the investigator removed the tailwheel assembly from the box, it was noted that the cotter pin was missing from the kingpin nut. Investigators had been previously advised by the pilot that he had disassembled the tailwheel assembly following the accident, then reassembled it.

**Photograph 1 – Tailwheel assembly, external, as received**

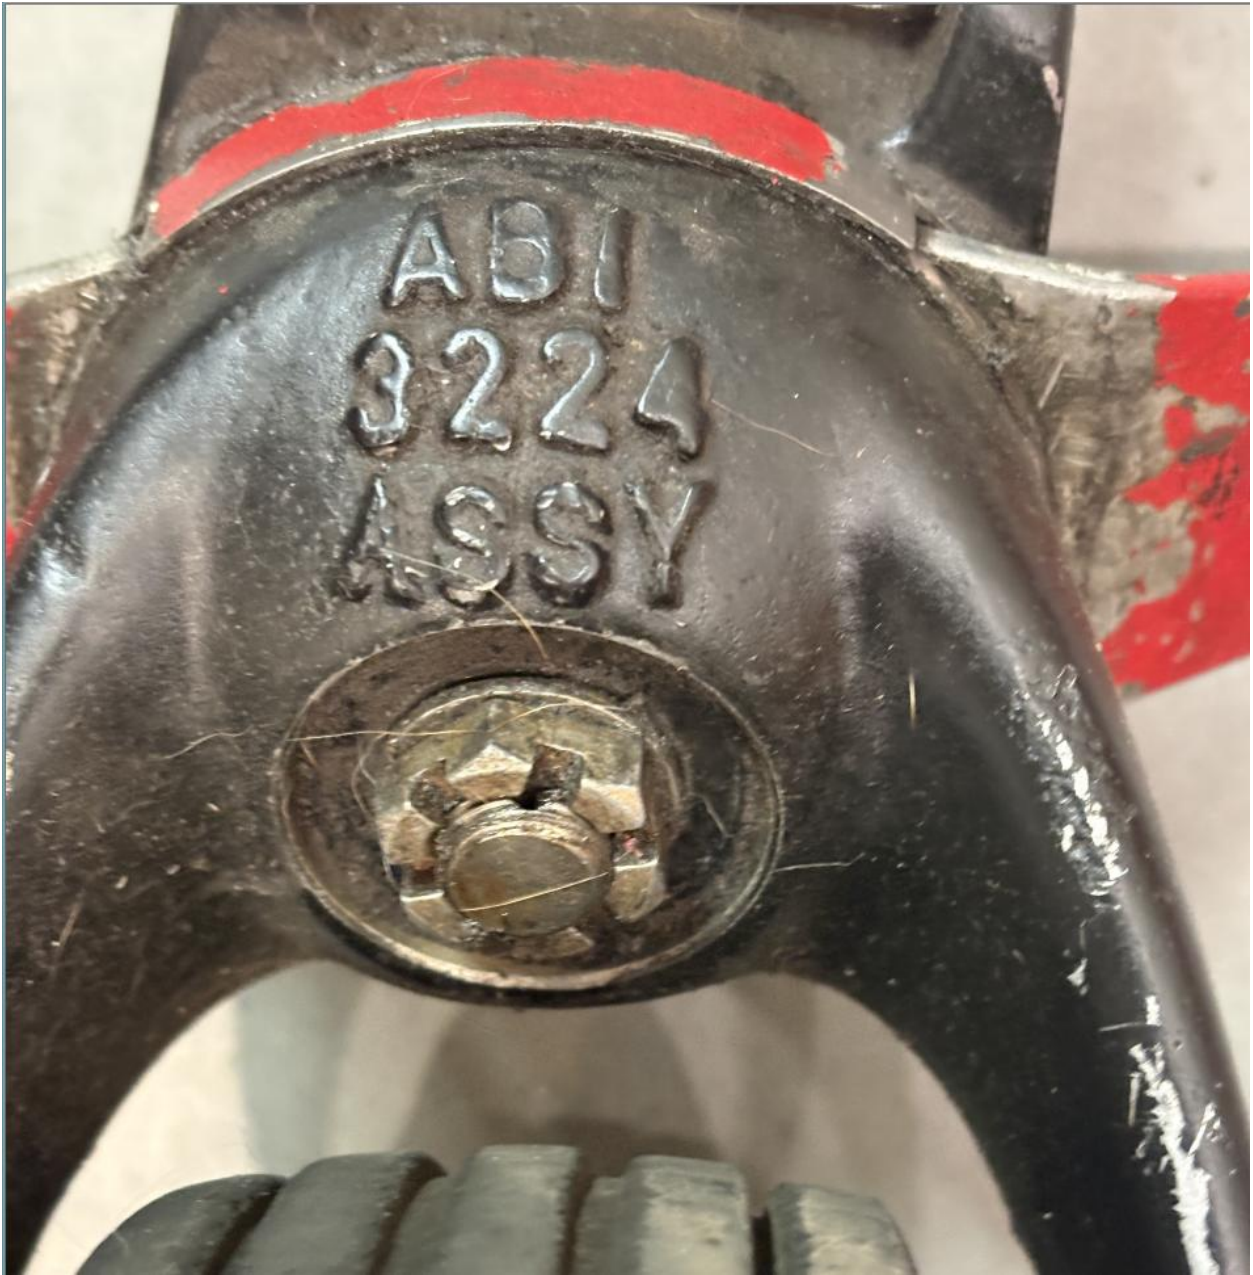
The pilot removed the tailwheel assembly from the accident airplane and shipped it to the National Transportation Safety Board for examination. The assembly was identified as an Alaskan Bushwheels (ABI) 3224-series tailwheel, a direct replacement part for the Scott 3200A tailwheel assembly originally supplied on the accident airplane model.

**Photograph 2 – Tailwheel assembly, brand marking and part number**

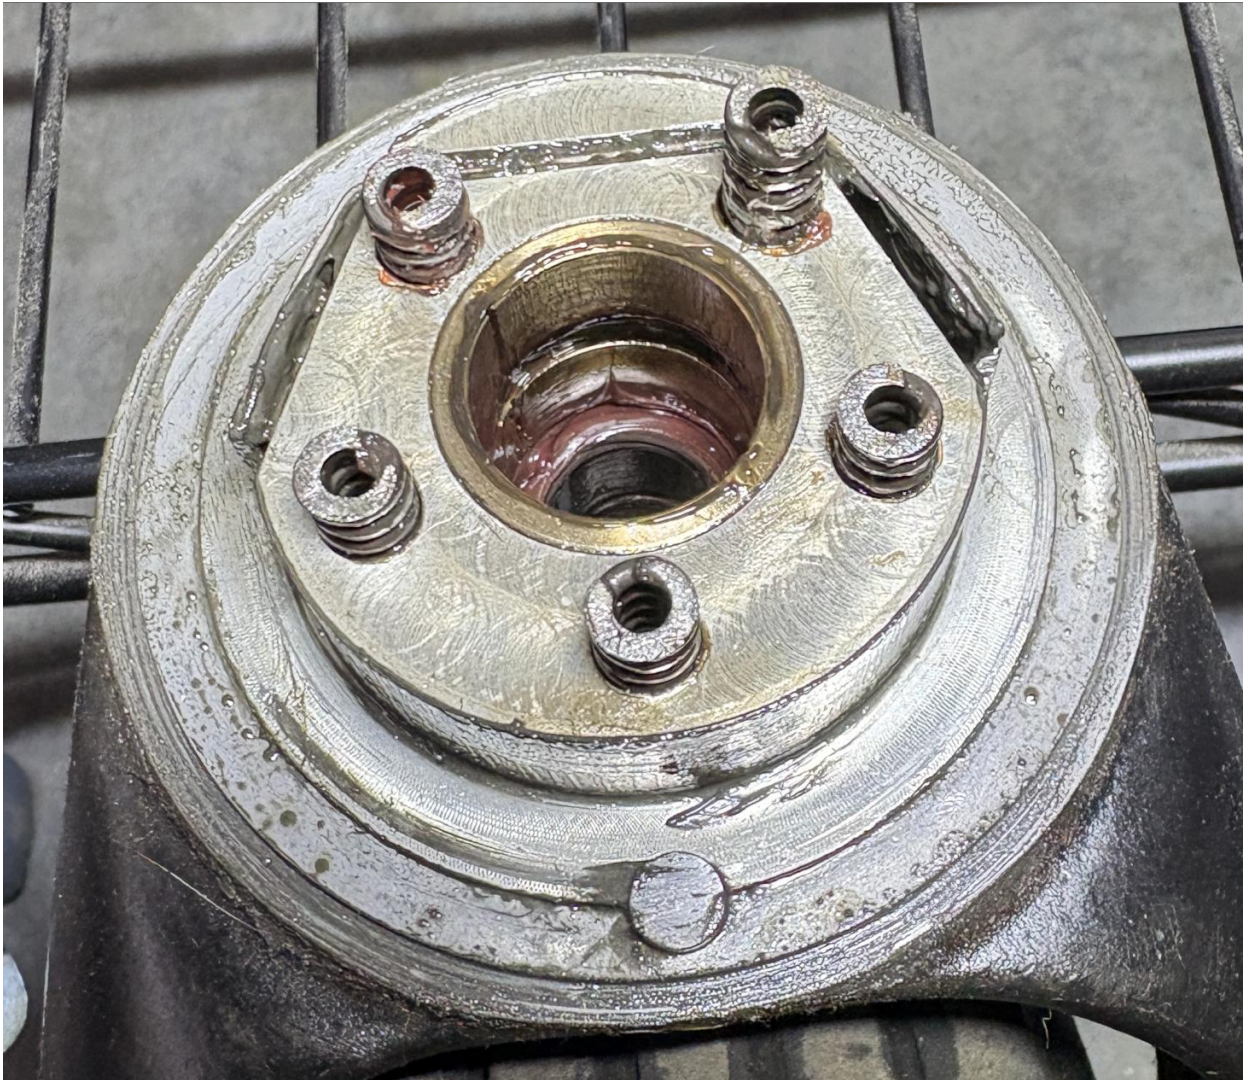
The lock pawl exhibited rounded edges and displayed an appearance consistent with mechanical abrasion/cleaning, likely from the use of a mechanical wire wheel.

**Photograph 3 – Tailwheel assembly, internal, showing wire wheel marks**

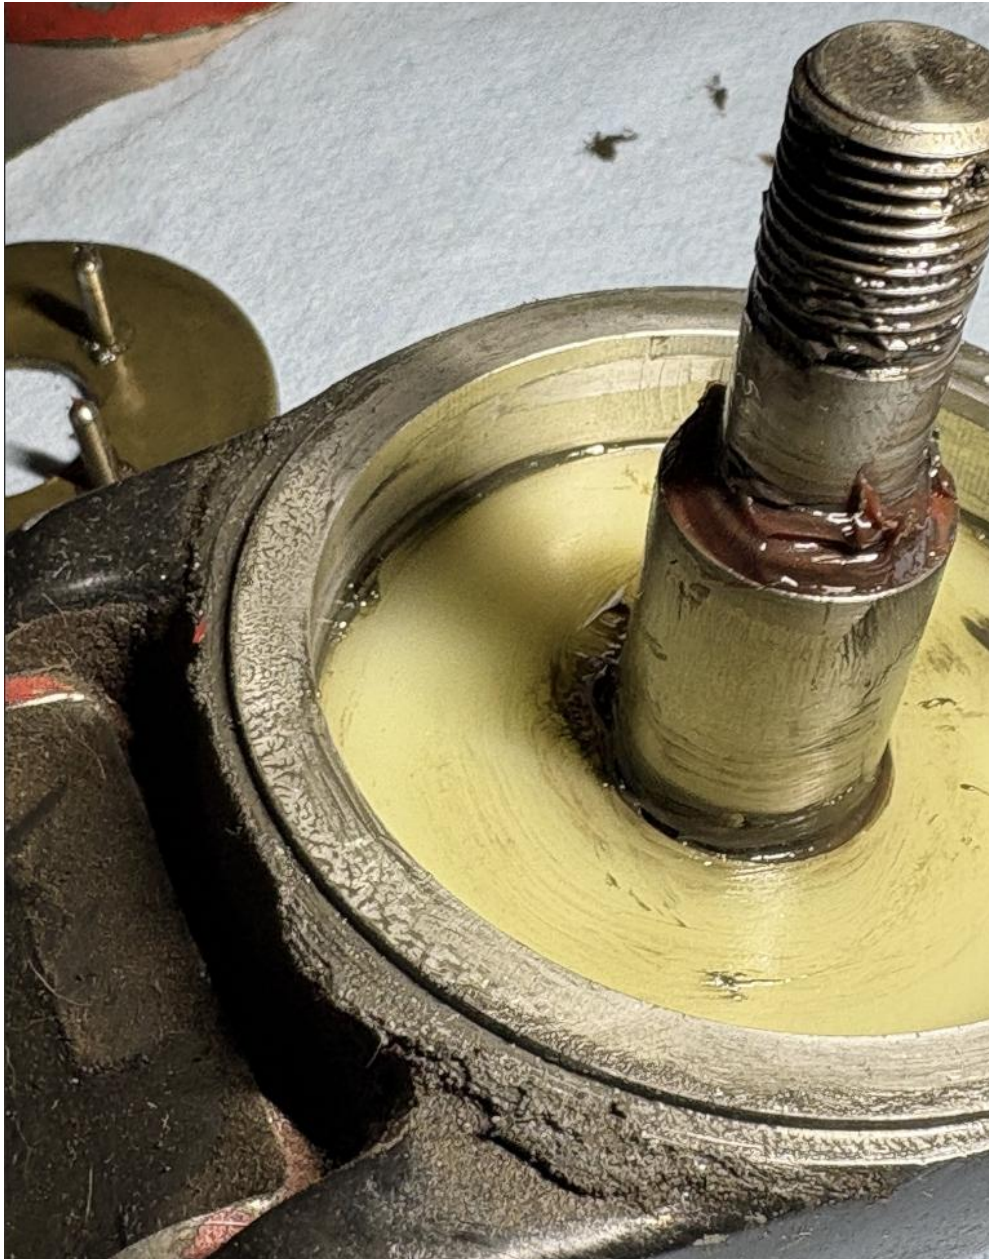
The tailwheel assembly was disassembled, cleaned, and examined. The assembly contained excess grease, which was dirty and contained visible grit. The fiber thrust washer, thrust plate assembly, compression springs, and the upper and lower thrust washers were examined and found to be unremarkable. The dowel pin was also examined and was unremarkable. The center bushing, center bearing race, and cone bearing were examined and were unremarkable.

**Photograph 4 – Tailwheel assembly, internal**

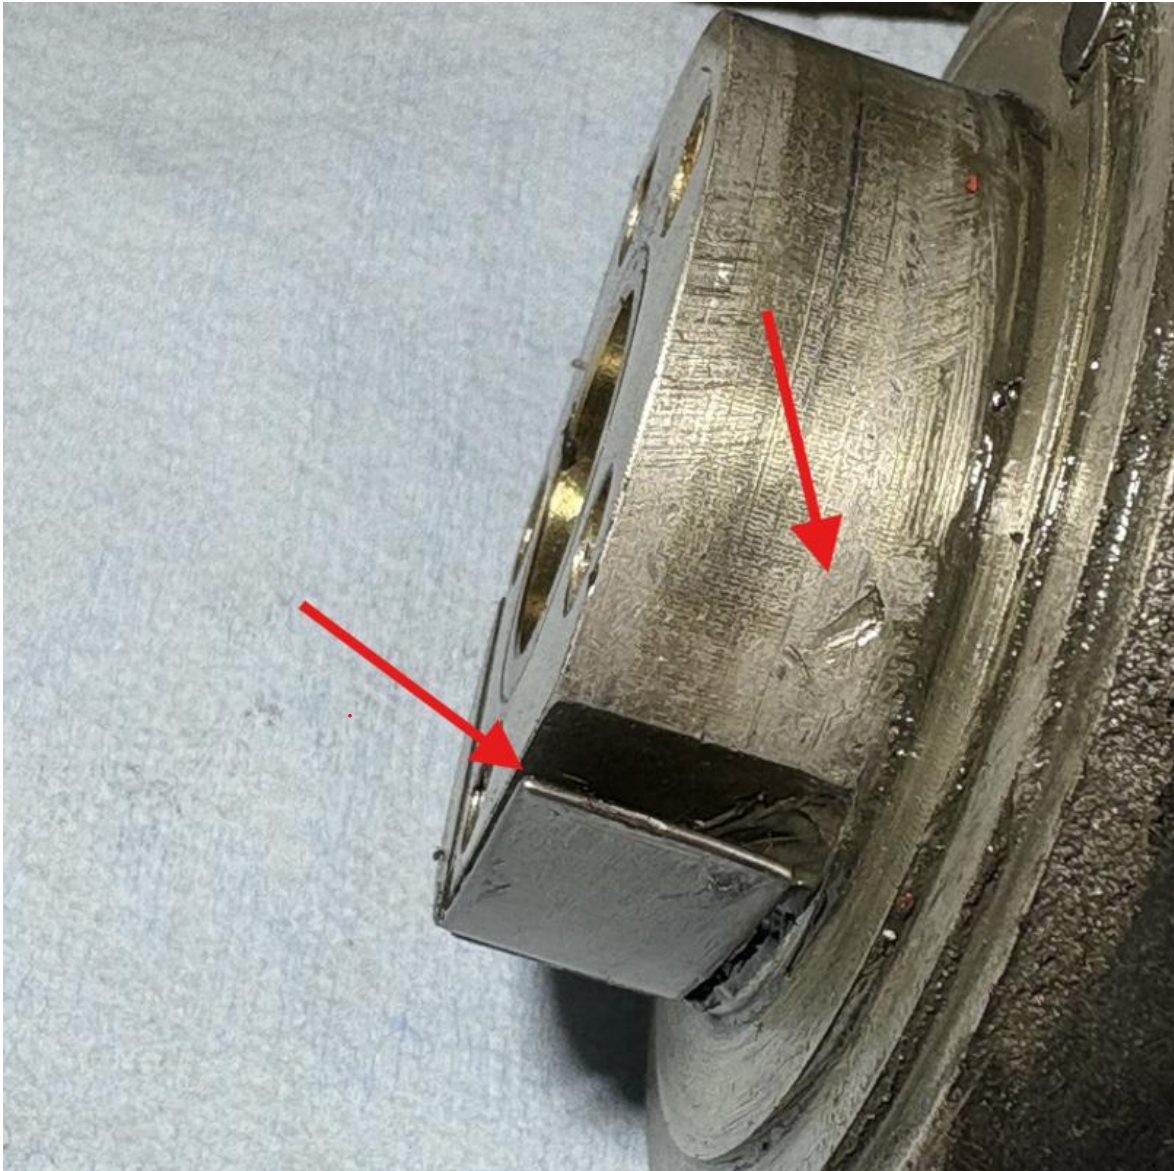
A gouge was noted in the outer bore of the tailwheel head. The gouge appeared consistent with contact from the lock pawl.

The outer race of the tailwheel fork assembly contained gouge marks near the turn lock spring. The edges of the turn lock spring, where it engages with the steering arm notches, were rounded.

**Photograph 5 – Tailwheel head, disassembled**  
**Arrows indicates gouges in outer bore, worn turn lock spring edges**

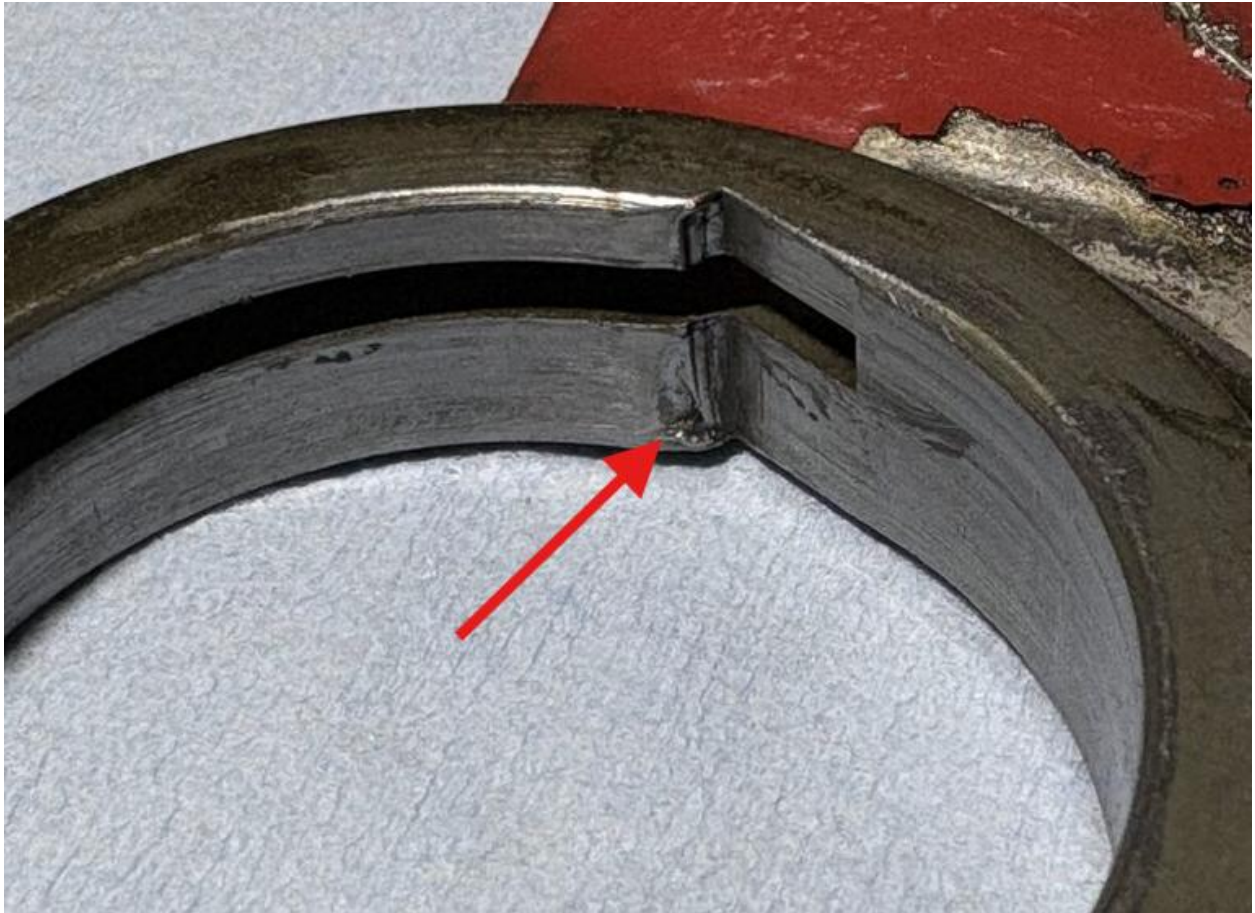
The inner race of the steering arm assembly displayed deep scratching and gouging at the lock notches.

**Photograph 6 – Tailwheel steering arm assembly  
Arrow indicates scratches/gouges at lock notch**

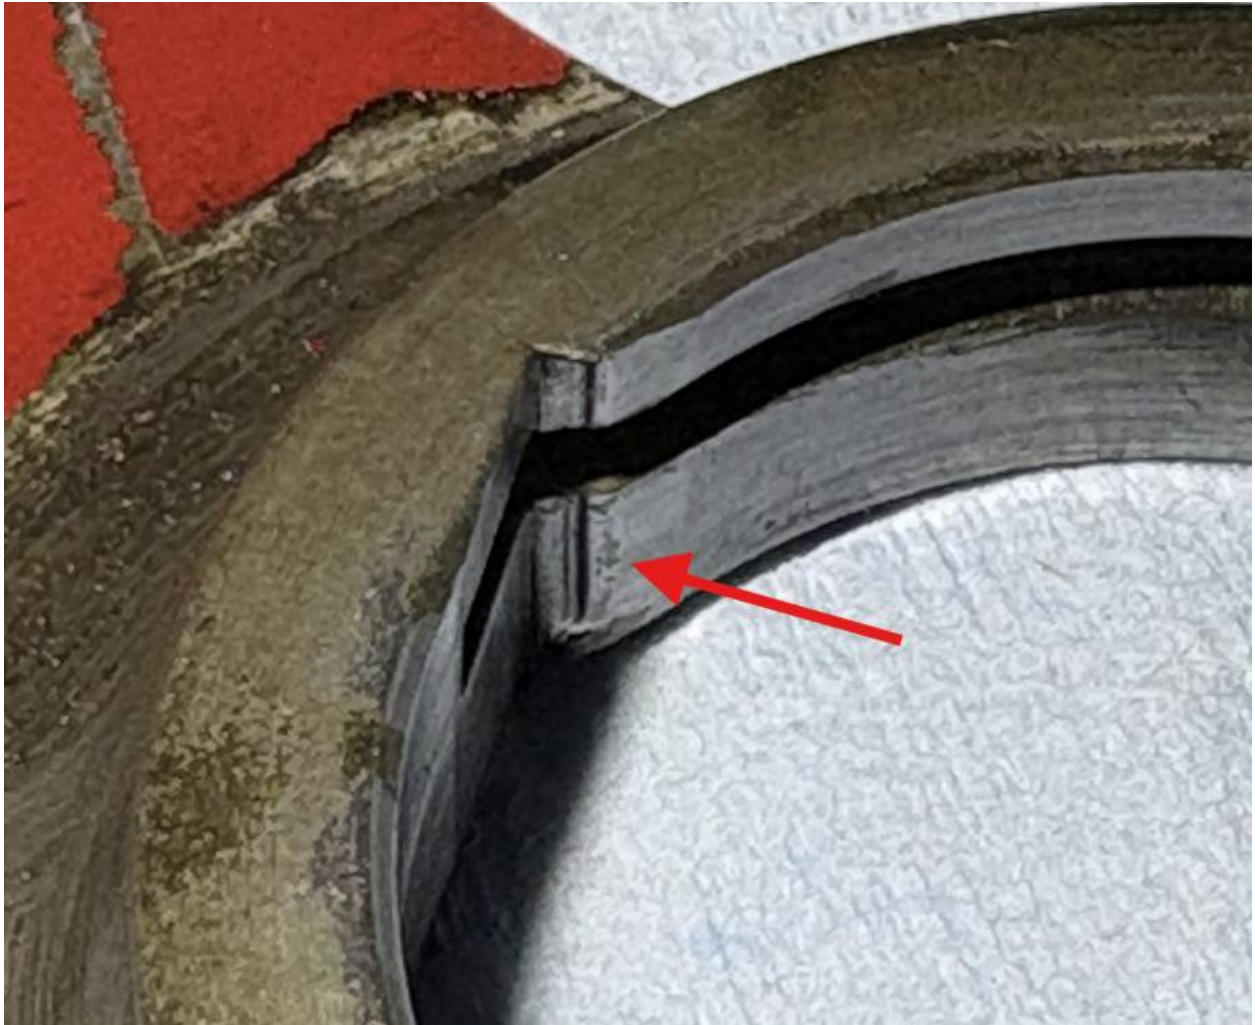
**Photograph 7 – Tailwheel steering arm assembly  
Arrow indicates scratches/gouges at lock notch**

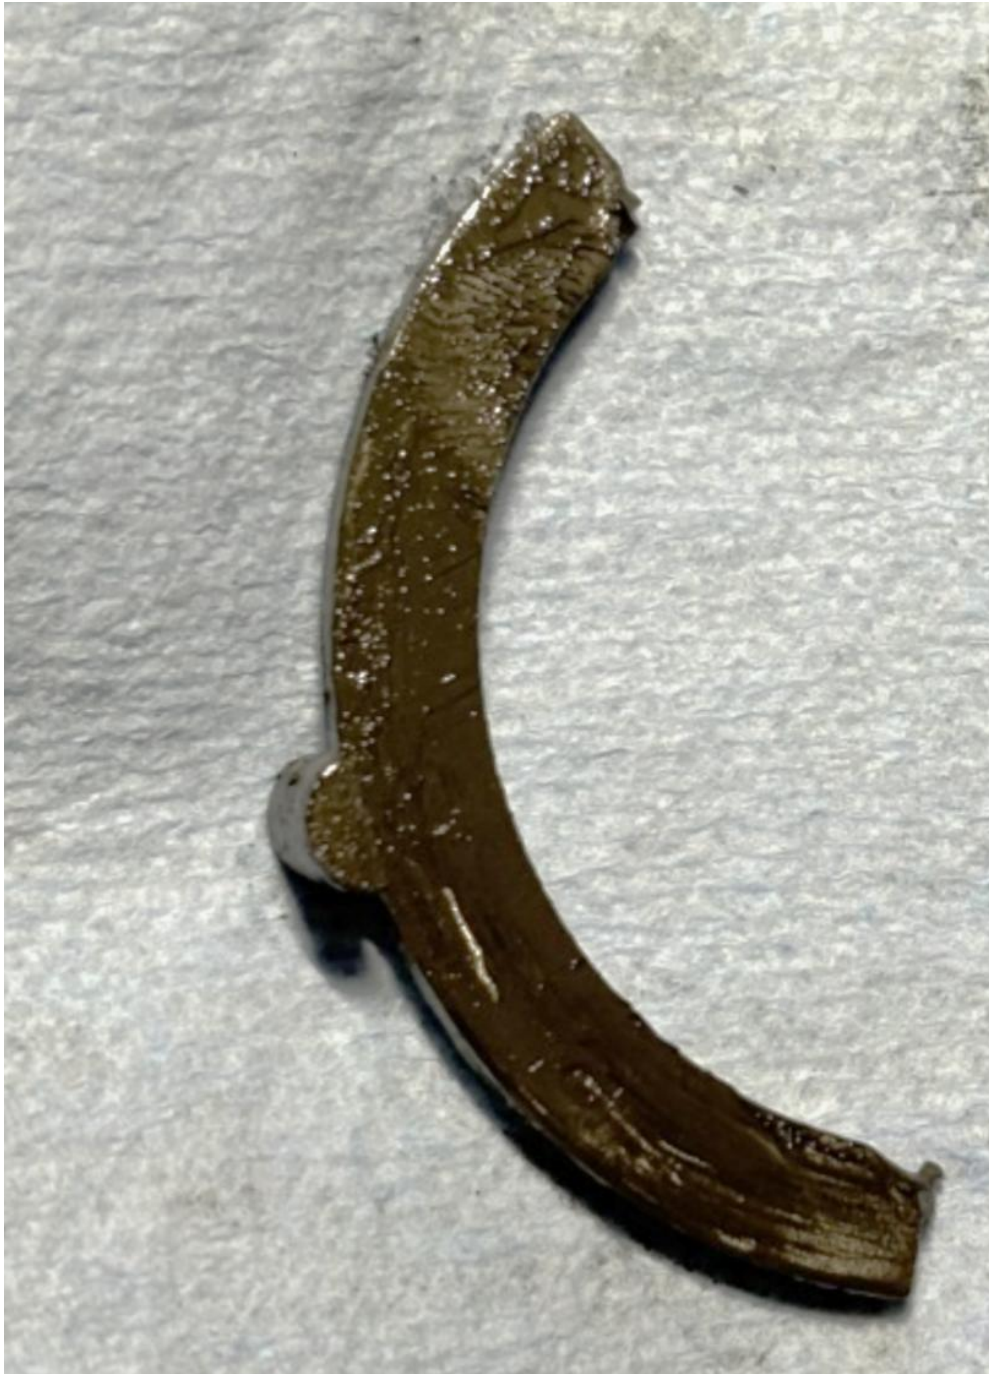
**Photograph 8 – Tailwheel pawl, before grease removal**

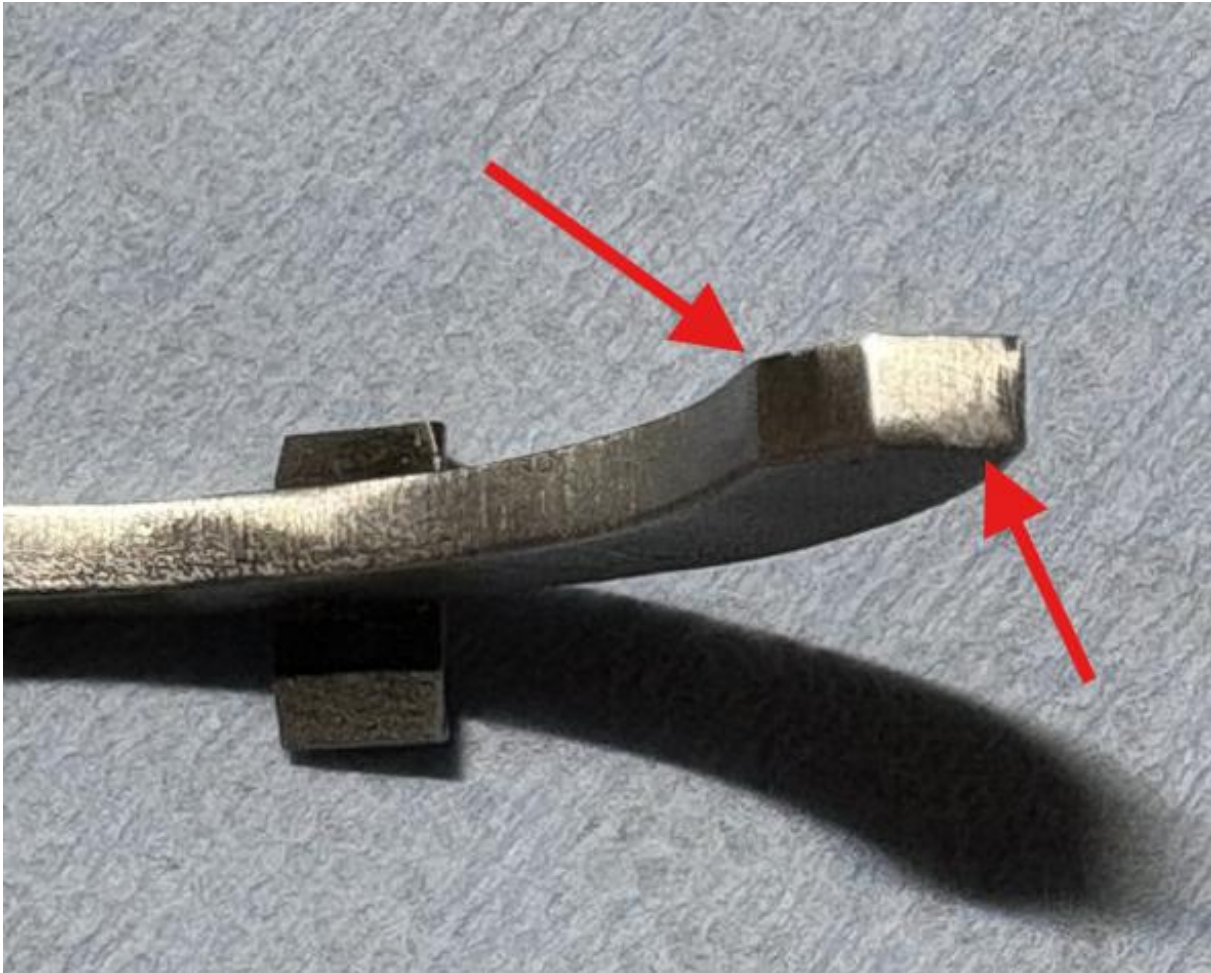
**Photograph 9 – Tailwheel pawl**  
**Arrows indicate worn/rounded areas**

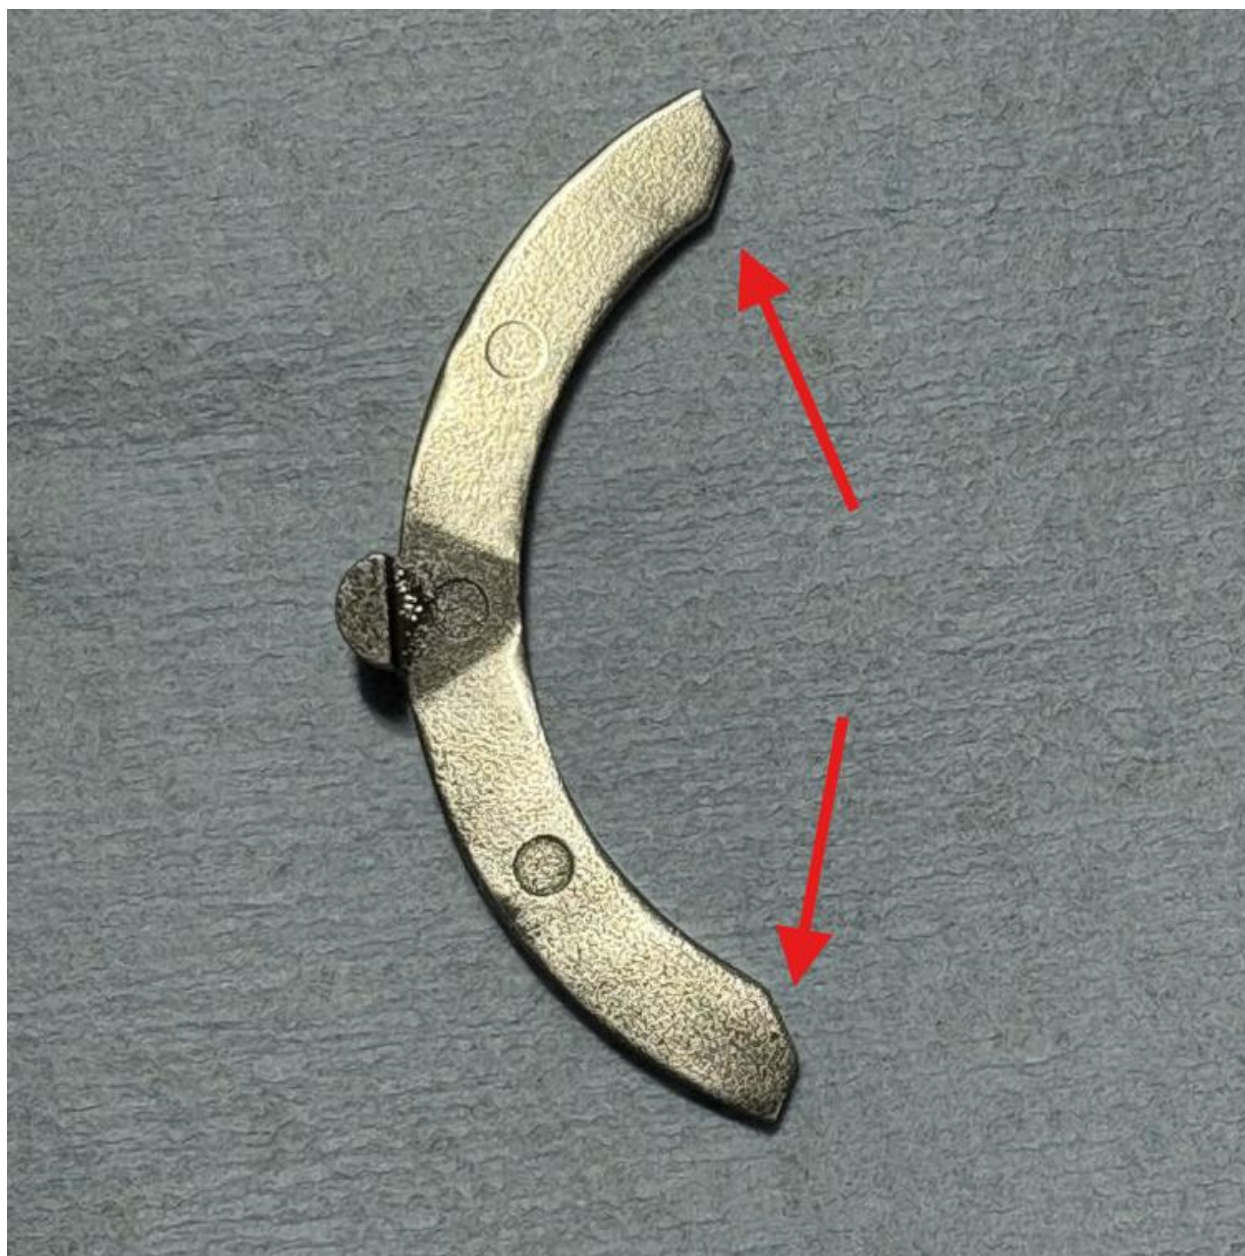
**Photograph 10 – Tailwheel pawl**  
**Arrows indicate worn/rounded edges**

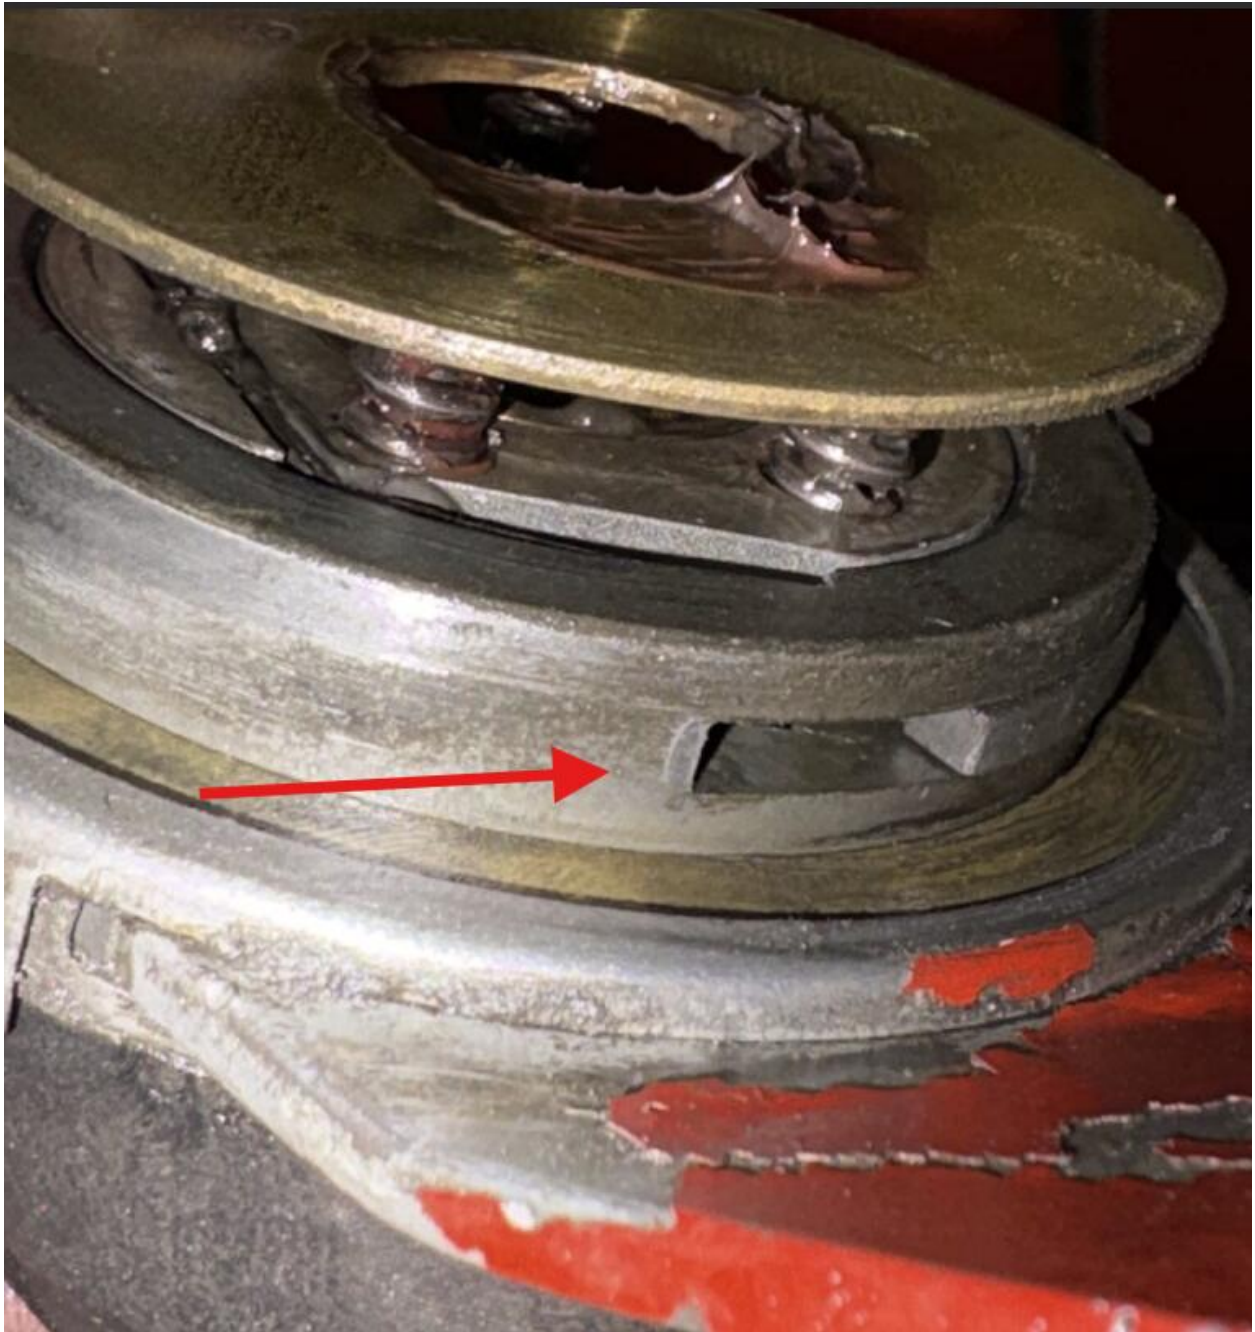
Slight outward material displacement was observed along each edge of the pawl slot on the outer race.

**Photograph 11 – Steering arm assembly, outer race  
Arrow indicates outward material displacement along edge of pawl slot**

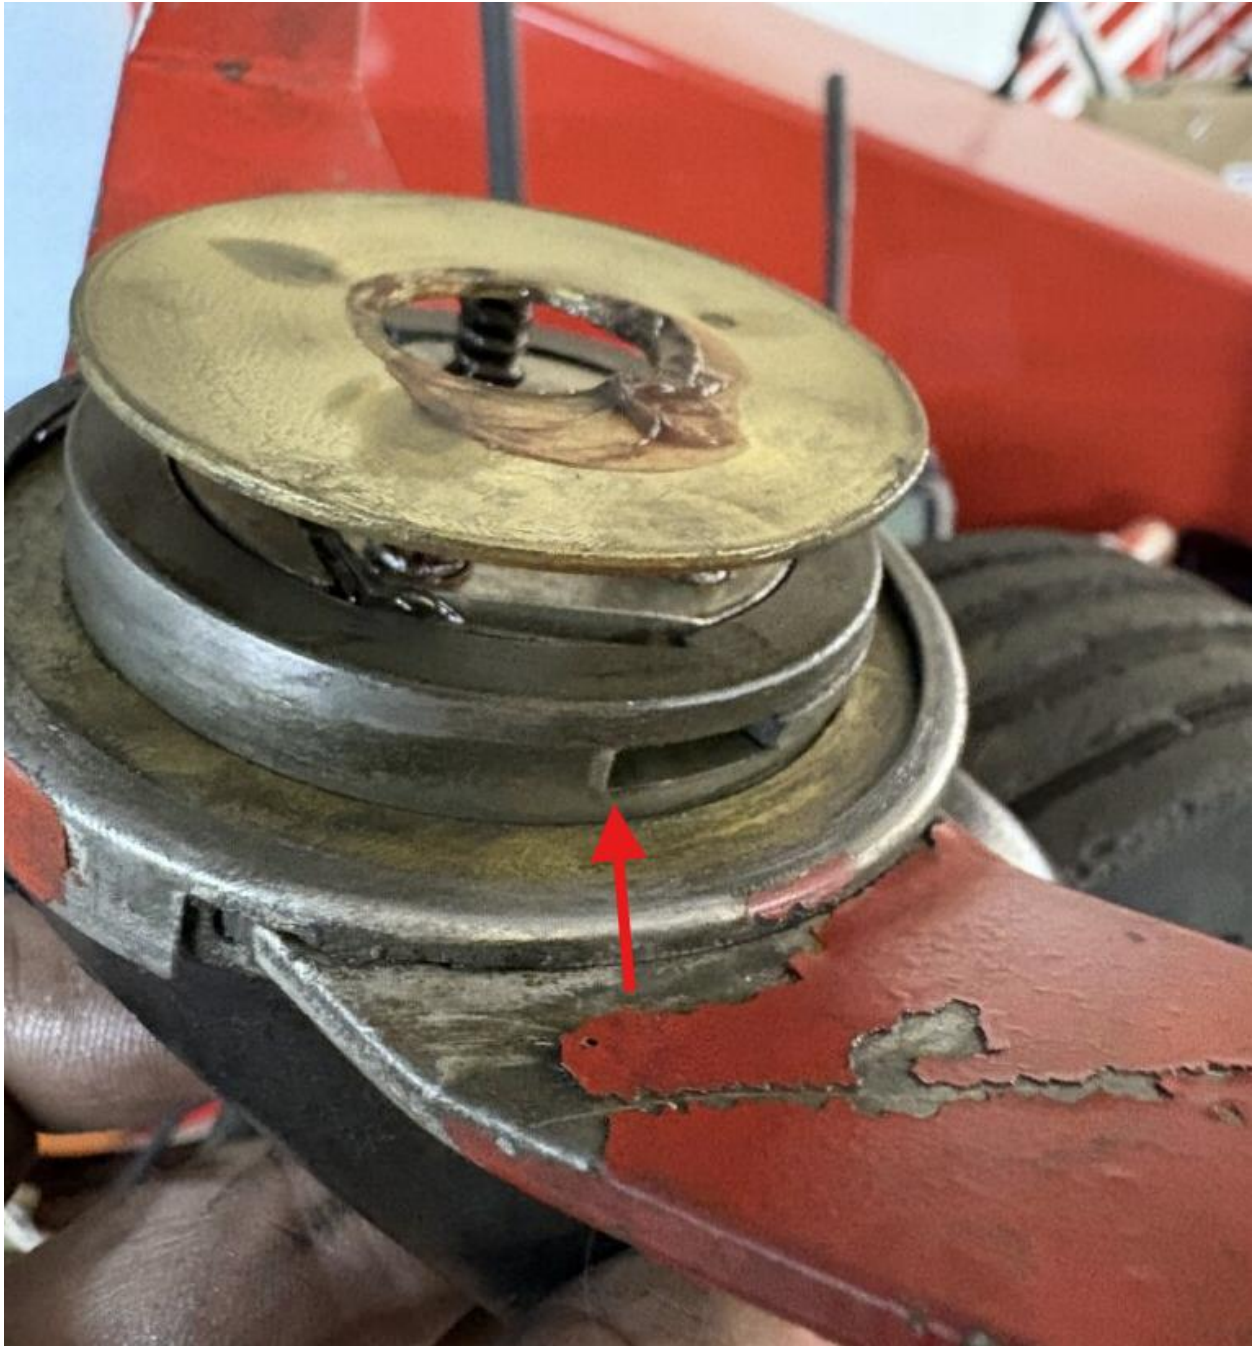
**Photograph 12 – Steering arm assembly, outer race  
Arrow indicates outward material displacement along edge of pawl slot**
