WPR26LA028

## INVESTIGATION PHOTOGRAPHS

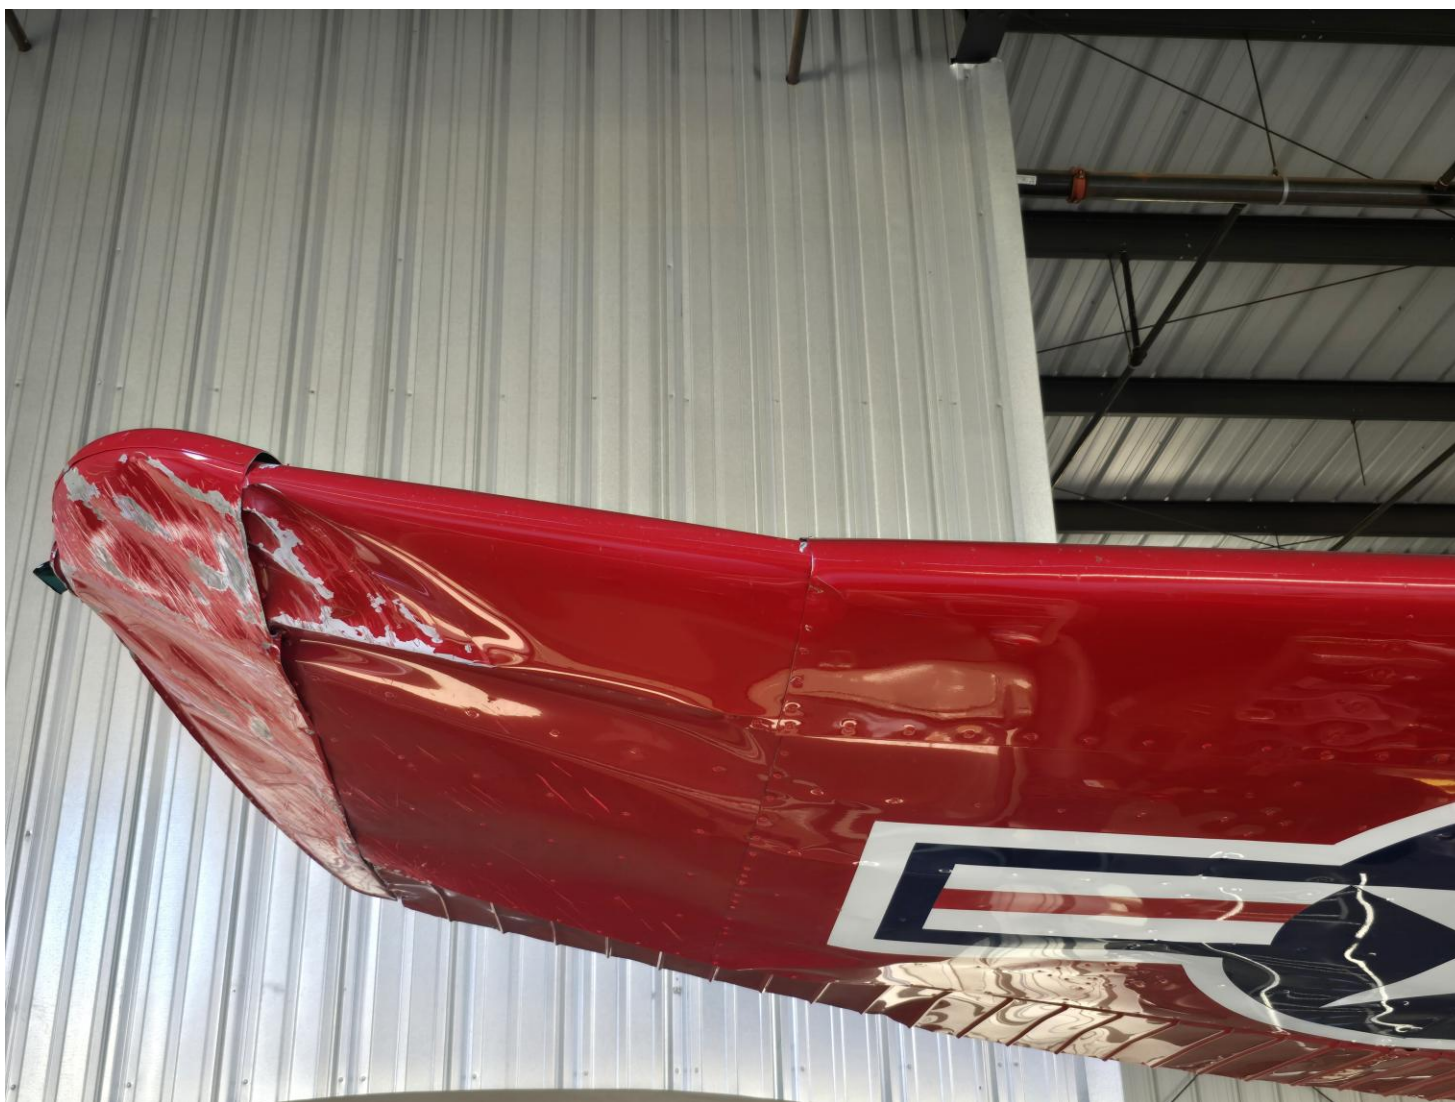
**Photograph 1 - Right wing damage (Courtesy of pilot/owner)**

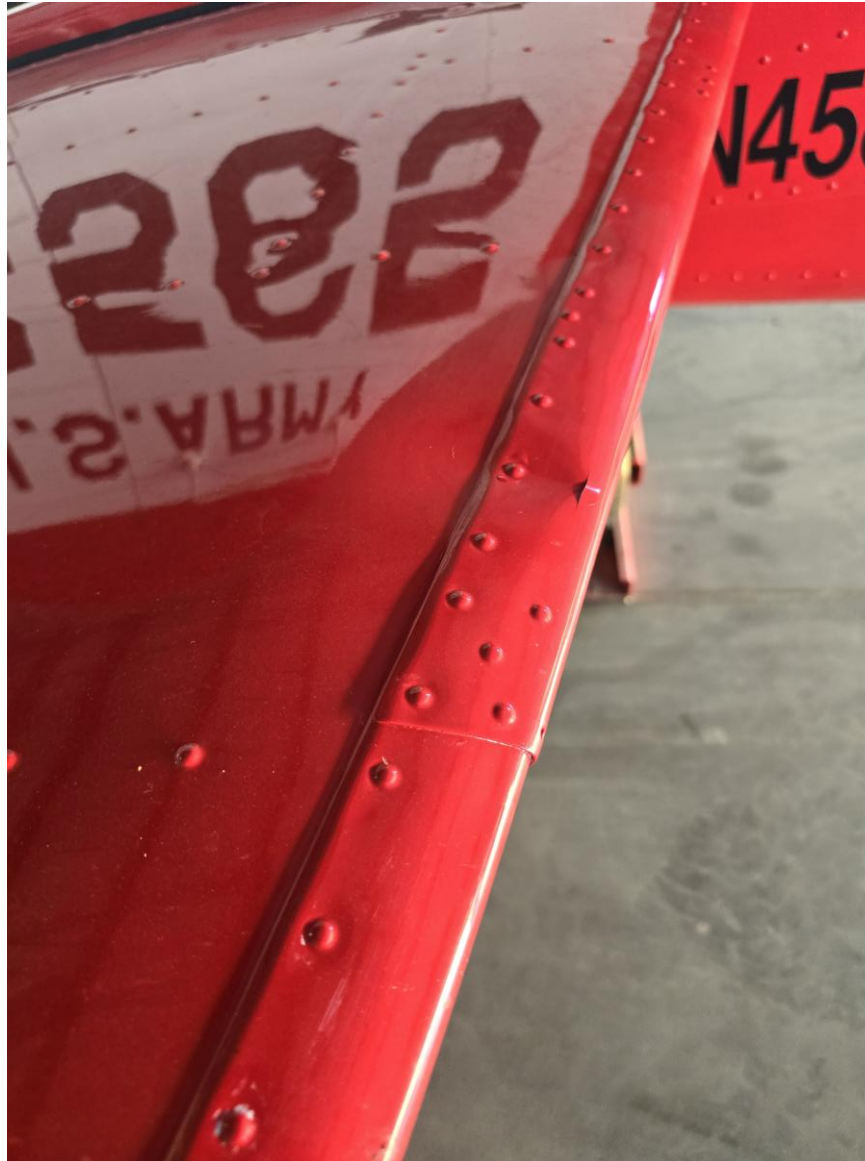
**Photograph 2 - Empennage damage (Courtesy of pilot/owner)**

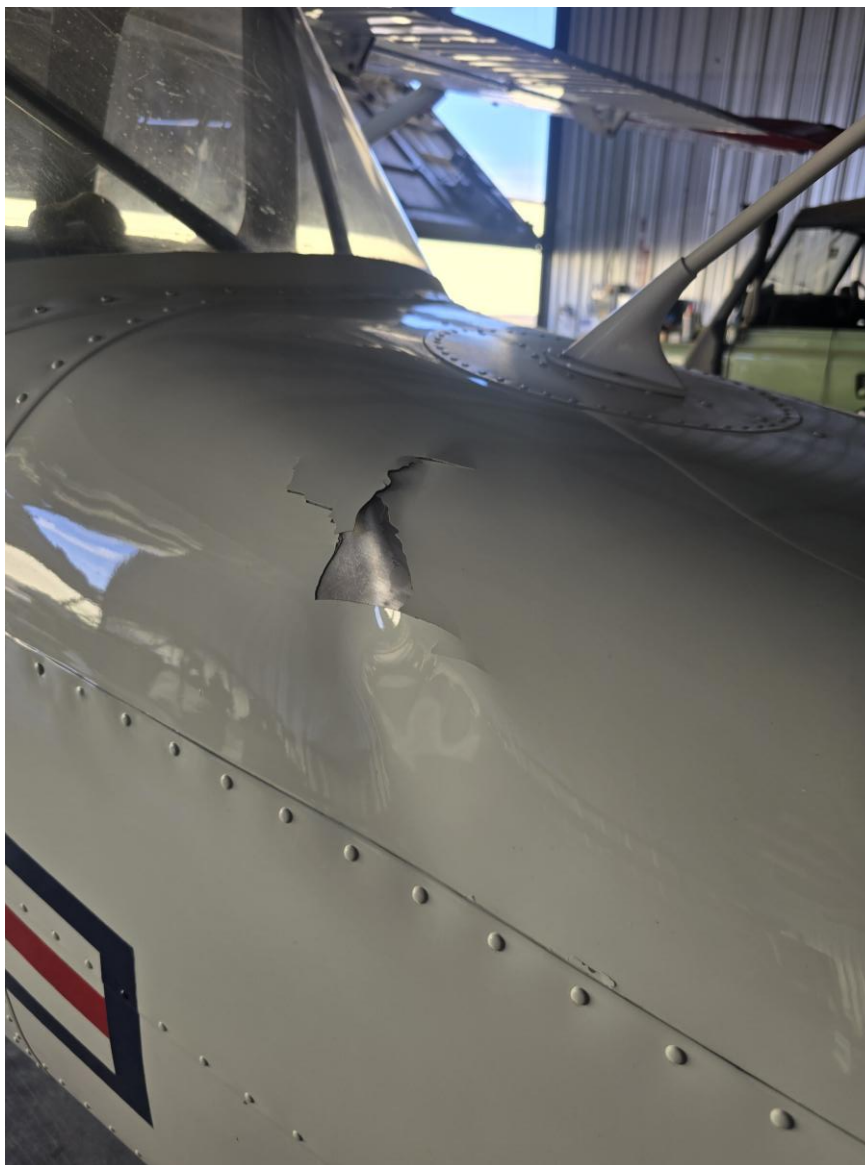
**Photograph 3 - Fuselage damage (Courtesy of pilot/owner)**

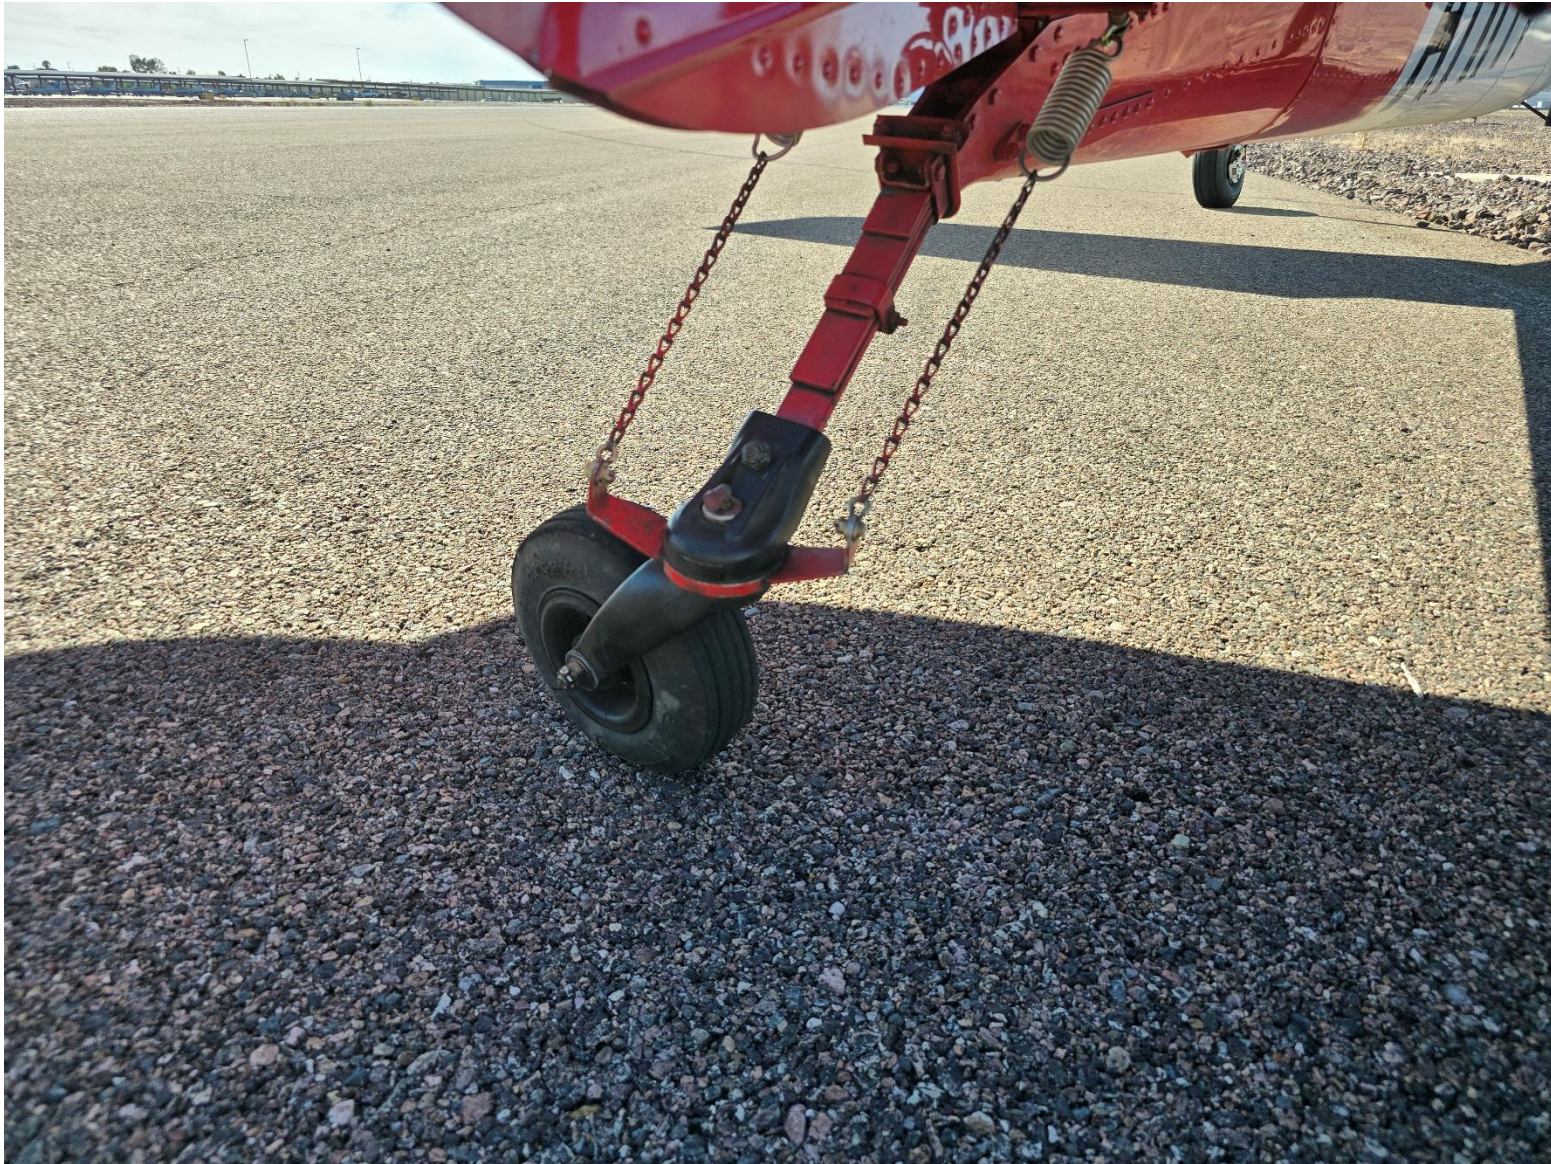
**Photograph 4 - Tailwheel assembly post-accident (Courtesy of pilot/owner)**

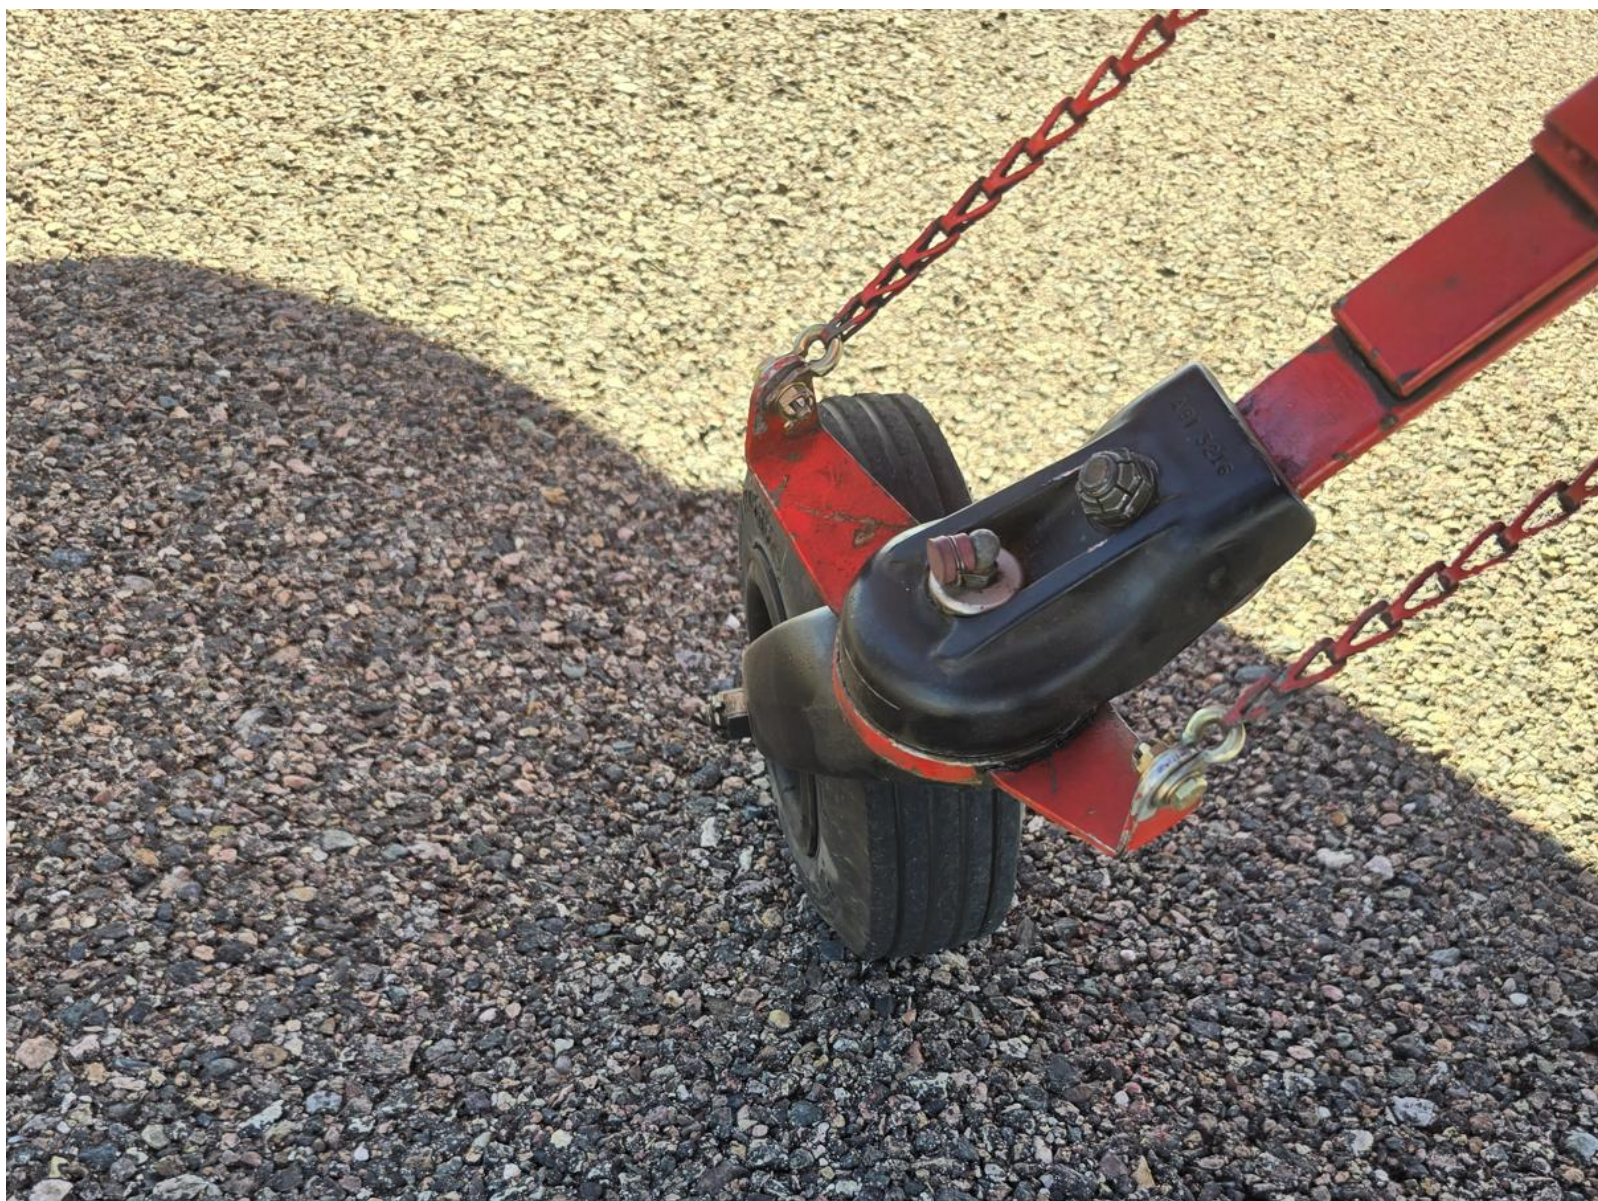
**Photograph 5 - Tailwheel assembly post-accident (Courtesy of pilot/owner)**

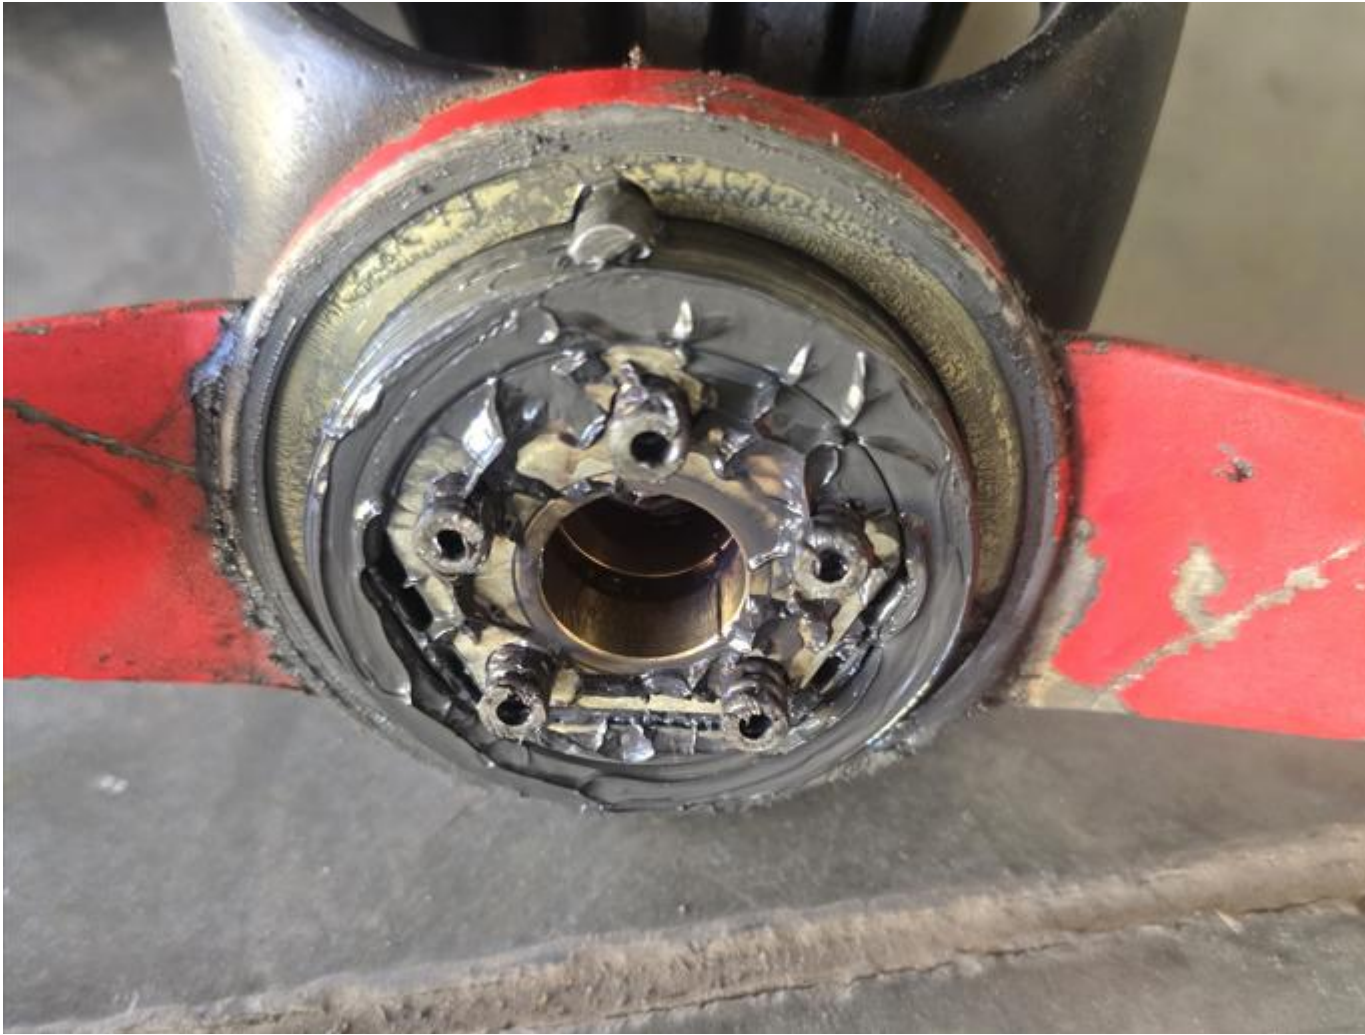
**Photograph 6 - Tailwheel assembly internal, post-accident (Courtesy of pilot/owner)**

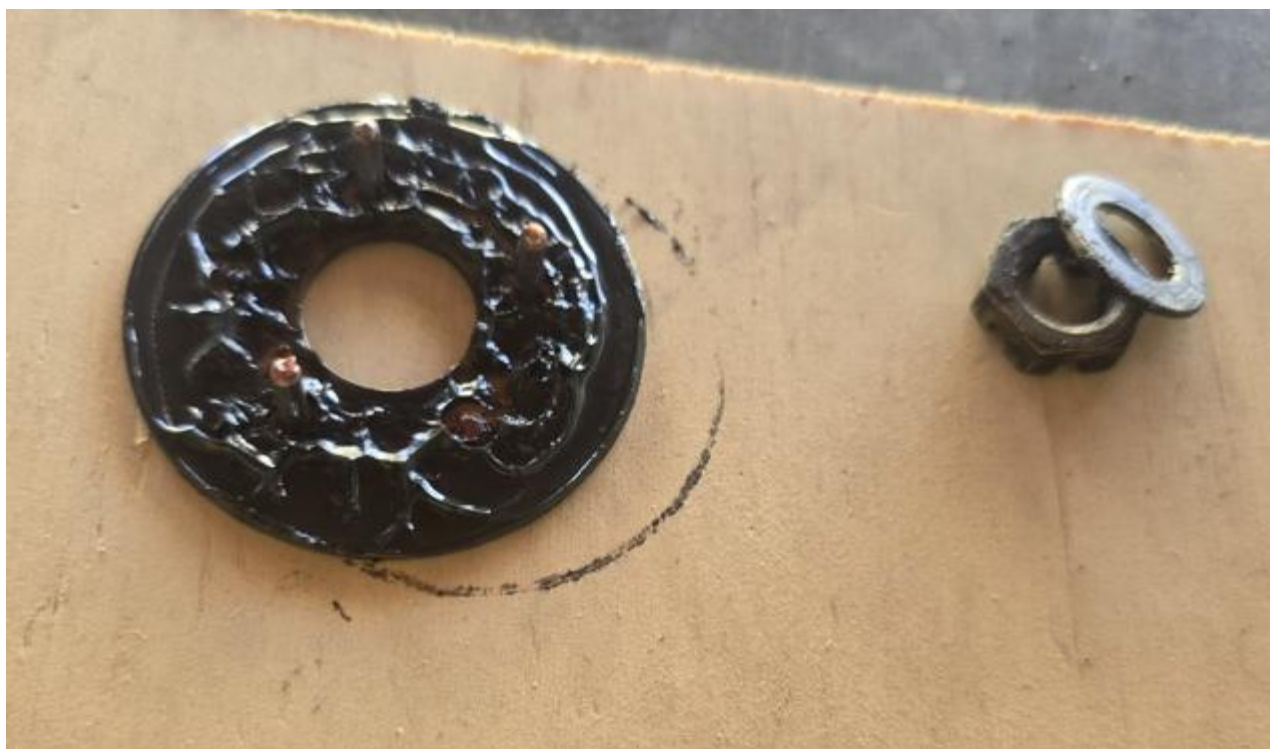
**Photograph 7 - Tailwheel assembly internal, post-accident (Courtesy of pilot/owner)**

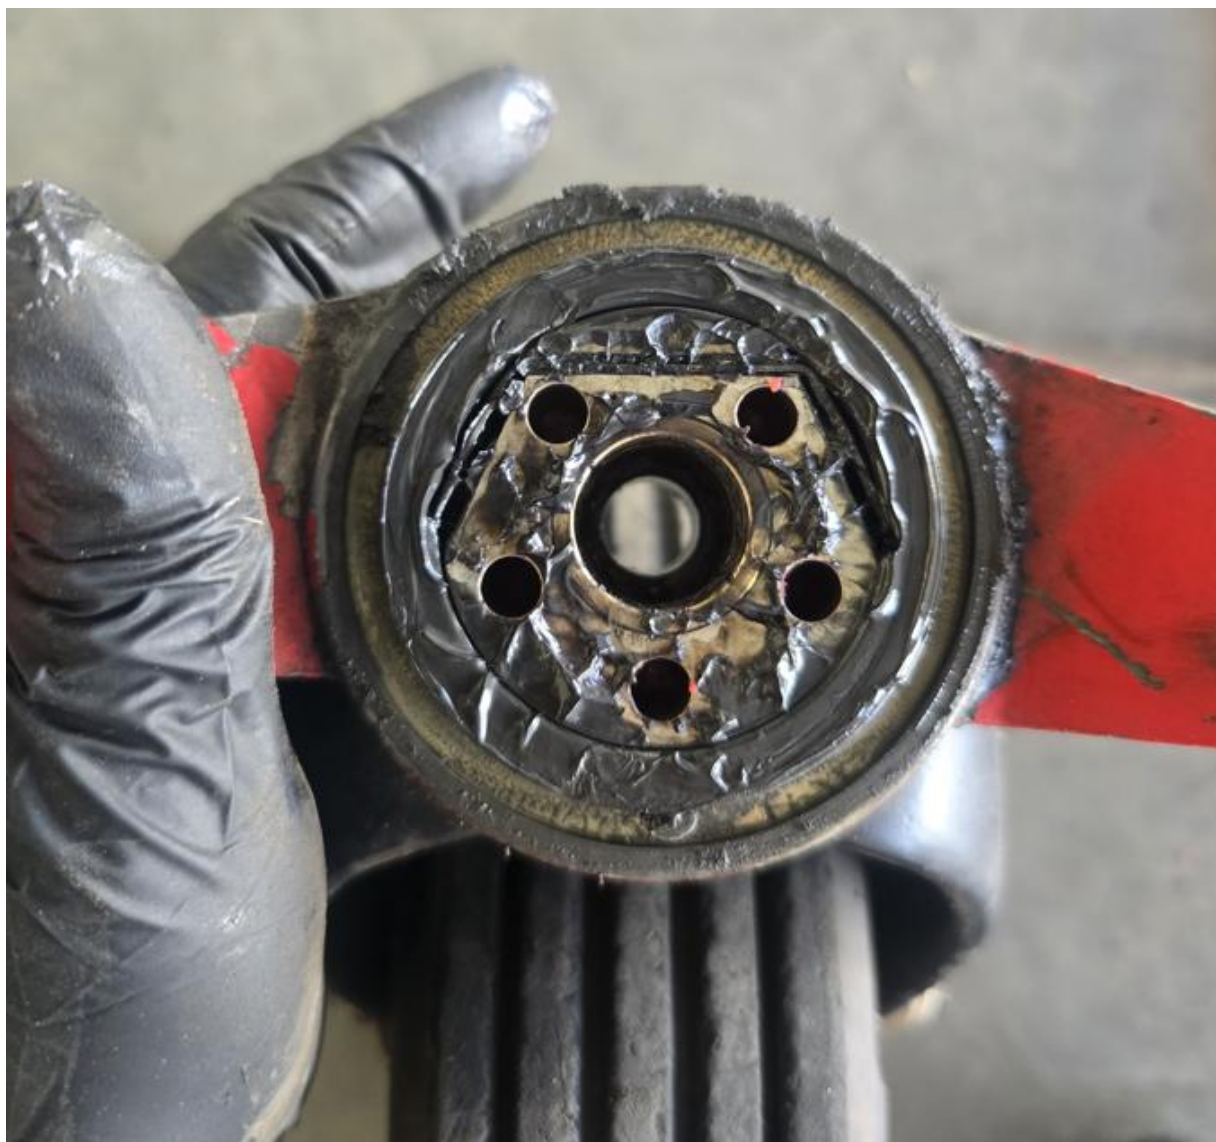
**Photograph 8 - Tailwheel assembly internal, post-accident (Courtesy of pilot/owner)**
