WPR26LA033

## INVESTIGATION PHOTOGRAPHS

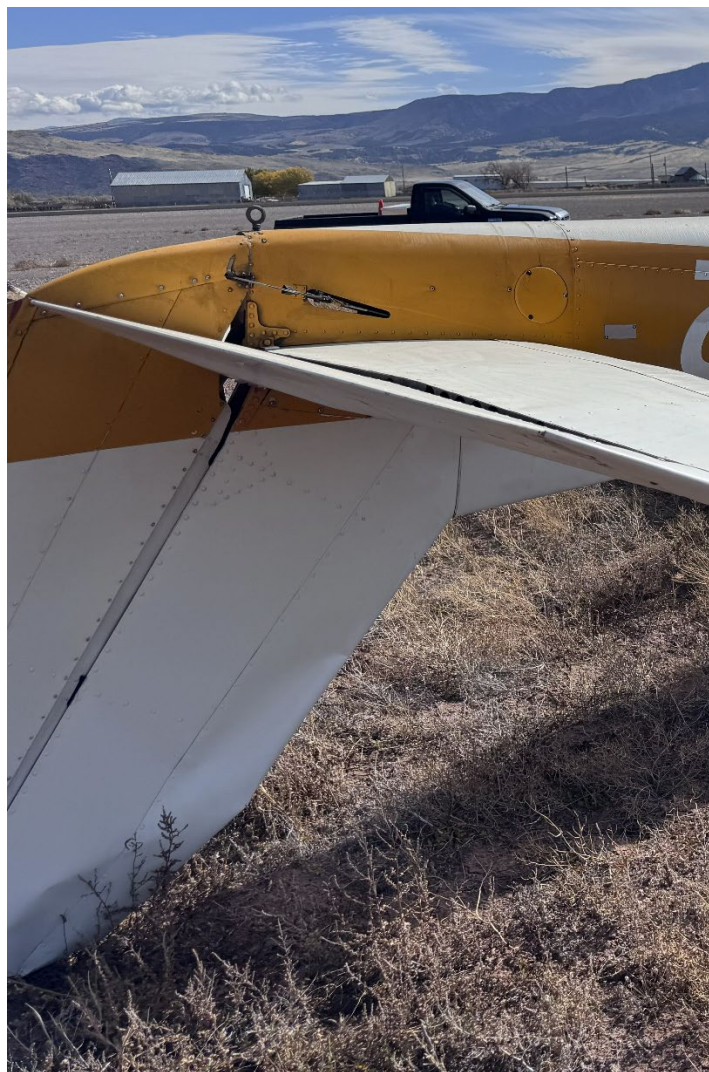
**Photograph 1 - Vertical Stabilizer damage (Courtesy of Richfield PD))**

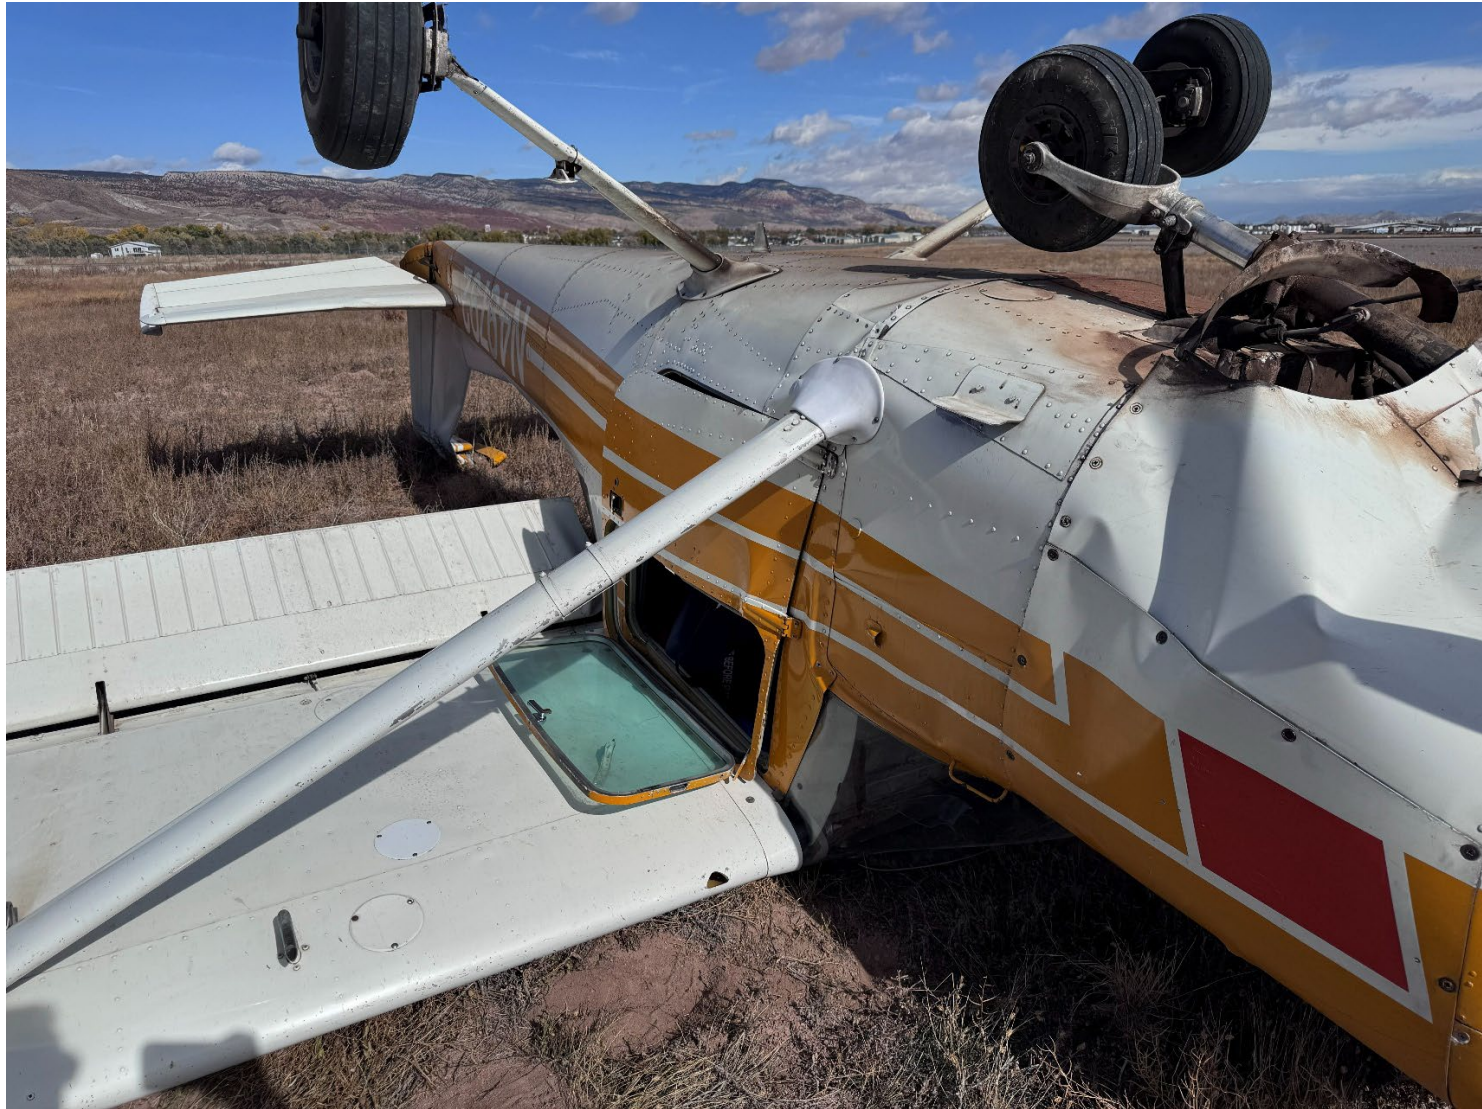
**Photograph 2 - Fuselage damage (Courtesy of Richfield PD)**
