WPR26LA042

## INVESTIGATION PHOTOGRAPHS

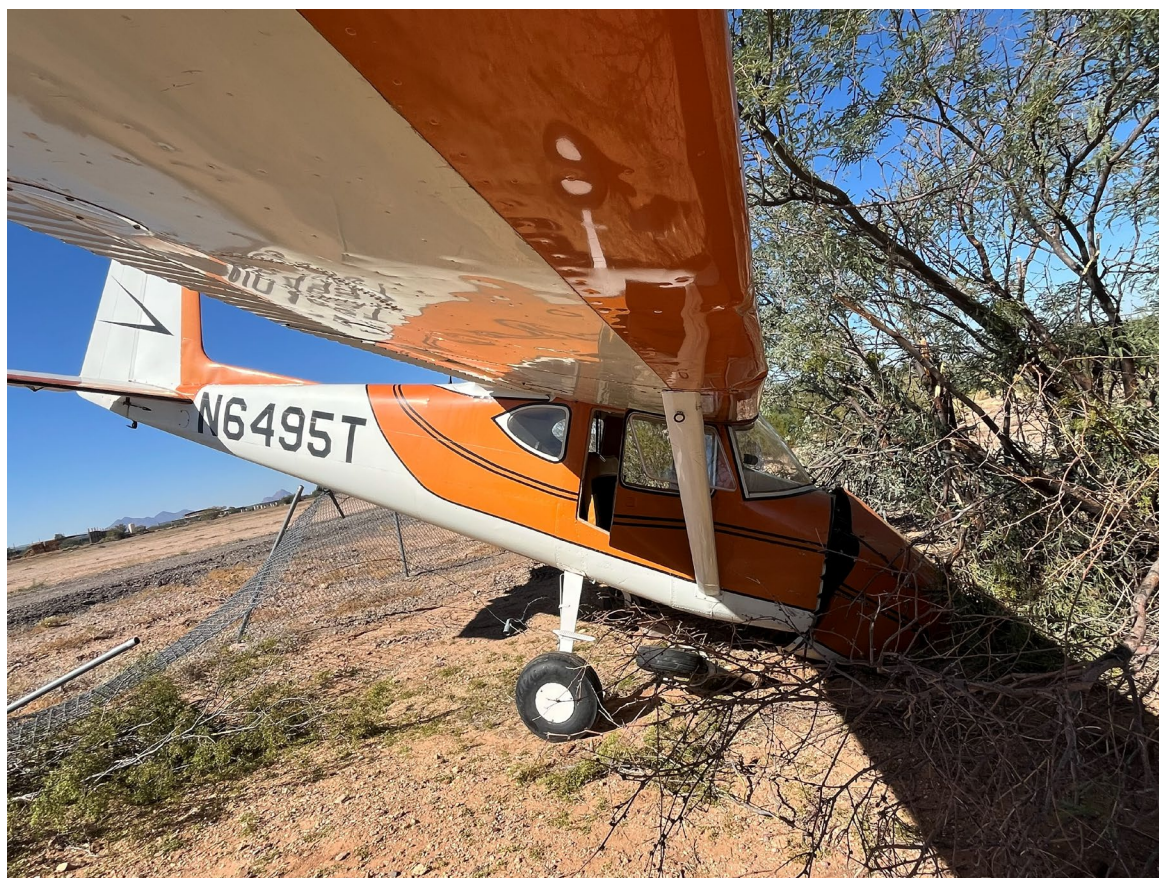
**Photograph 1 - View of accident airplane (Courtesy of Airport Operations)**

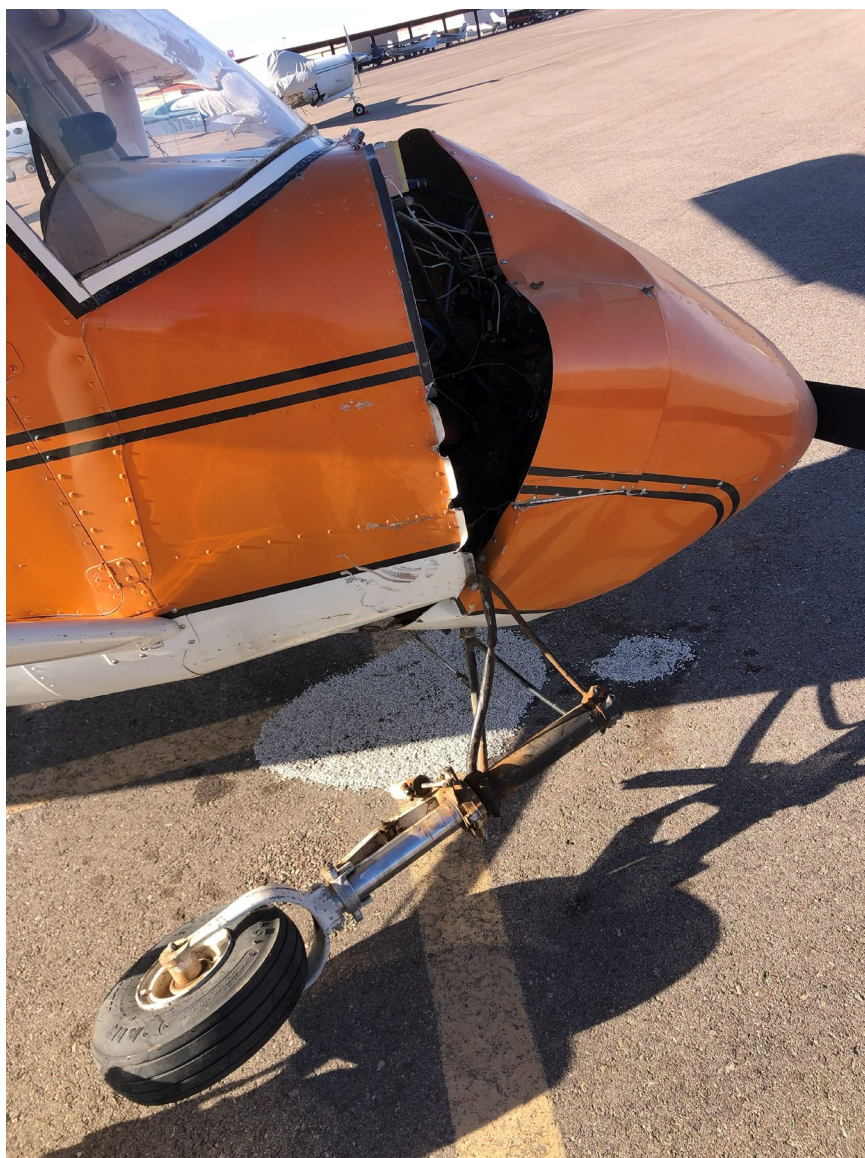
**Photograph 2 - View of bent and severed engine mount attached to nose gear (Courtesy of Pilot)**
