WPR26LA057

## INVESTIGATION PHOTOGRAPHS

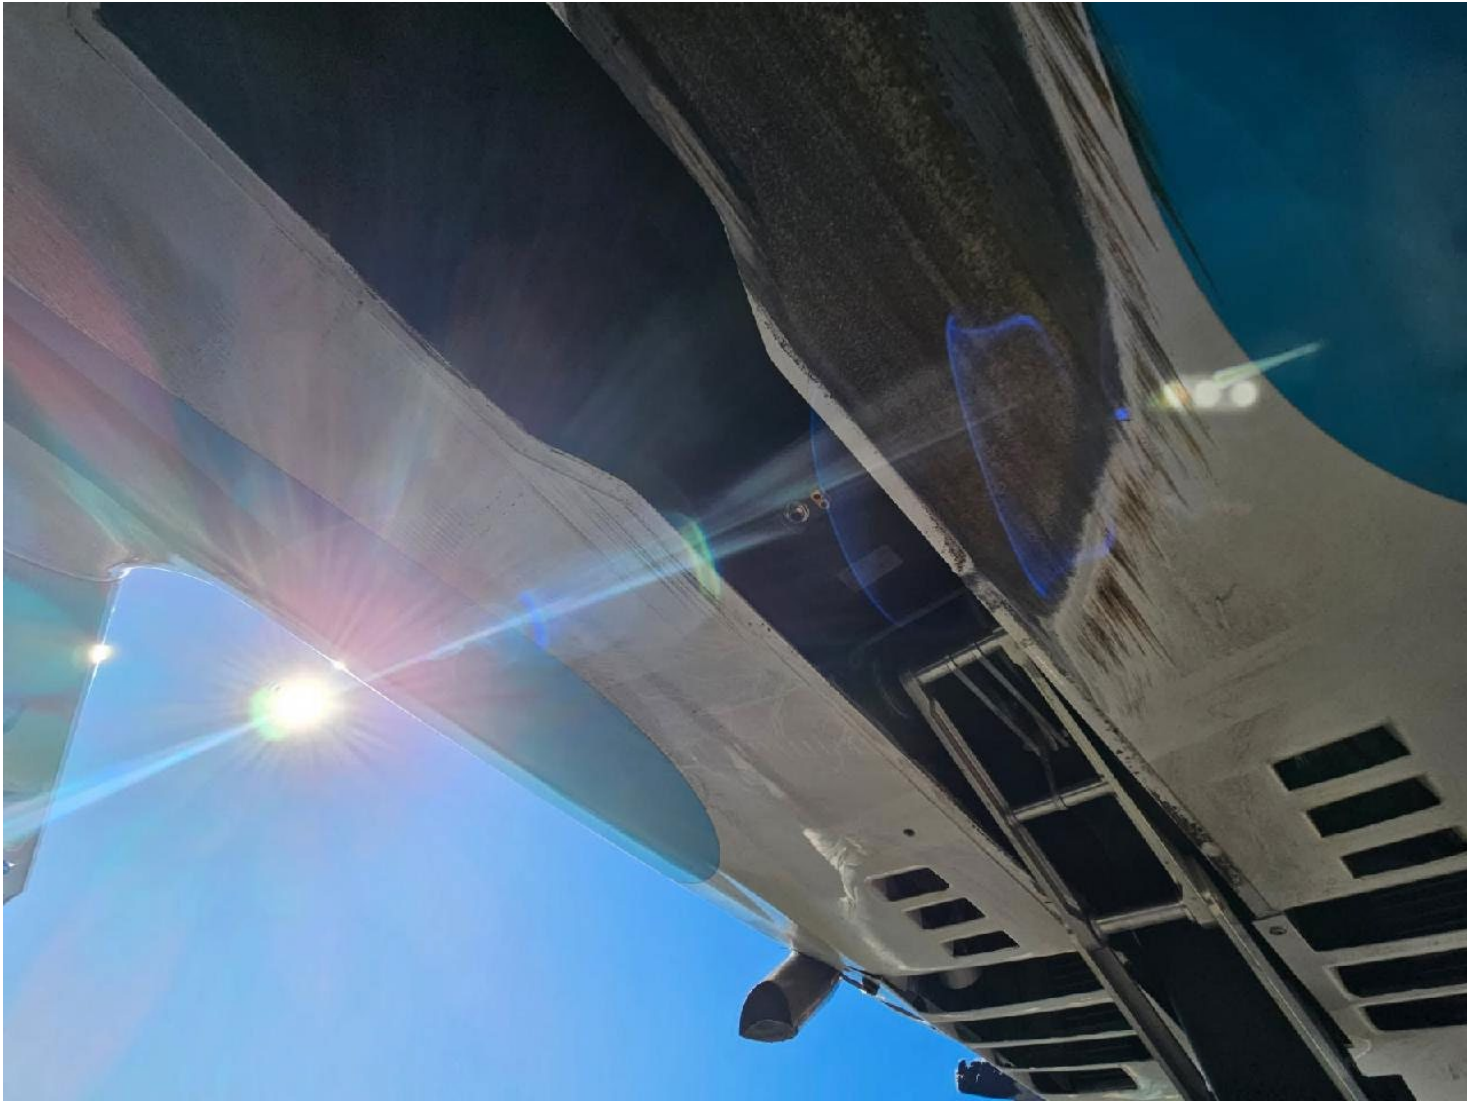
**Photograph 1 - Carbon Fiber Abrasion right of nose-gear (courtesy of airport operations director)**

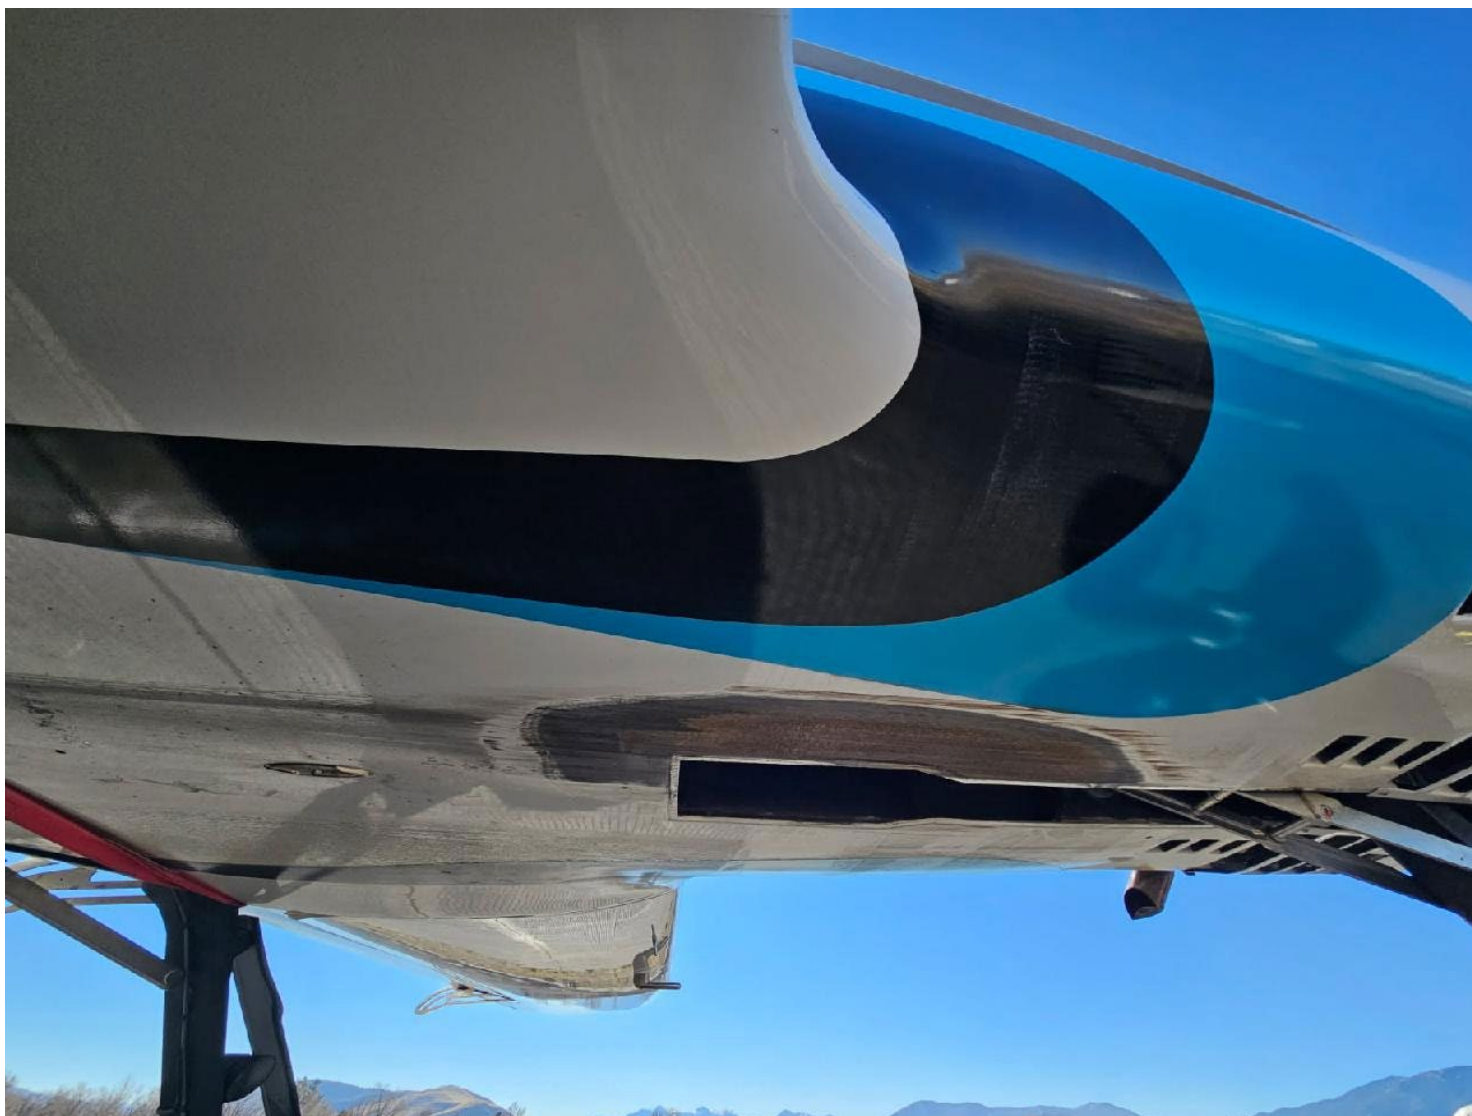
**Photograph 2 - Carbon Fiber Abrasion right of nose-gear (courtesy of airport operations director)**

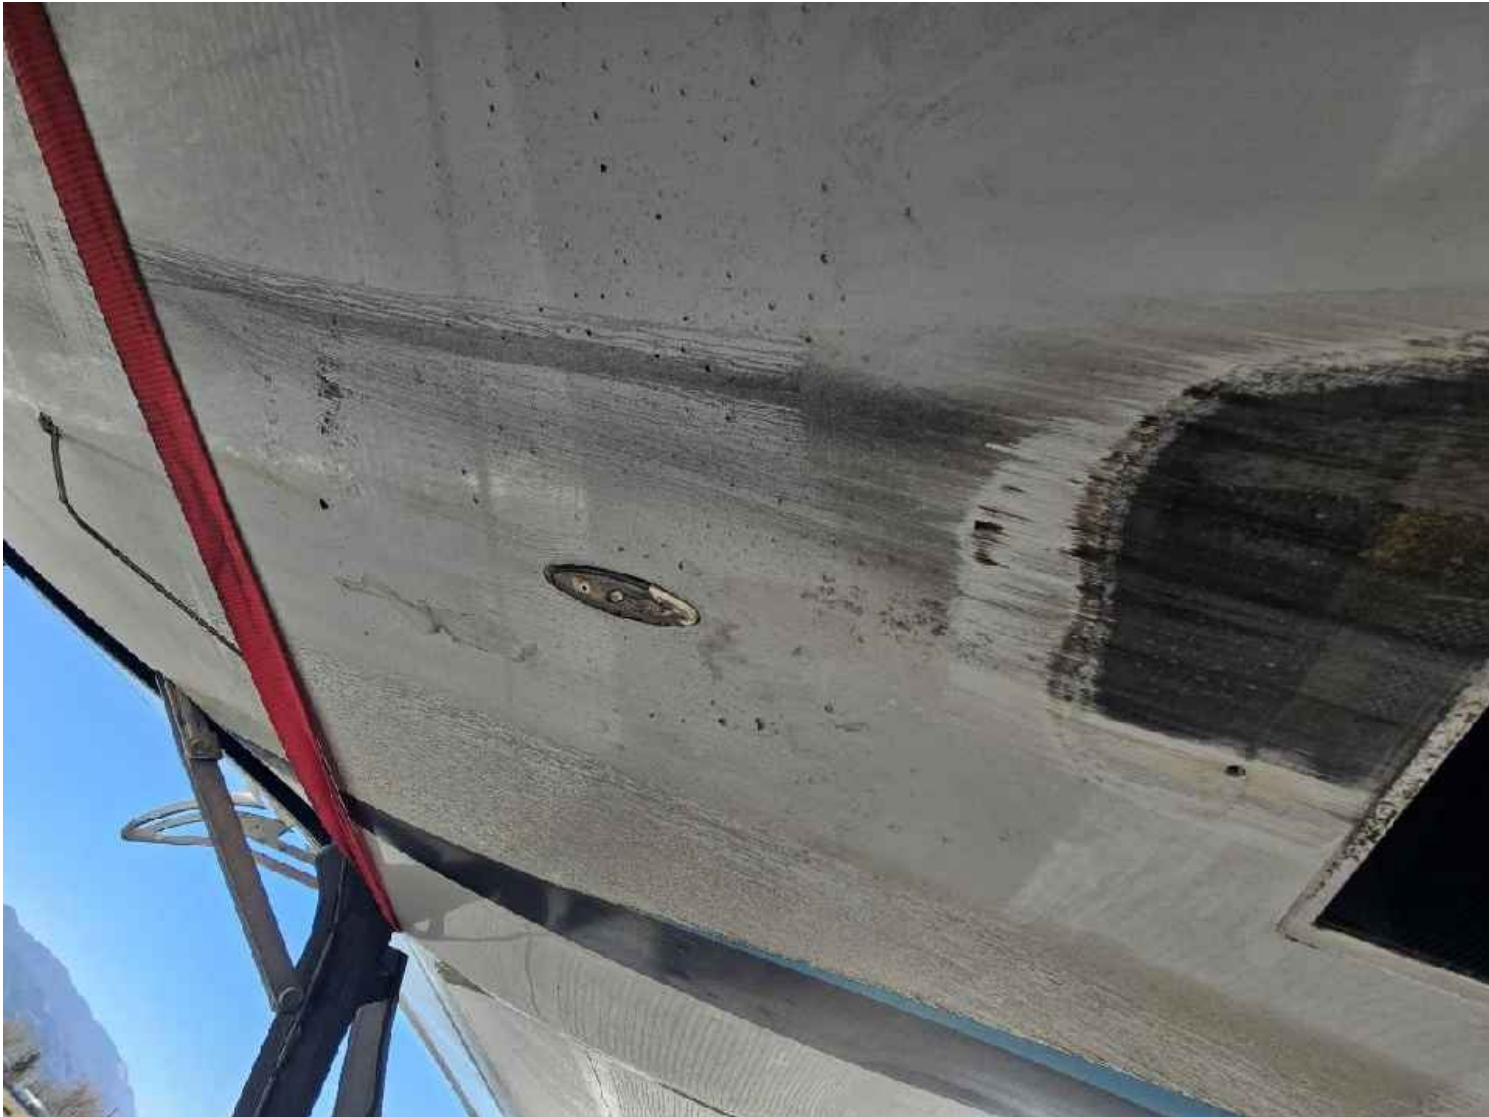
**Photograph 3 - Carbon Fiber Abrasion on belly (courtesy of airport operations director)**

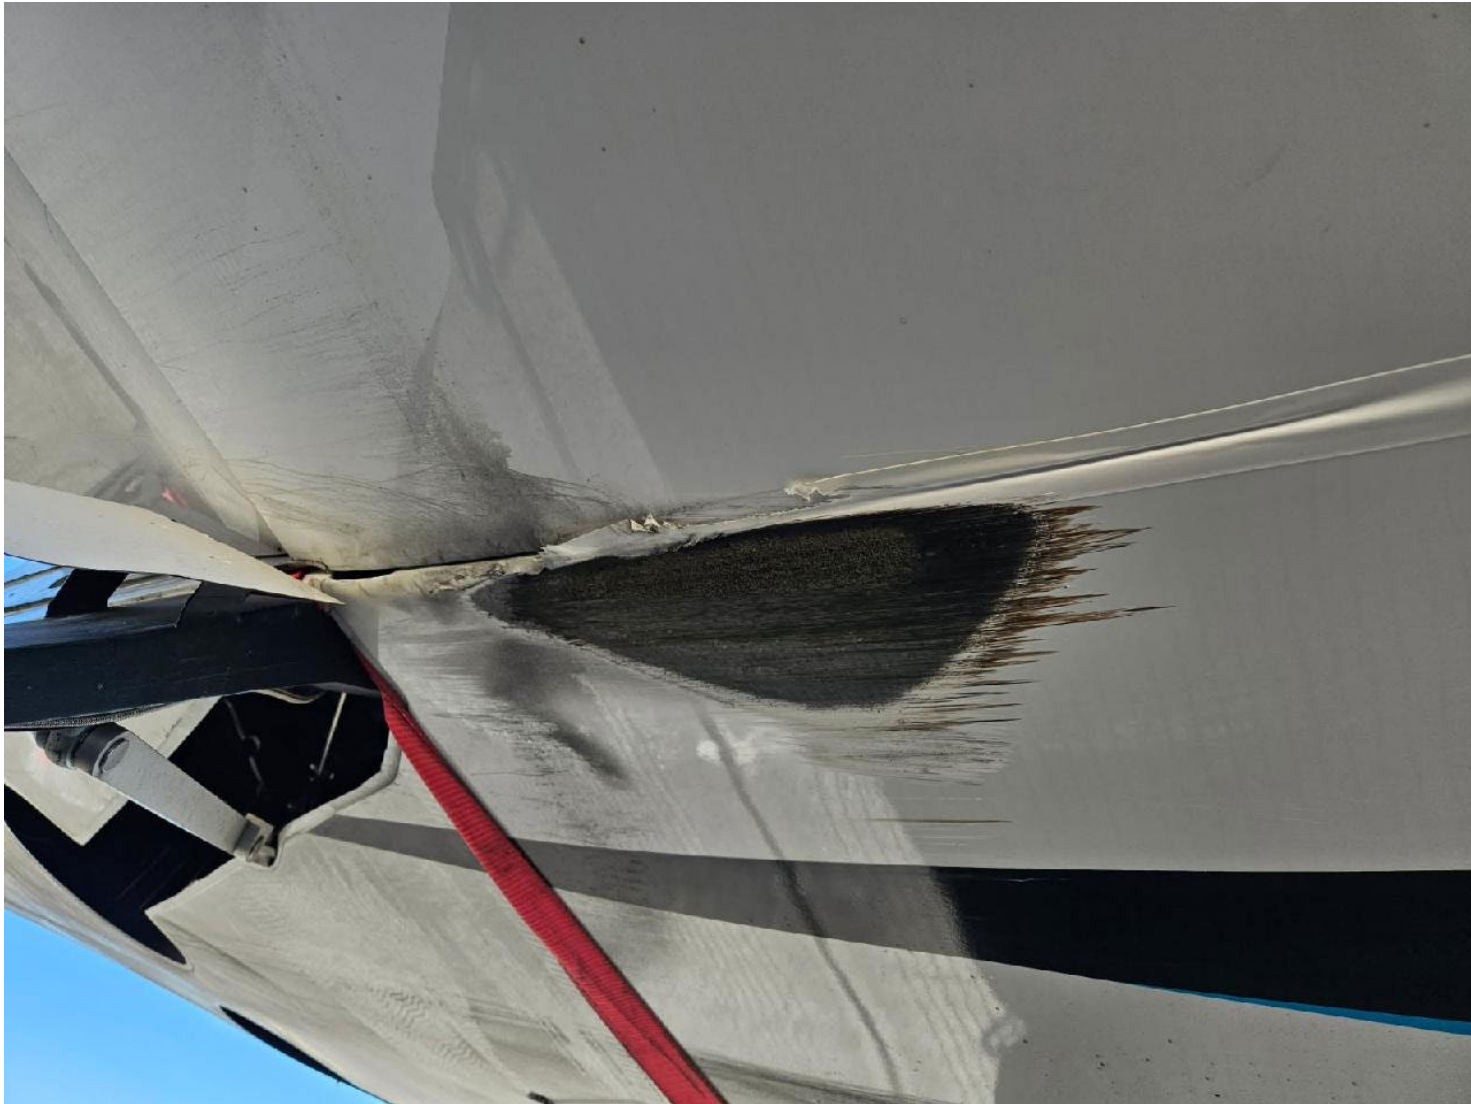
**Photograph 4 - Carbon Fiber Abrasion on belly (courtesy of airport operations director)**

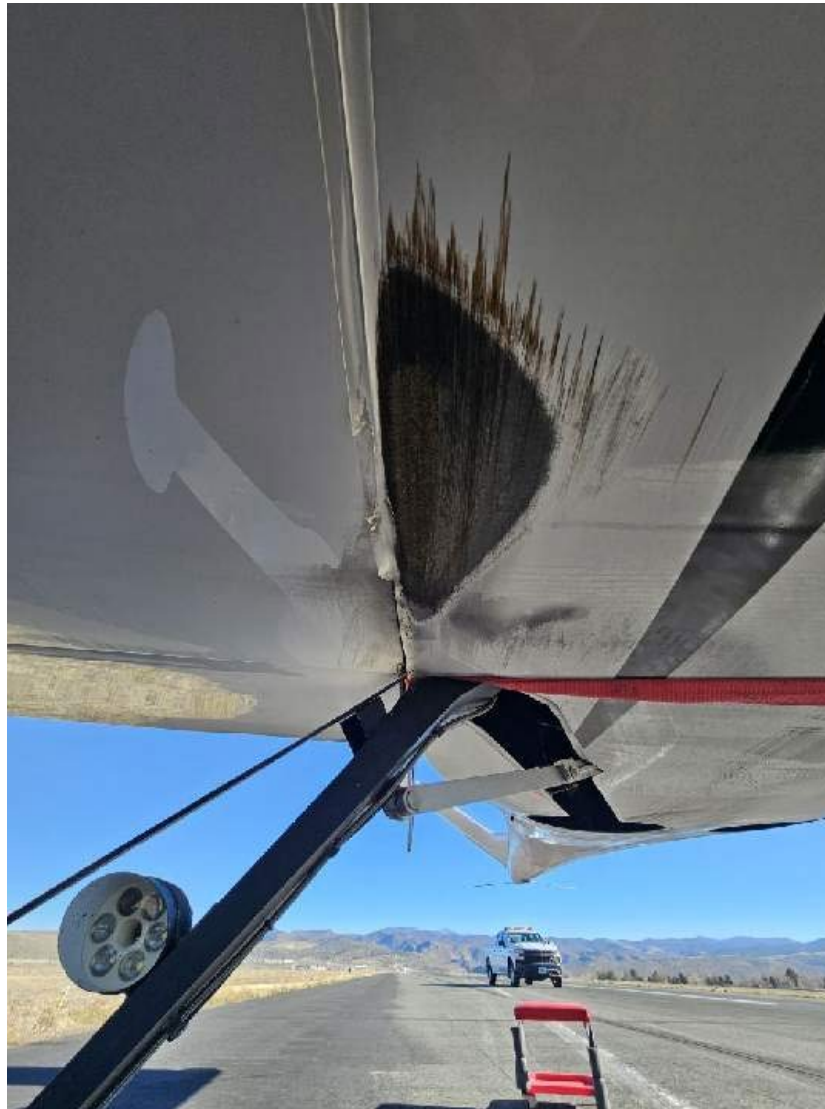
**Photograph 6 - Carbon Fiber Abrasion on belly (courtesy of airport operations director)**

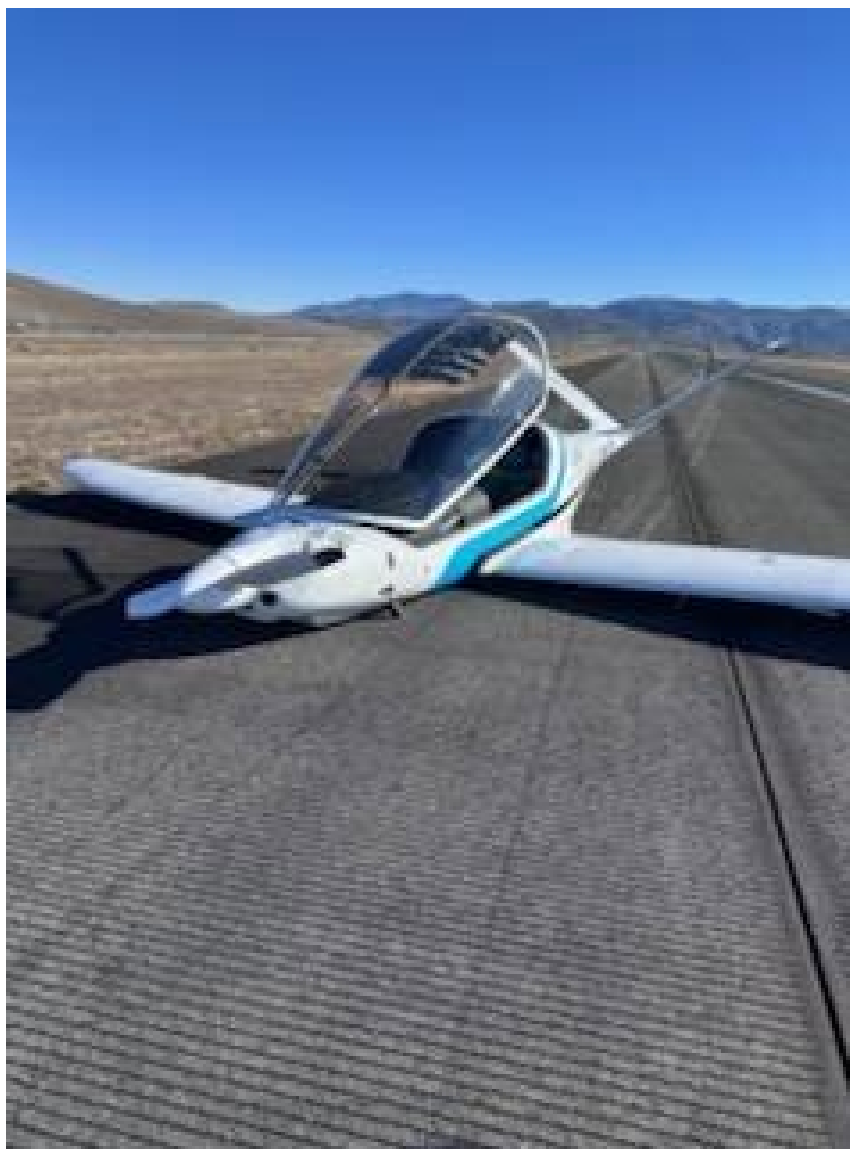
**Photograph 7 - Aircraft on Runway 27 (courtesy of airport operations director)**
