WPR26LA081

## INVESTIGATION PHOTOGRAPHS

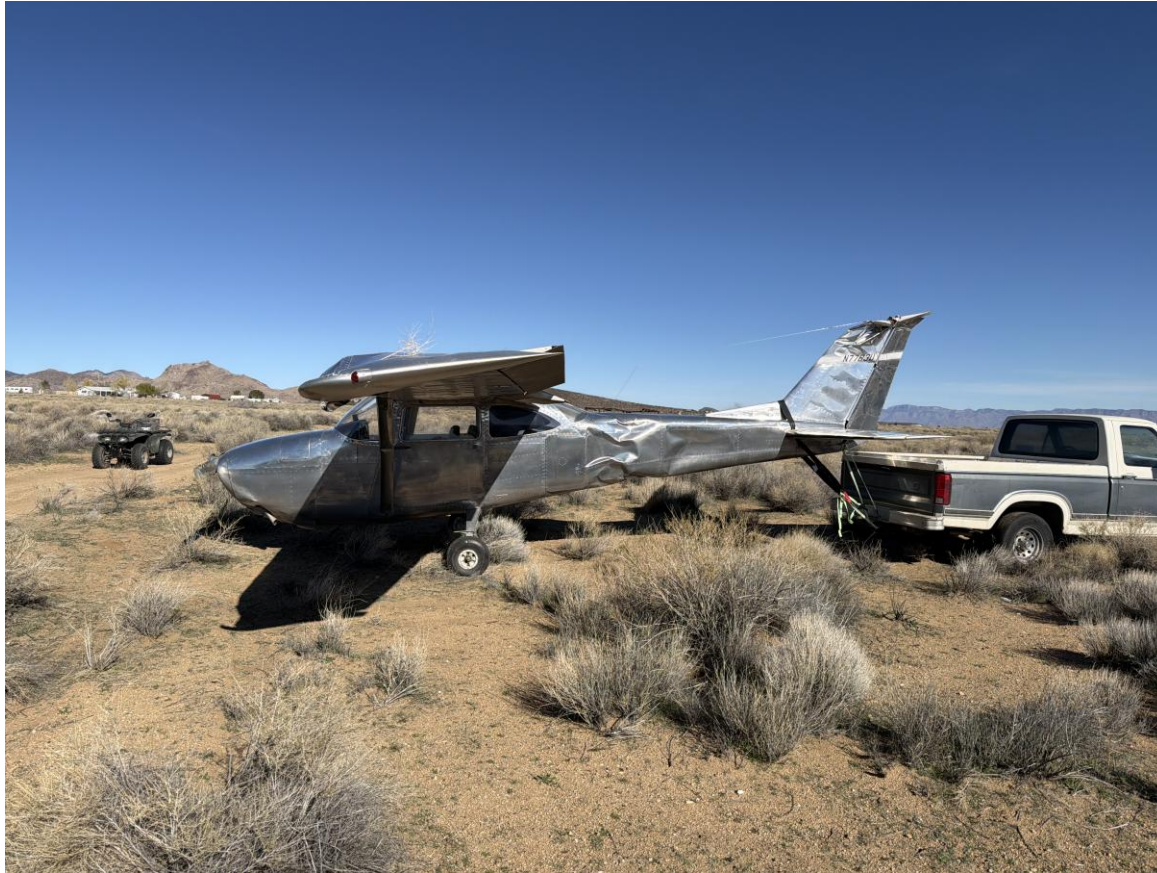
**Photograph 1 - View of aft fuselage damage (Courtesy of local law enforcement)**

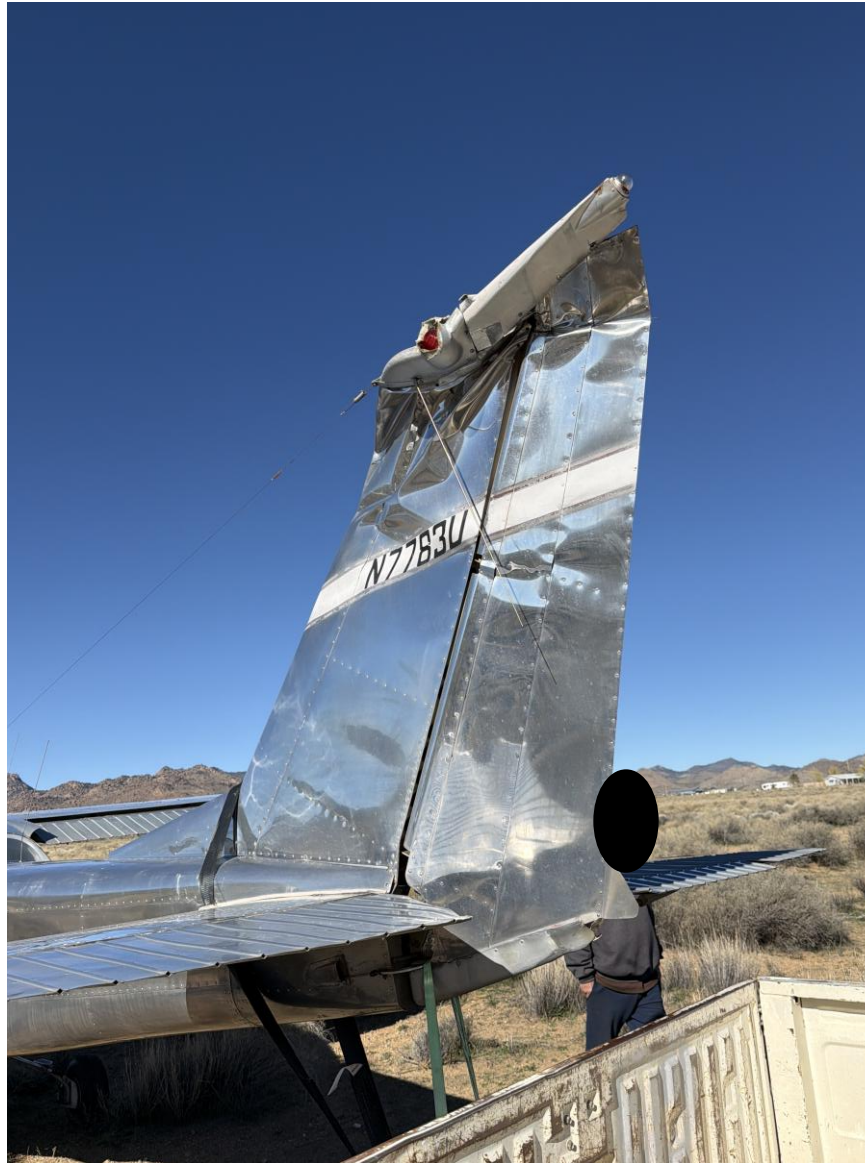
**Photograph 2 - View of vertical stabilizer / rudder damage (Courtesy of local law enforcement)**
