WPR26LA092

## INVESTIGATION PHOTOGRAPHS

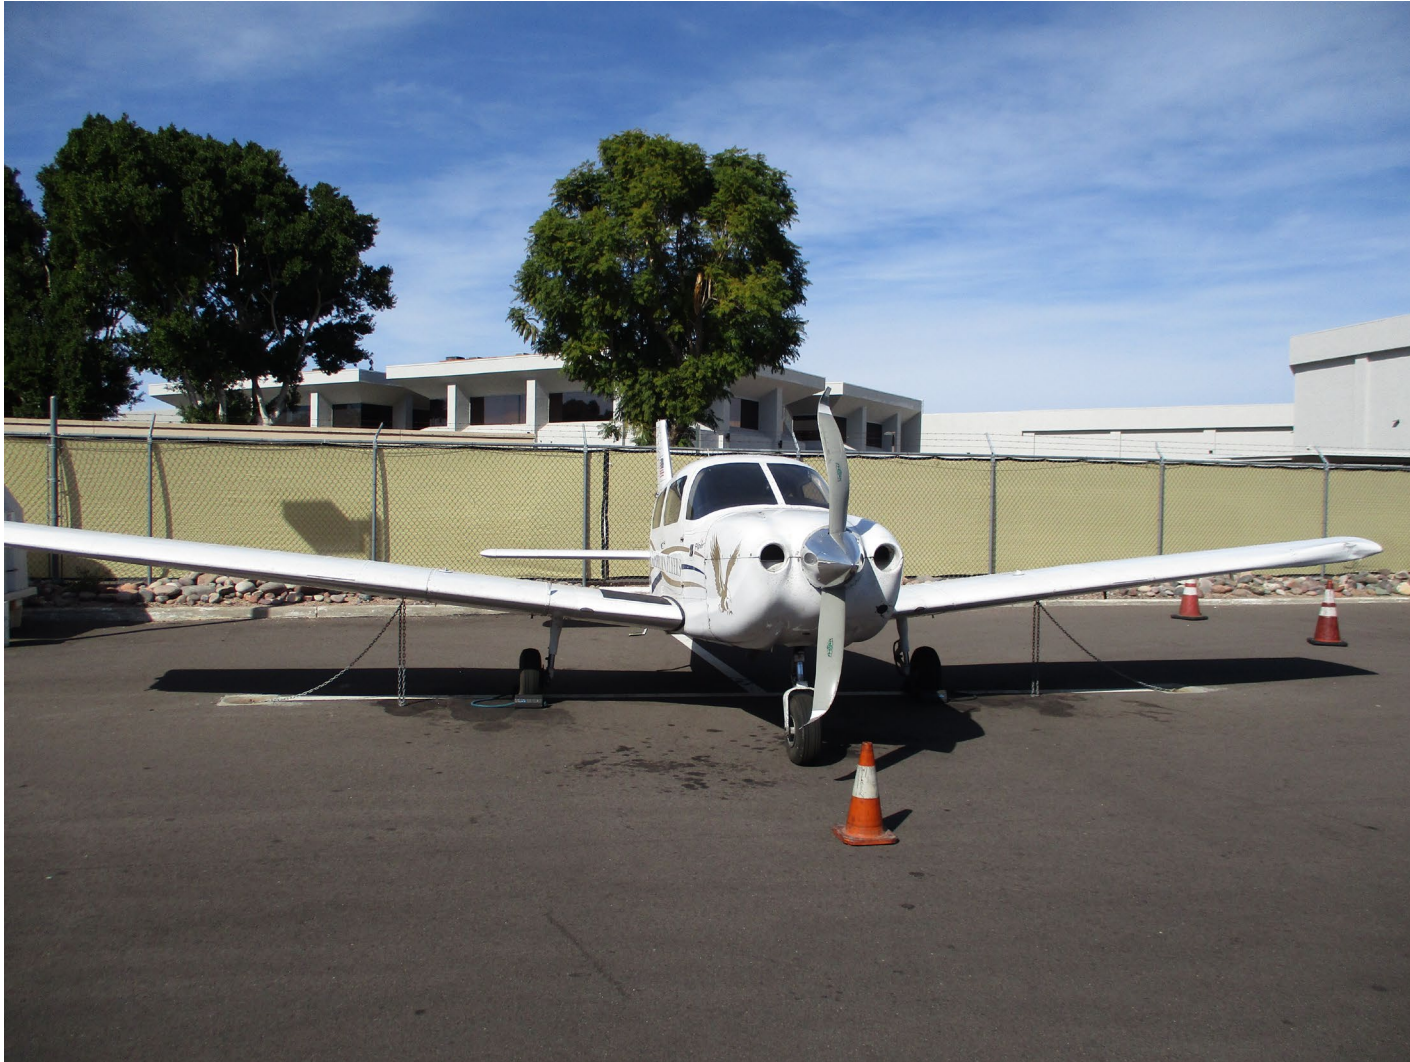
**Photograph 1 - View of aircraft from the front, post recovery (courtesy of FAA)**

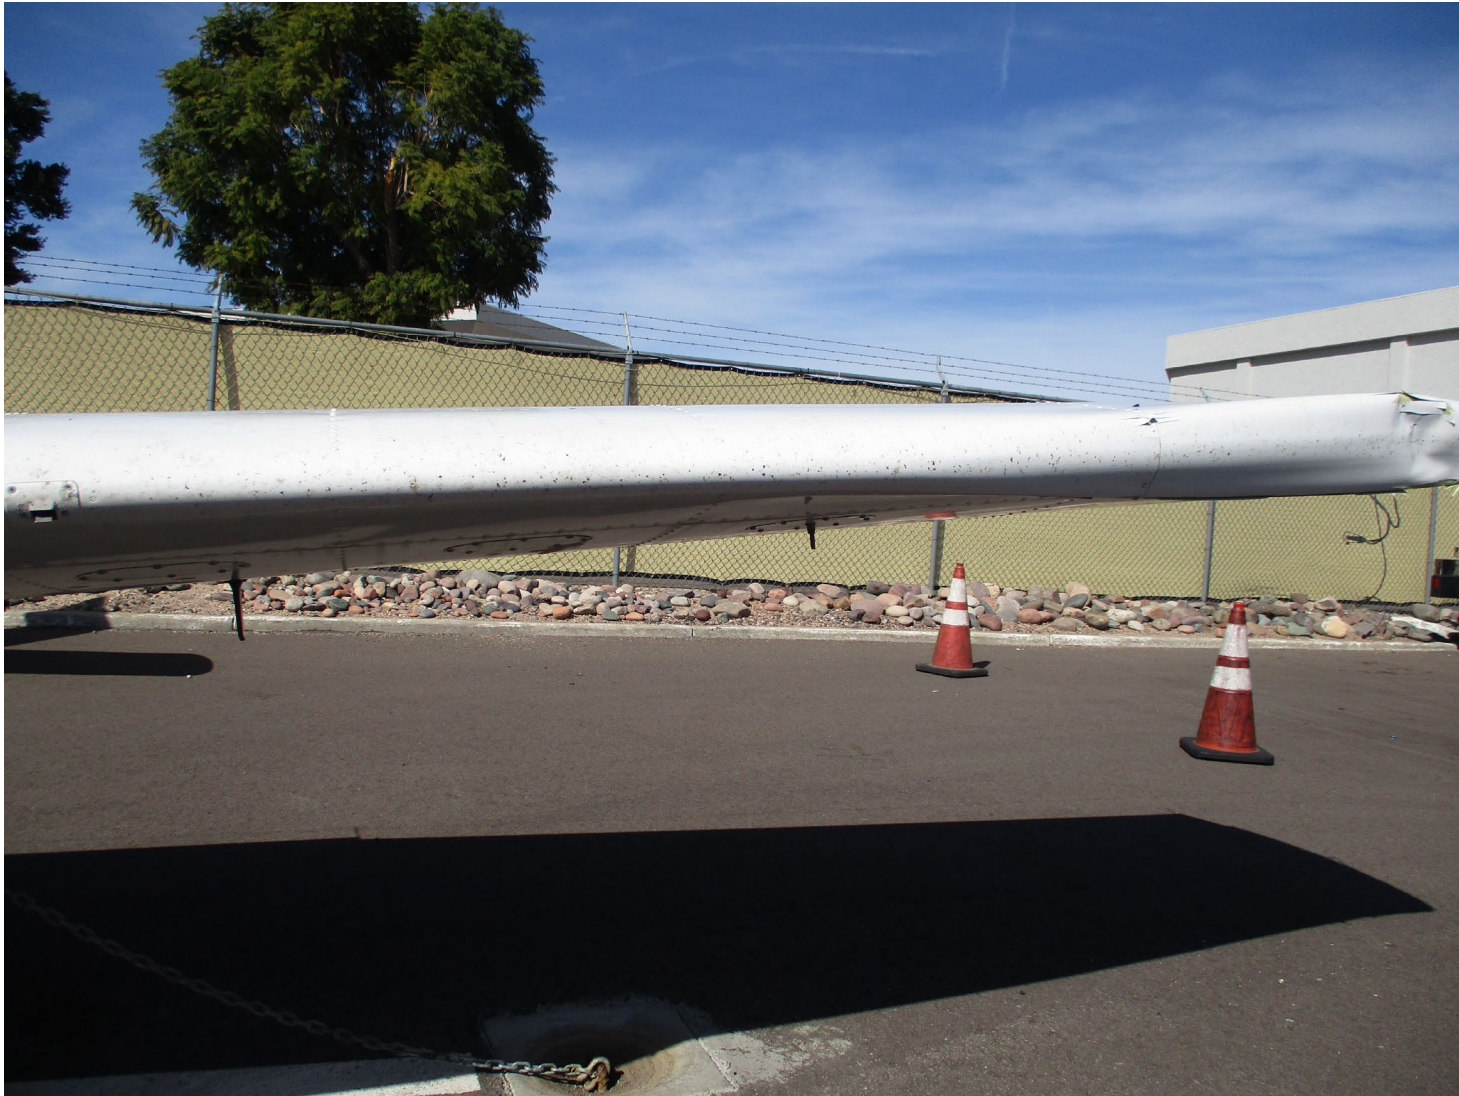
**Photograph 2 - Left-wing leading-edge damage (courtesy of FAA)**

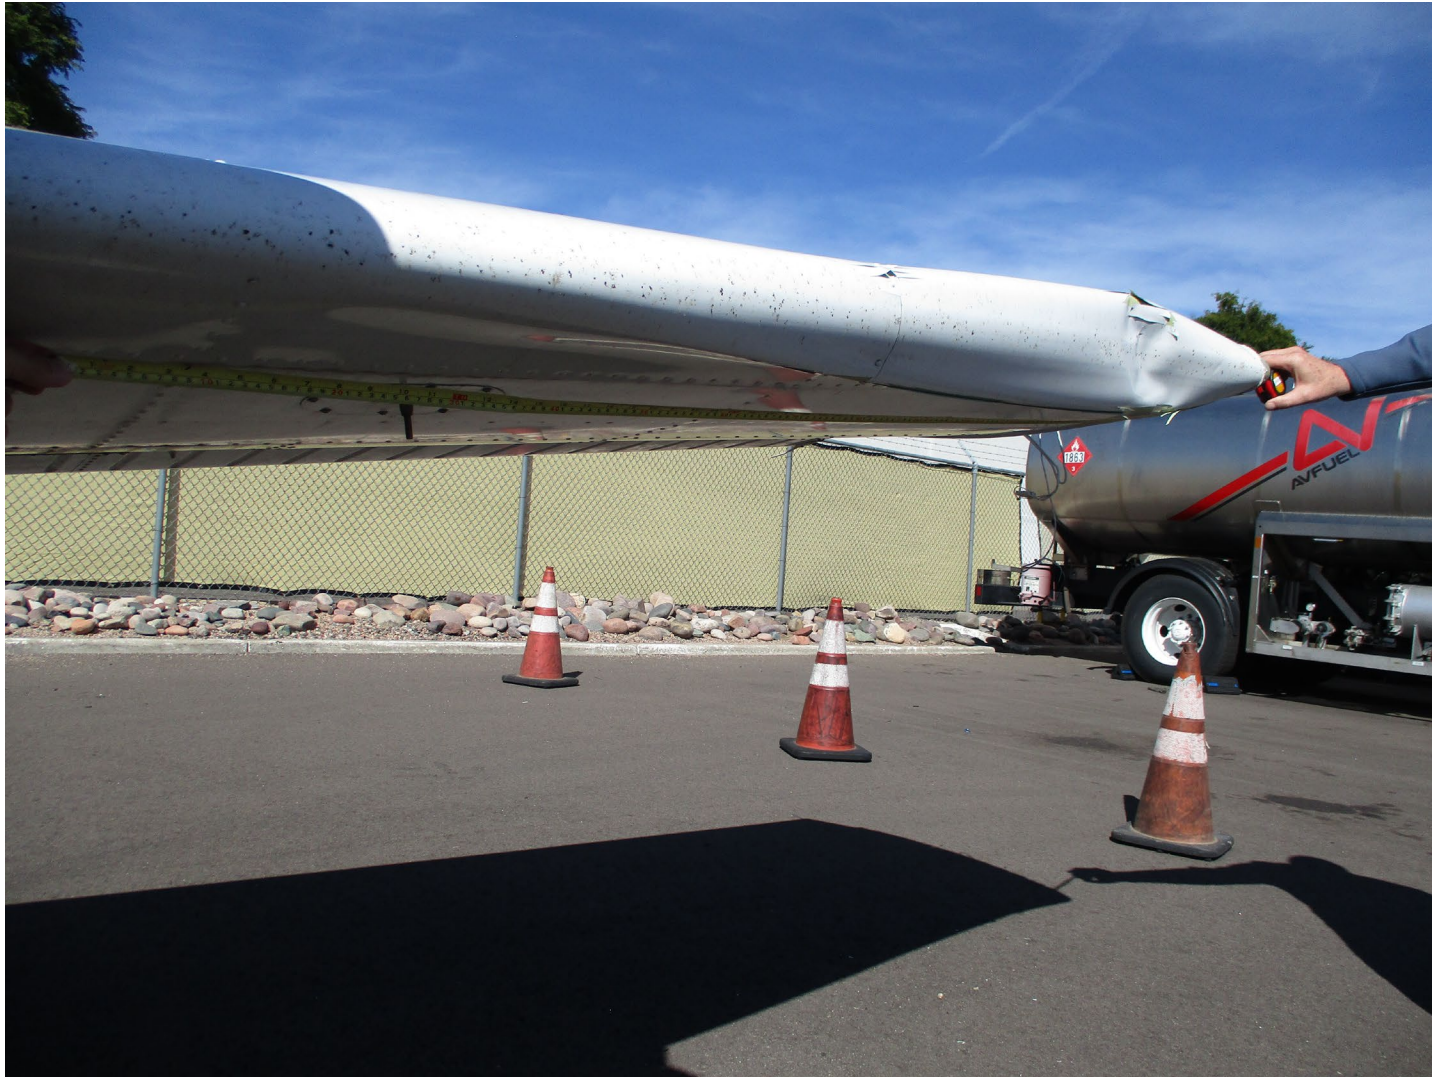
**Photograph 3 - Left-wing leading-edge damage (courtesy of FAA)**

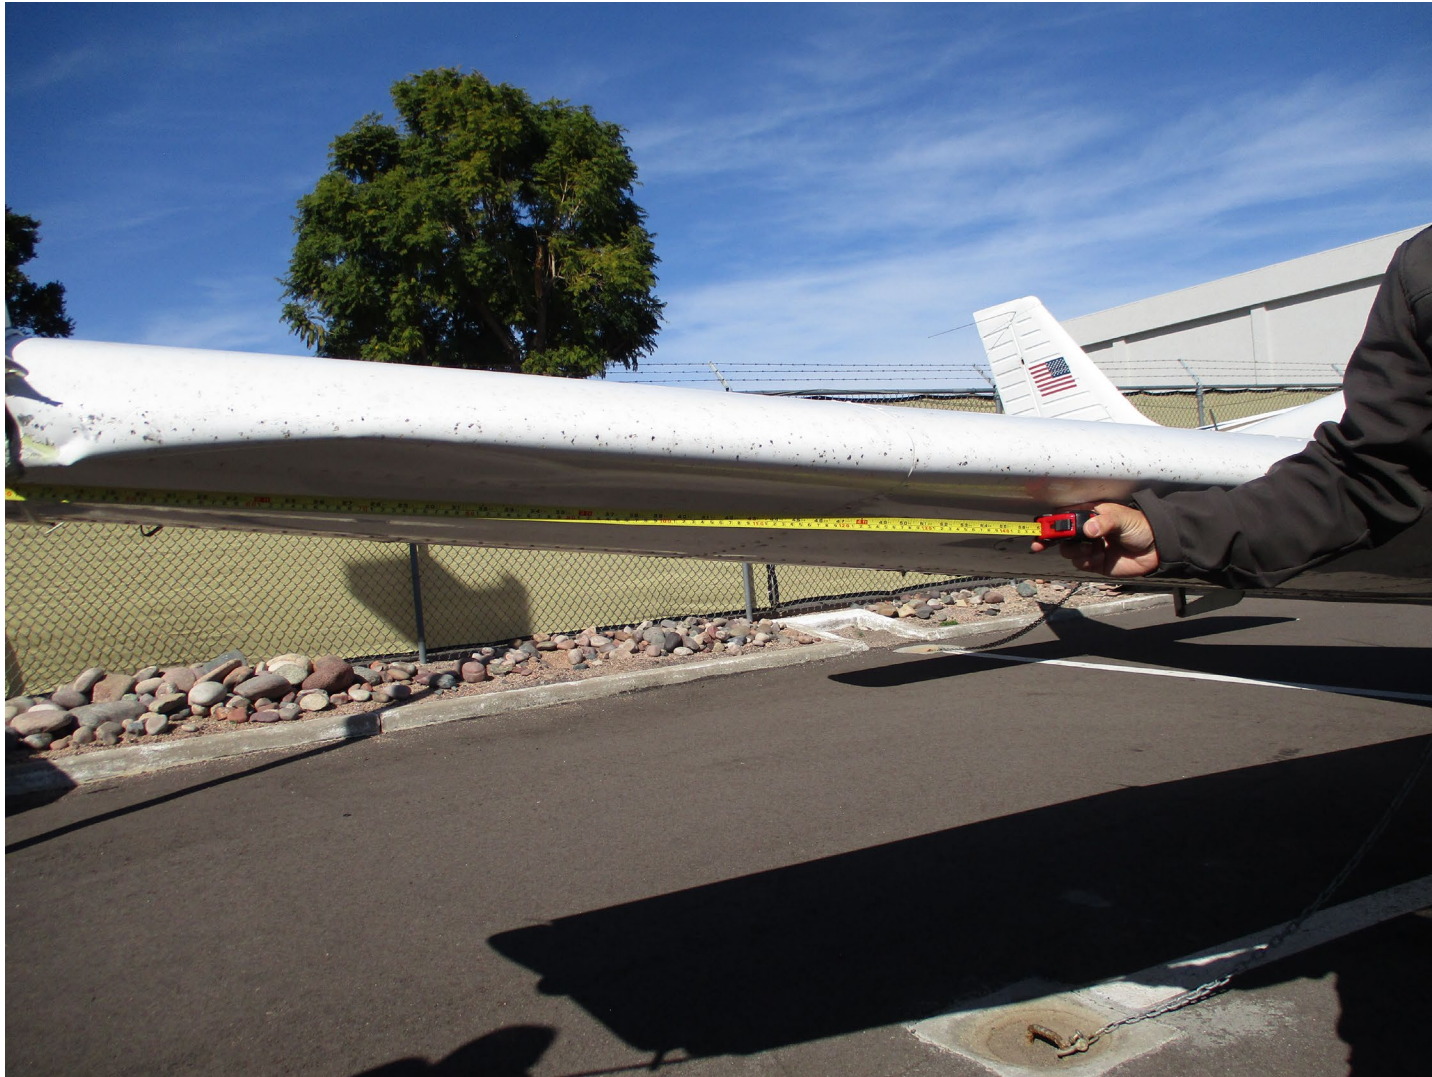
**Photograph 4 - Right-wing leading-edge damage (courtesy of FAA)**

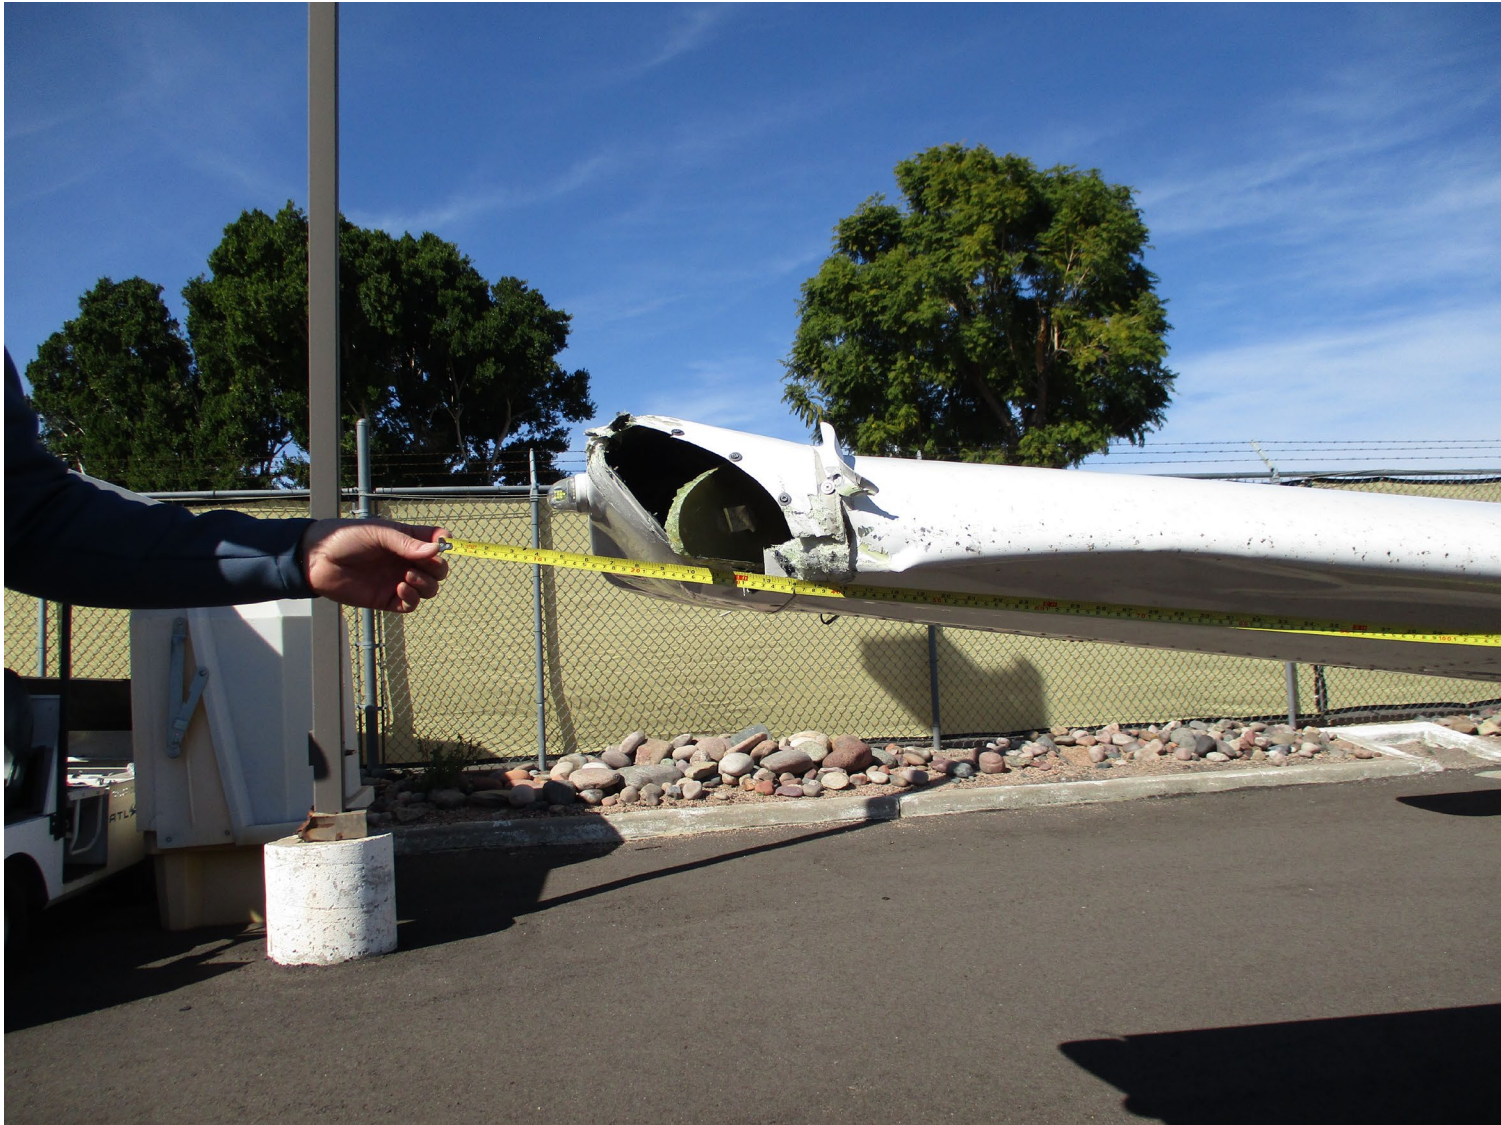
**Photograph 5 - Right-wing leading-edge damage (courtesy of FAA)**
