WPR26LA099

## INVESTIGATION PHOTOGRAPHS

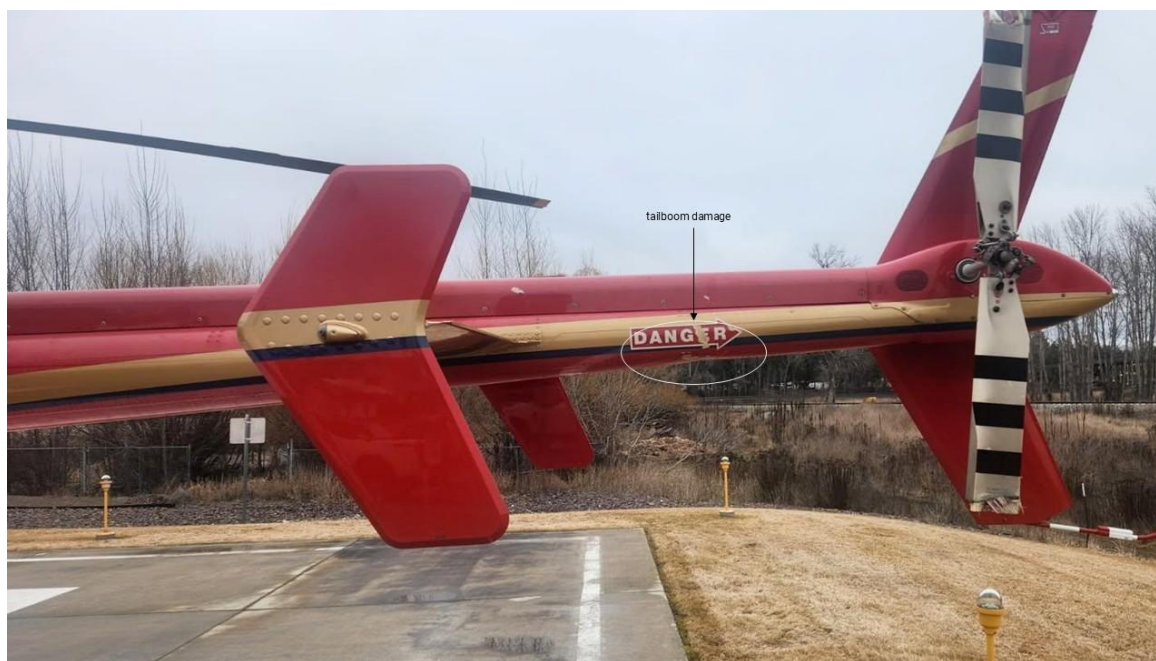
**Photograph 1 - Side view of tailboom damage (Courtesy of Aircraft Operator)**

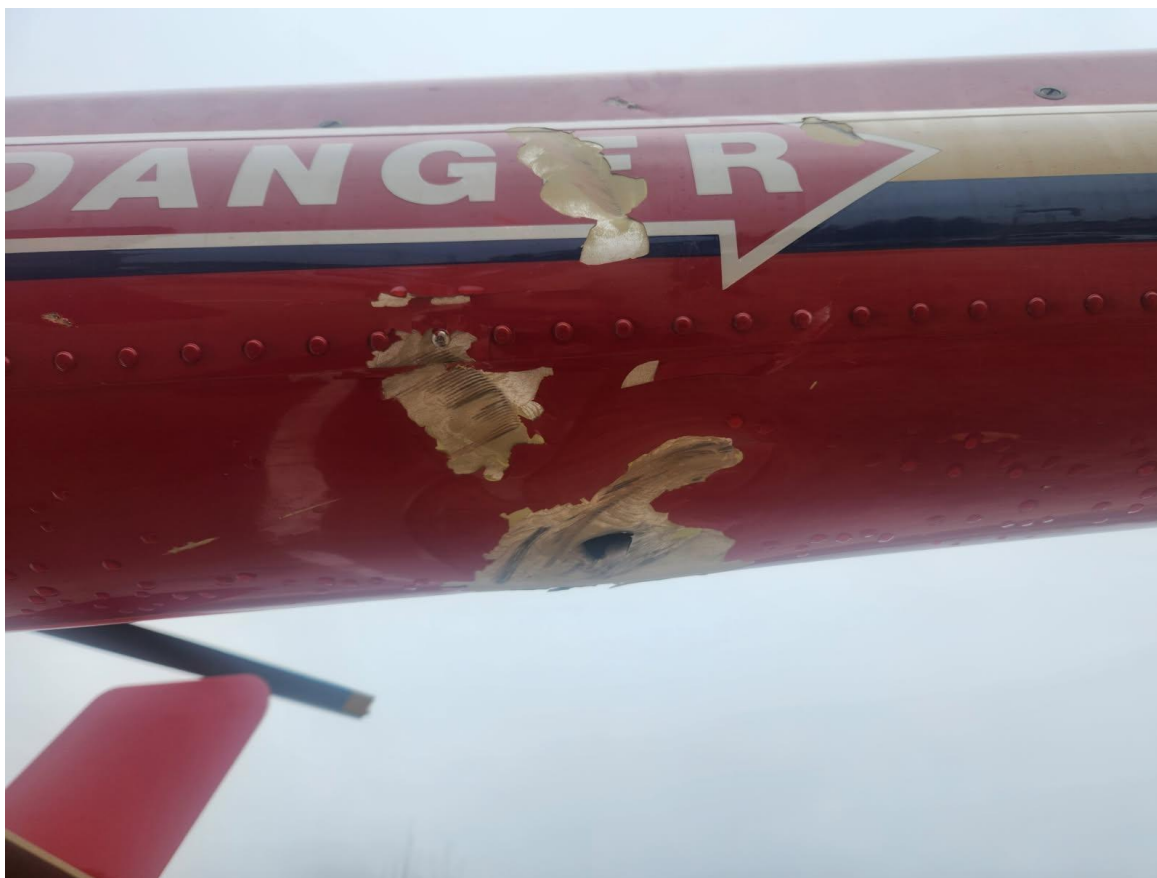
**Photograph 2 - Bottom view of tailboom damage (Courtesy of Aircraft Operator)**

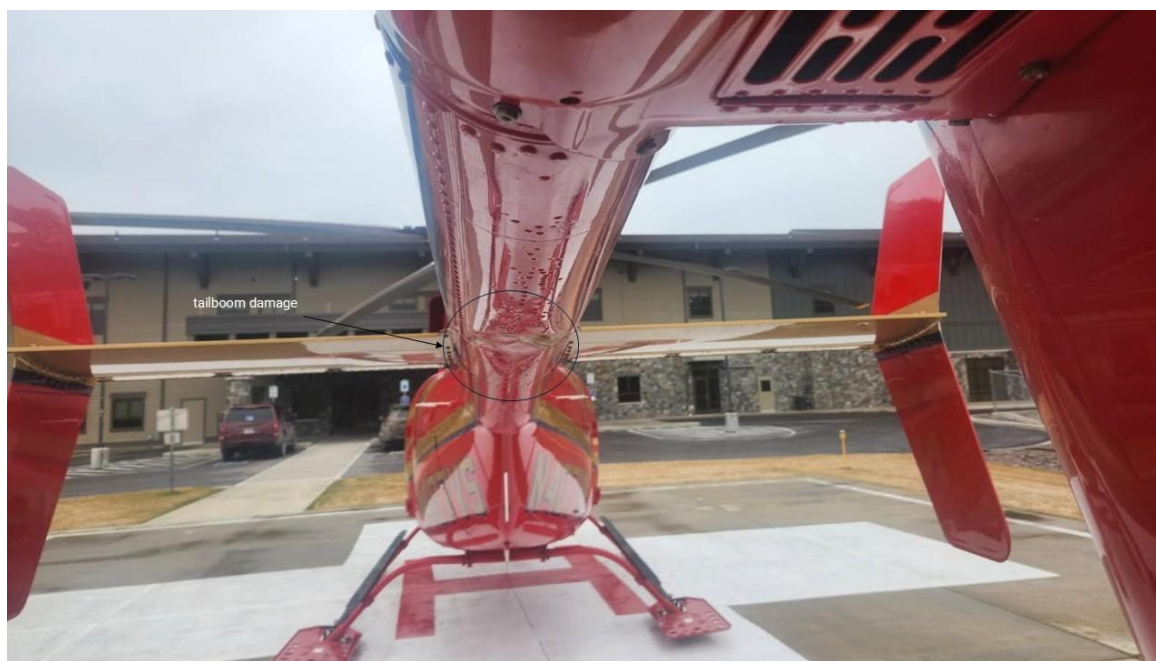
**Photograph 3 - Rear view of tailboom damage (Courtesy of Aircraft Operator)**

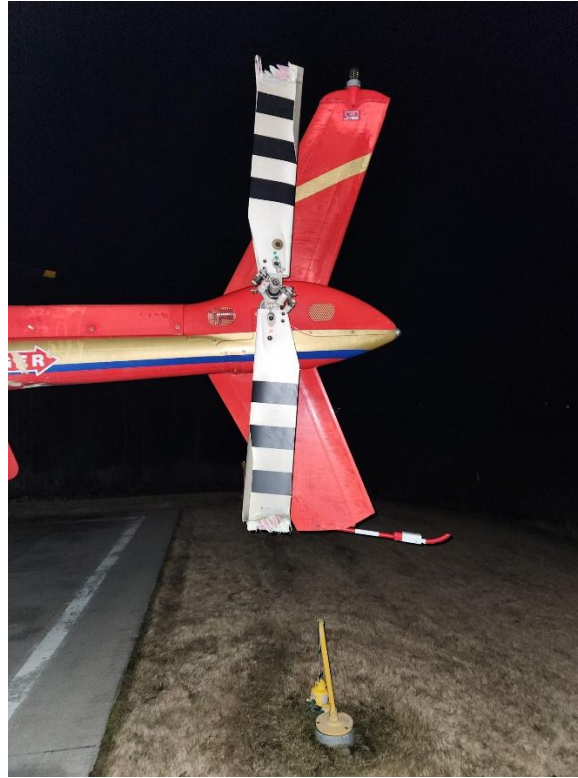
**Photograph 4- View of tailboom, tail rotor, and light post damage (Courtesy of Pilot)**
