WPR26LA104

## INVESTIGATION PHOTOGRAPHS

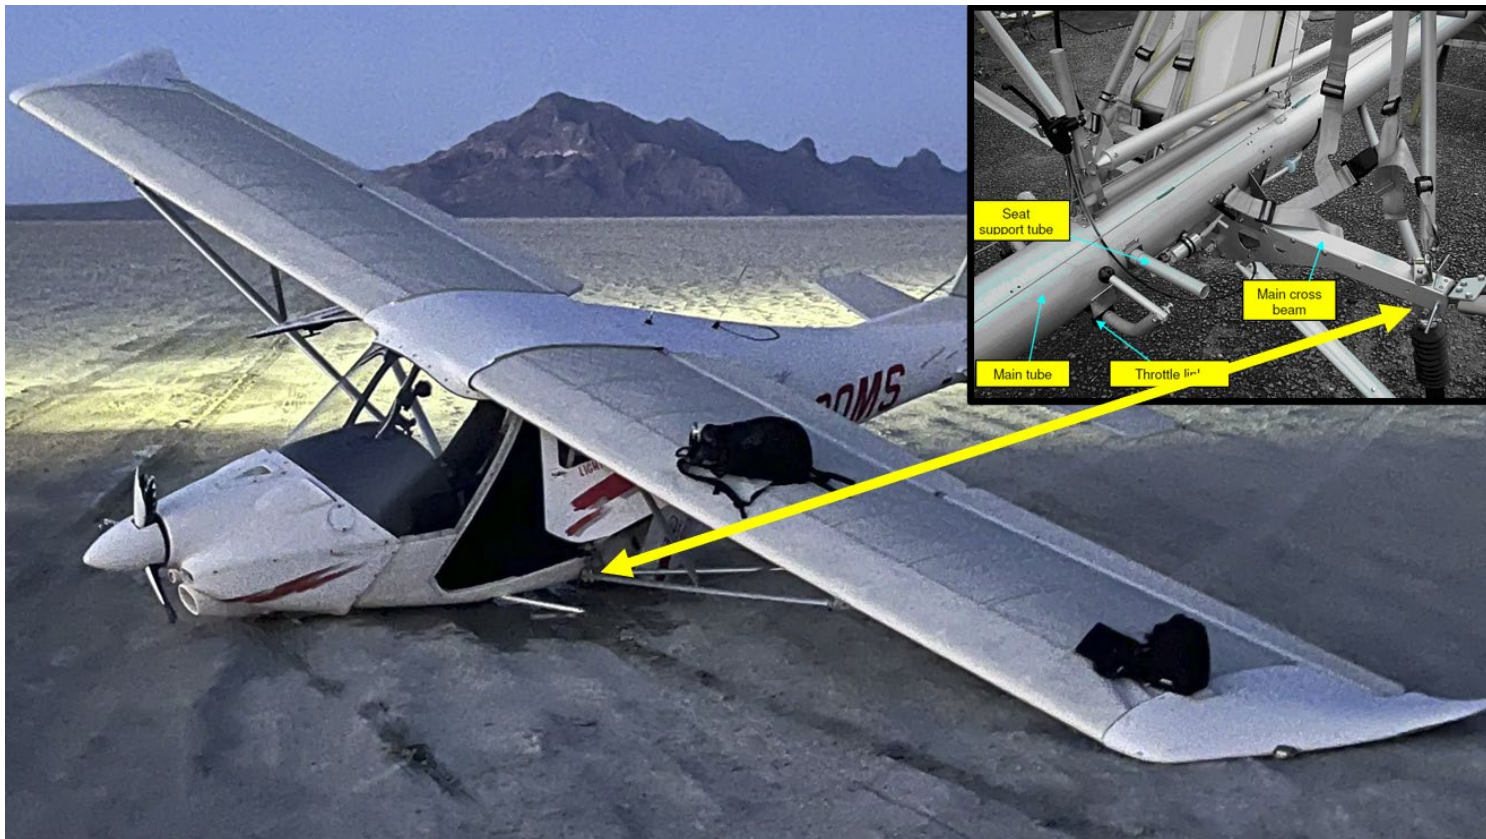
**Photograph 1 - View of damage to the left main landing gear attachment points (Courtesy of LEA)**

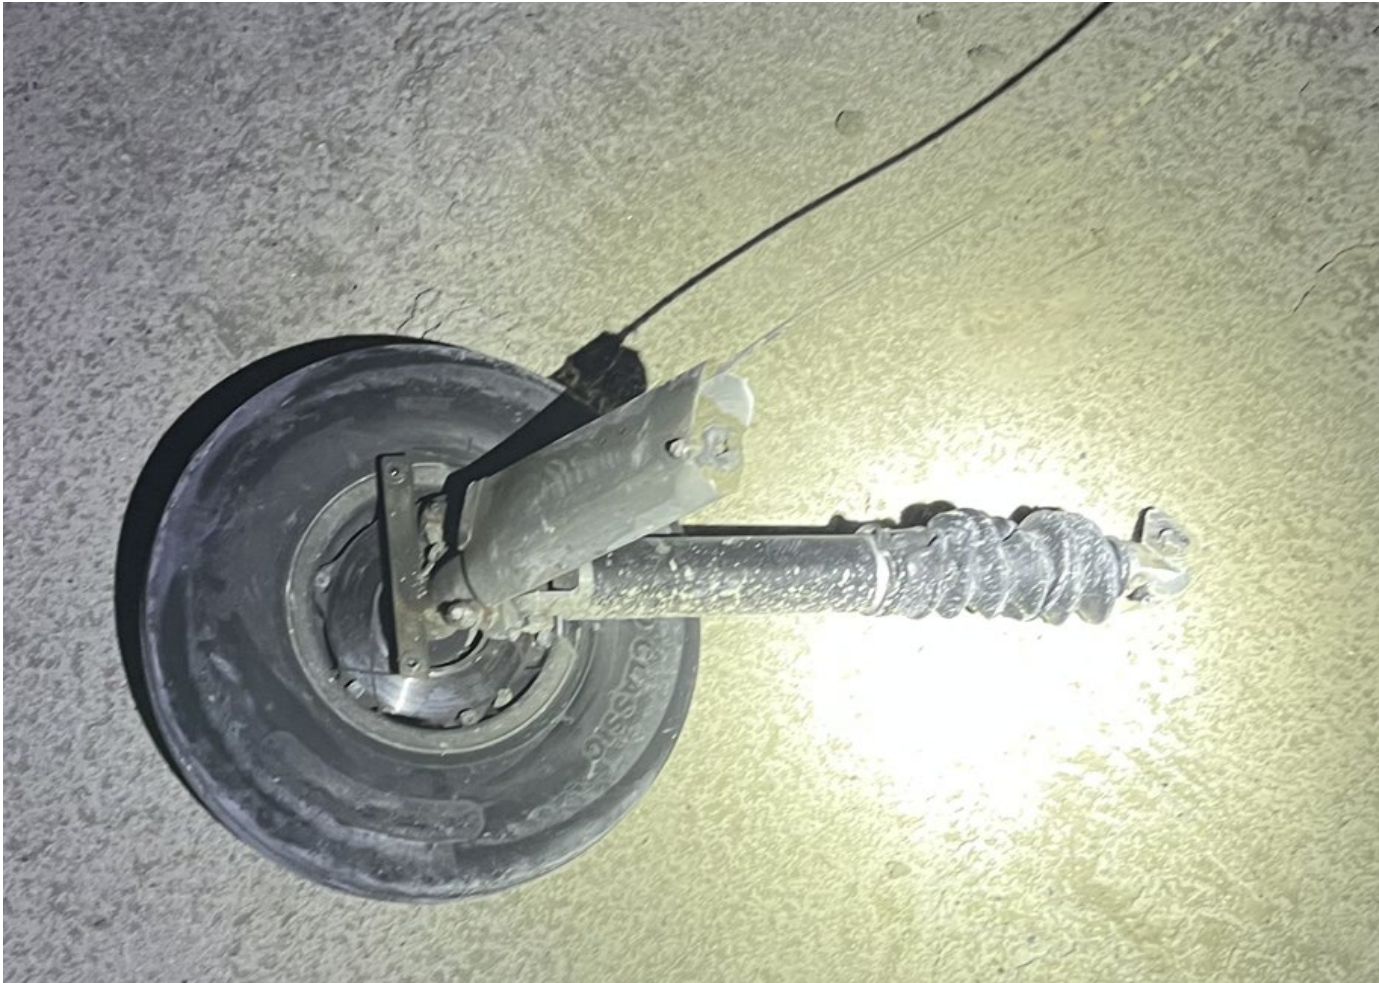
**Photograph 2 - View of the left main landing gear attachment point separation (Courtesy of LEA)**
