WPR26LA113

## INVESTIGATION PHOTOGRAPHS

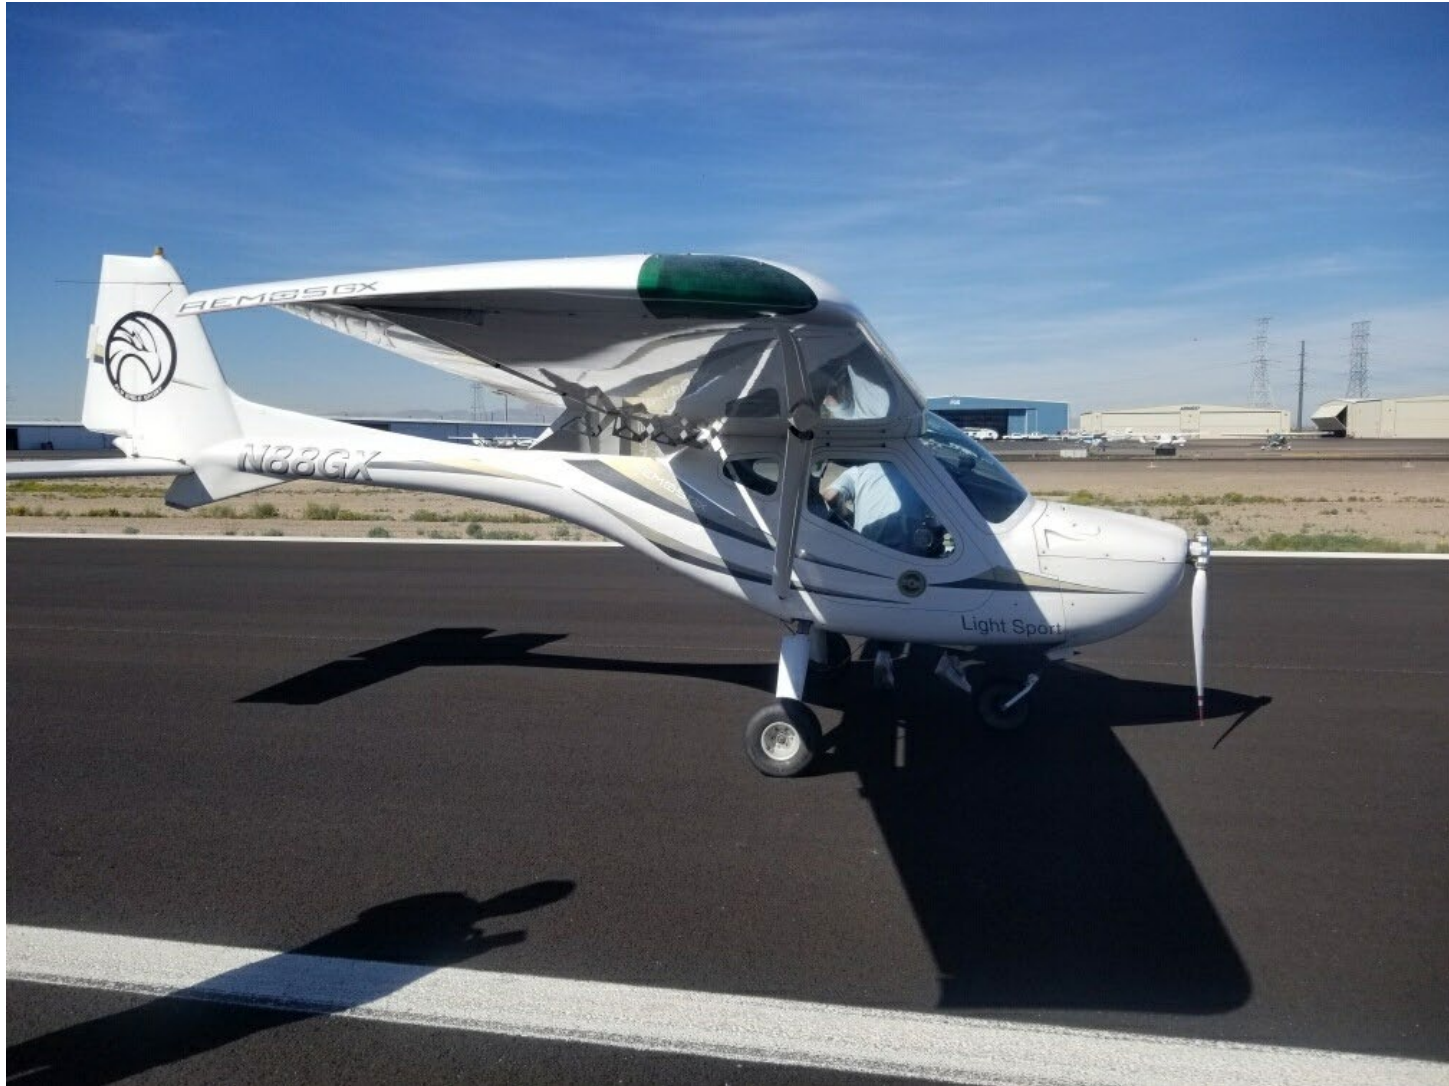
**Photograph 1 - View of airplanes right side on runway (Courtesy of airport operations)**

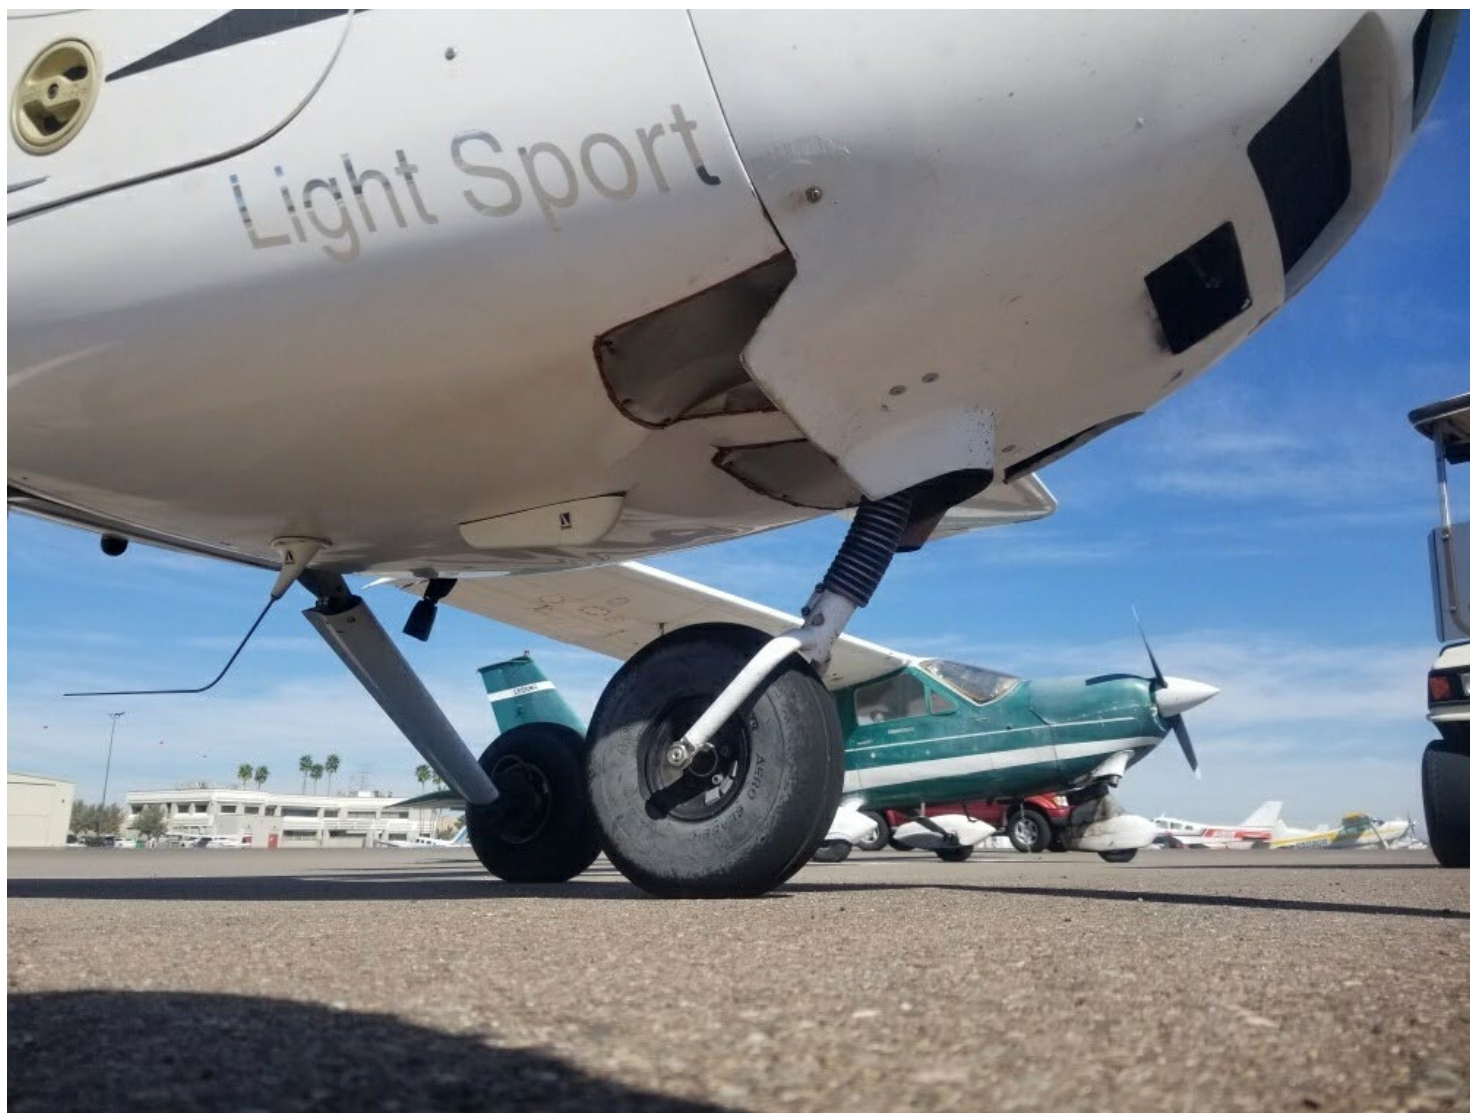
**Photograph 2 - View of nose gear buckled (Courtesy of airport operations)**

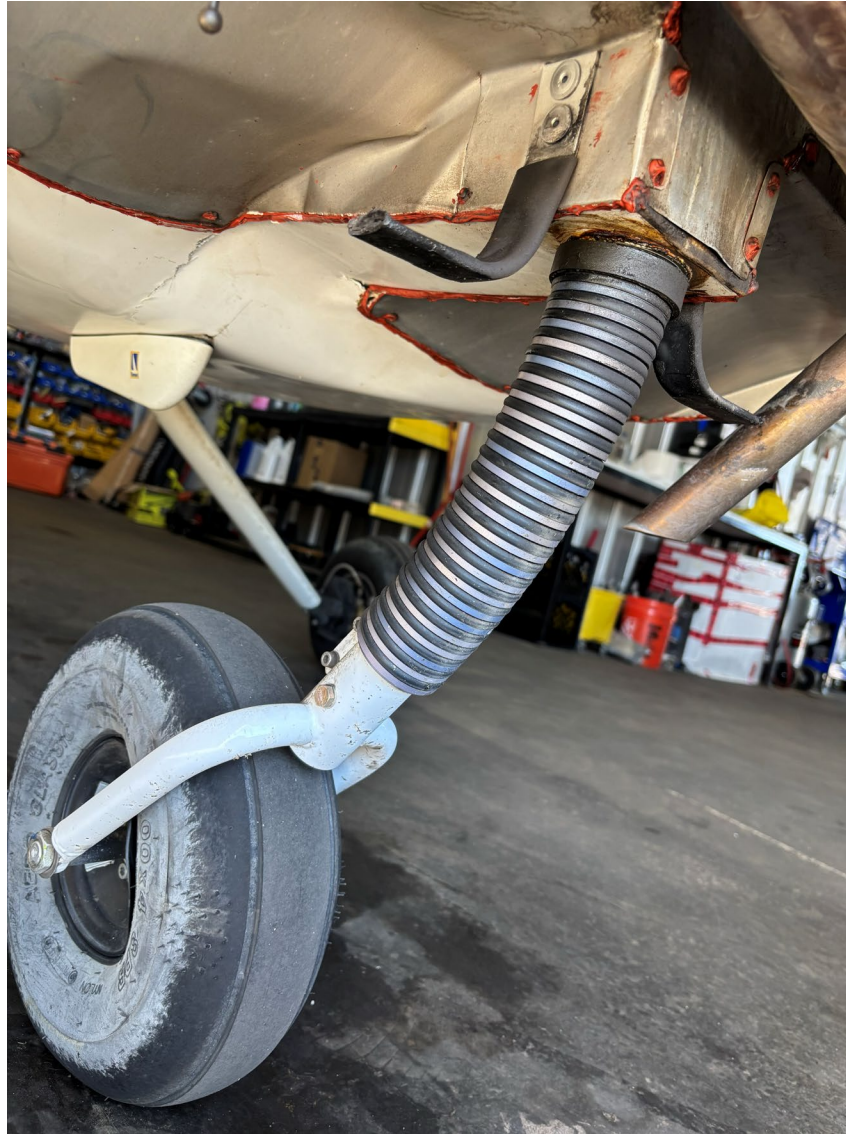
**Photograph 3 - View of firewall and fuselage damage (Courtesy of operator)**

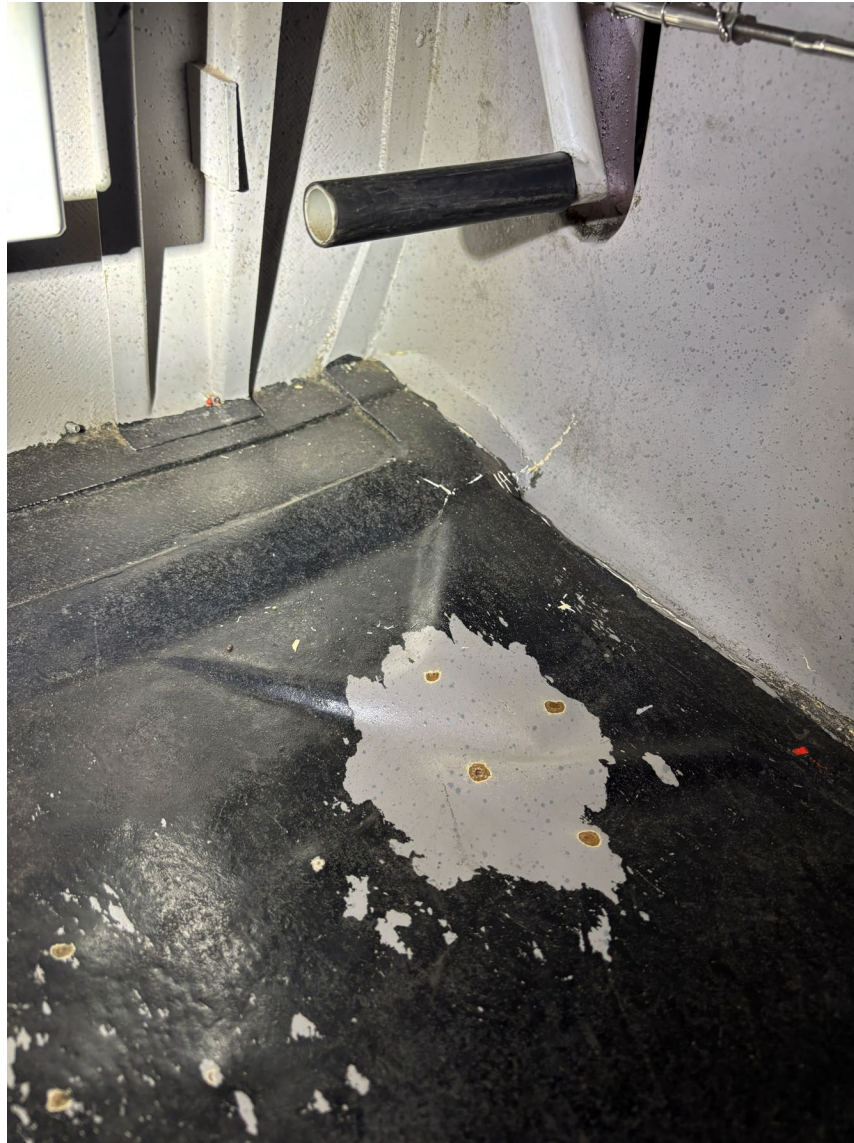
**Photograph 4 - View of damage to the right-side floorboard (Courtesy of operator)**

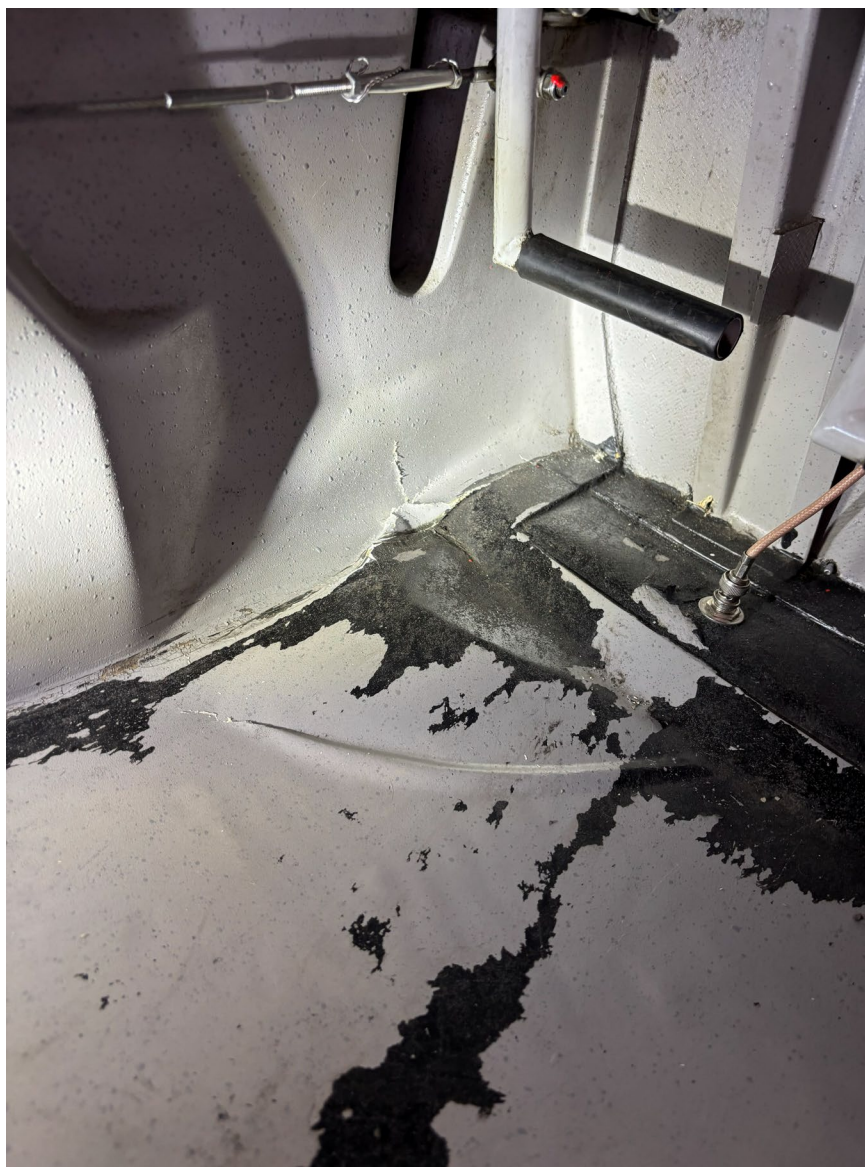
**Photograph 5 - View of damage to left side floorboard (Courtesy of operator)**
