WPR26LA122

## INVESTIGATION PHOTOGRAPHS

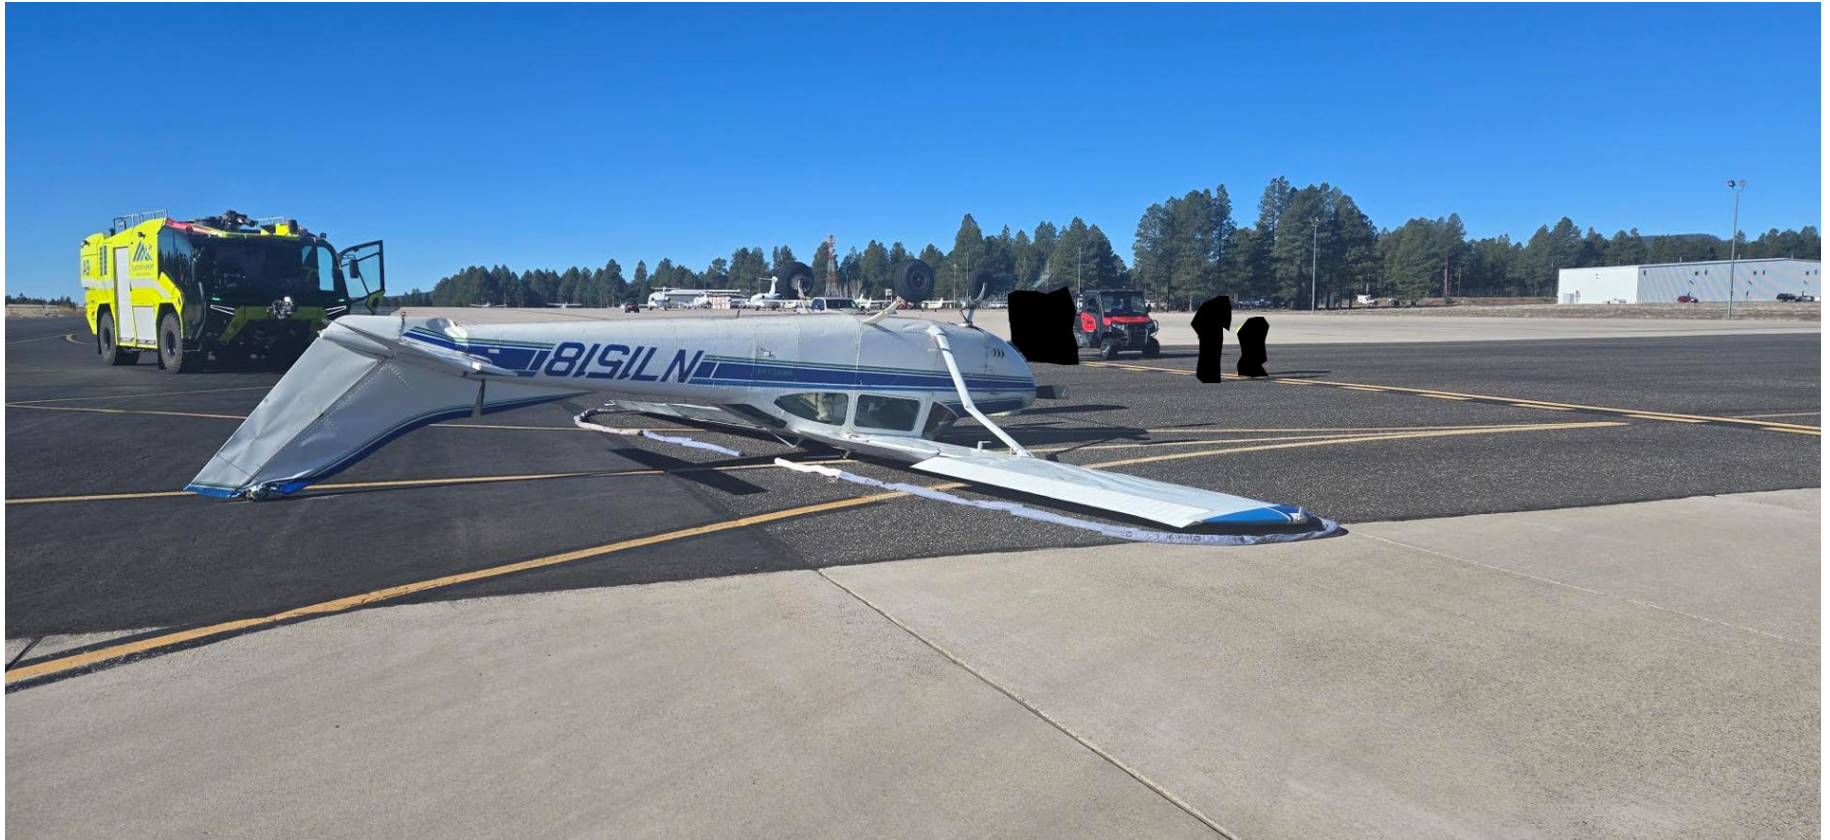
**Photograph 1 - The Cessna 182, with substantial damage visible to the empennage and right wing, inverted near taxiway A6. (Courtesy of airport operations).**

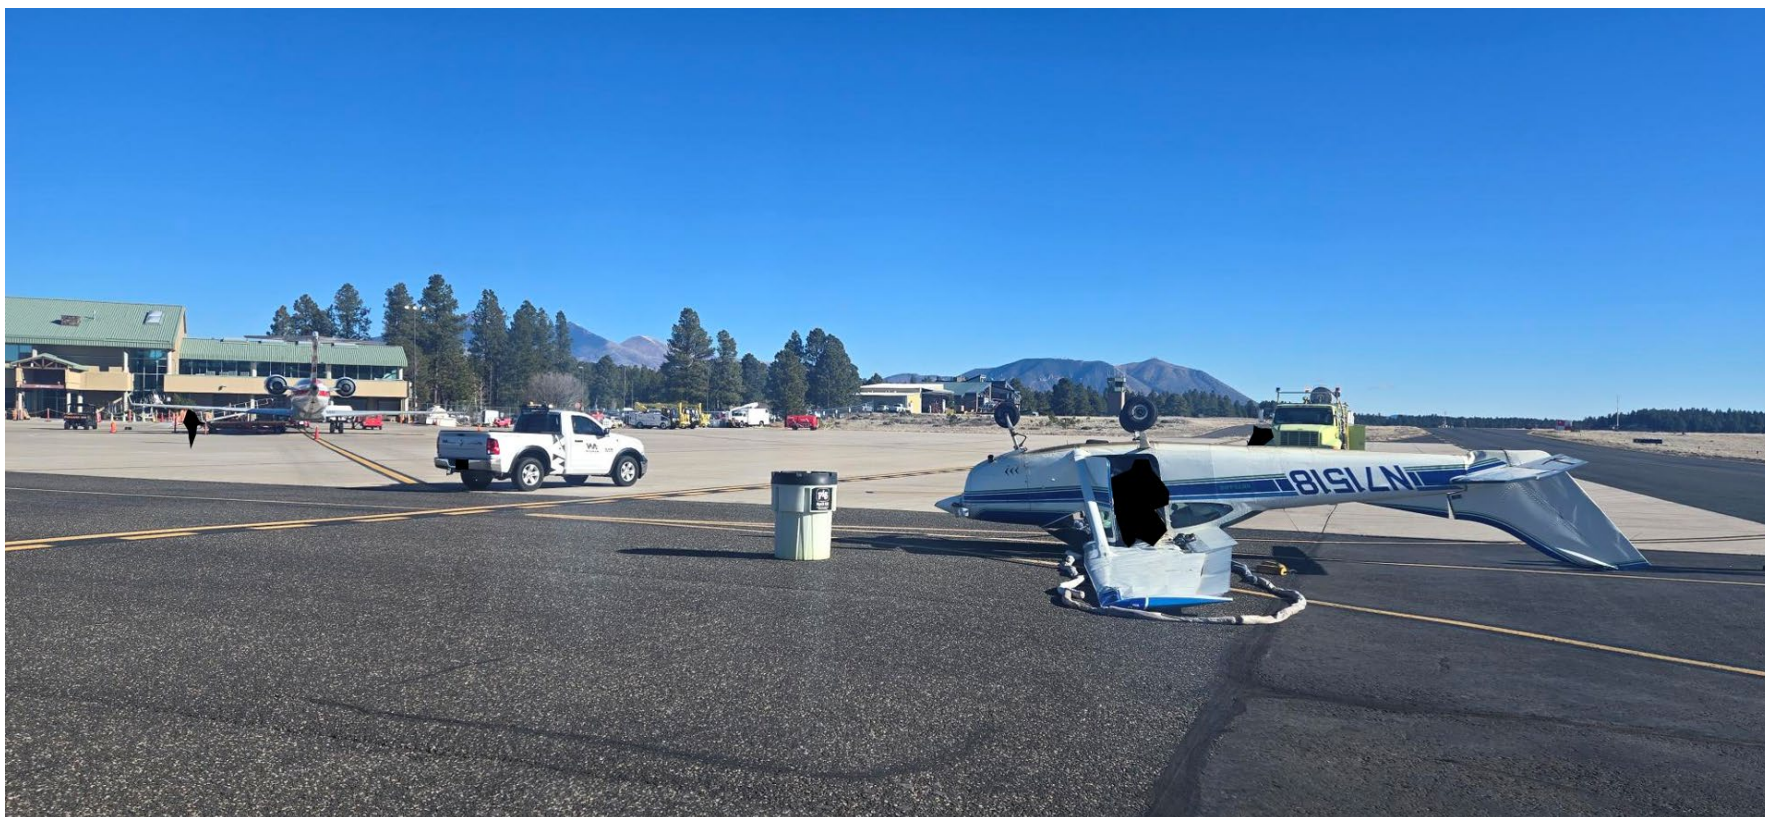
**Photograph 2 - The Cessna 182 with the SkyWest CRJ700 visible on the left. (Courtesy of airport operations).**

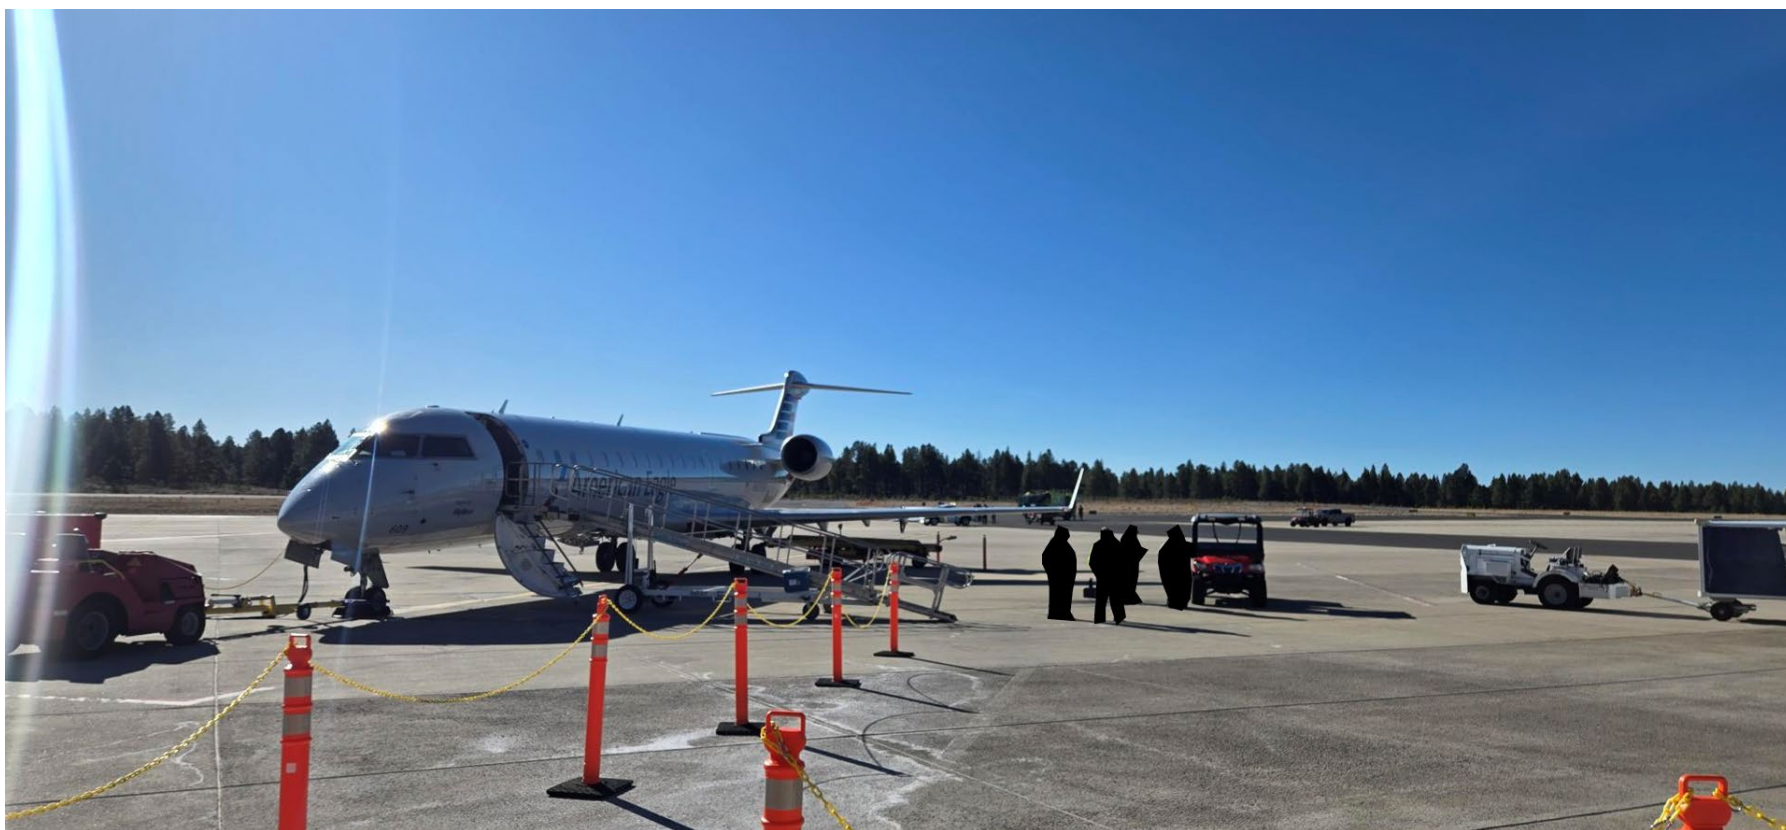
**Photograph 3 - The CRJ700 on the commercial ramp. (Courtesy of airport operations).**
