WPR26LA143

## INVESTIGATION PHOTOGRAPHS

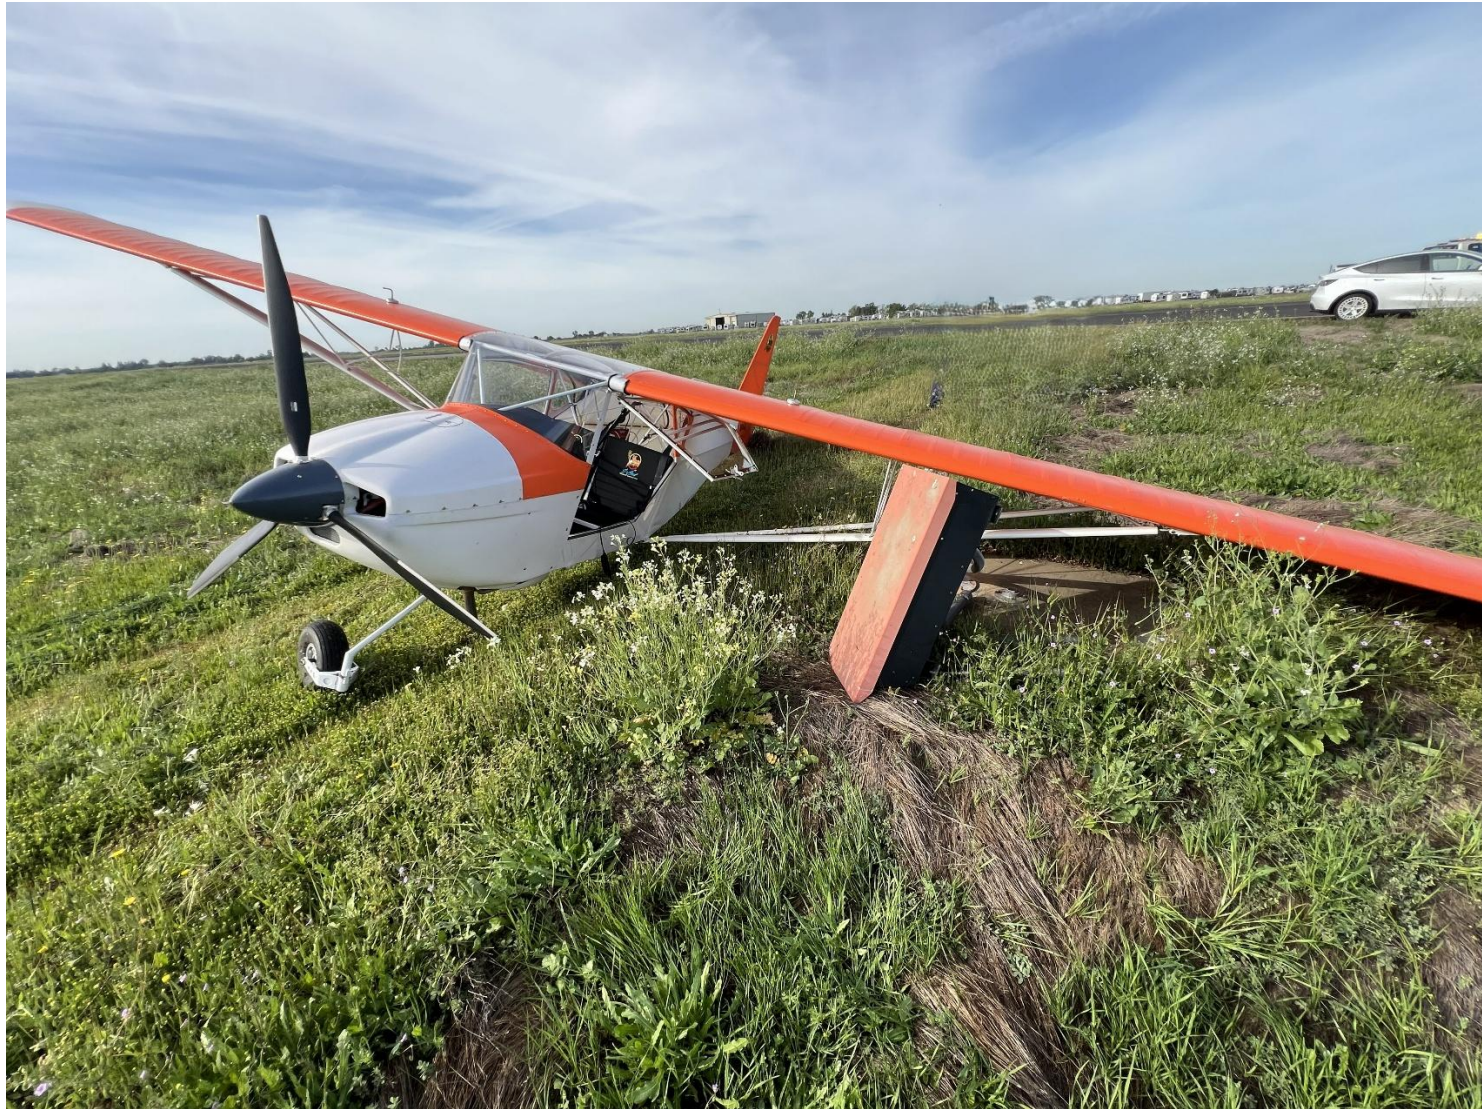
**Photograph 1 - View of airplane at accident scene (Courtesy of airfield operations)**

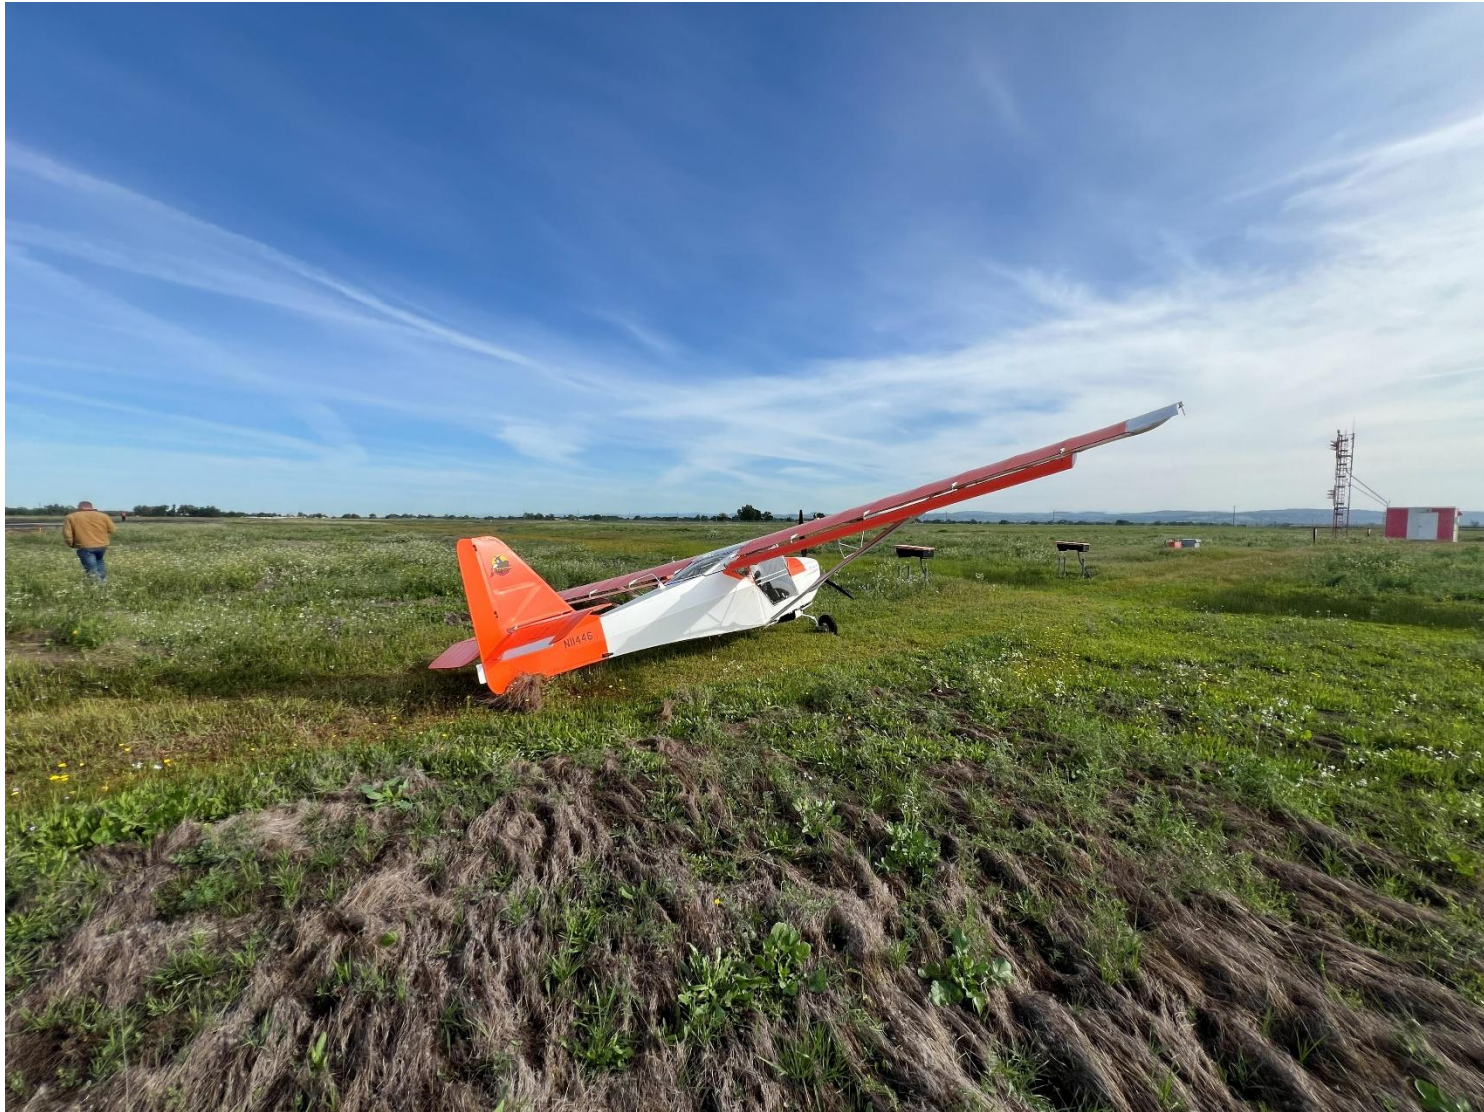
**Photograph 2 - Right side view of airplane showing missing landing gear (Courtesy of airfield operations)**

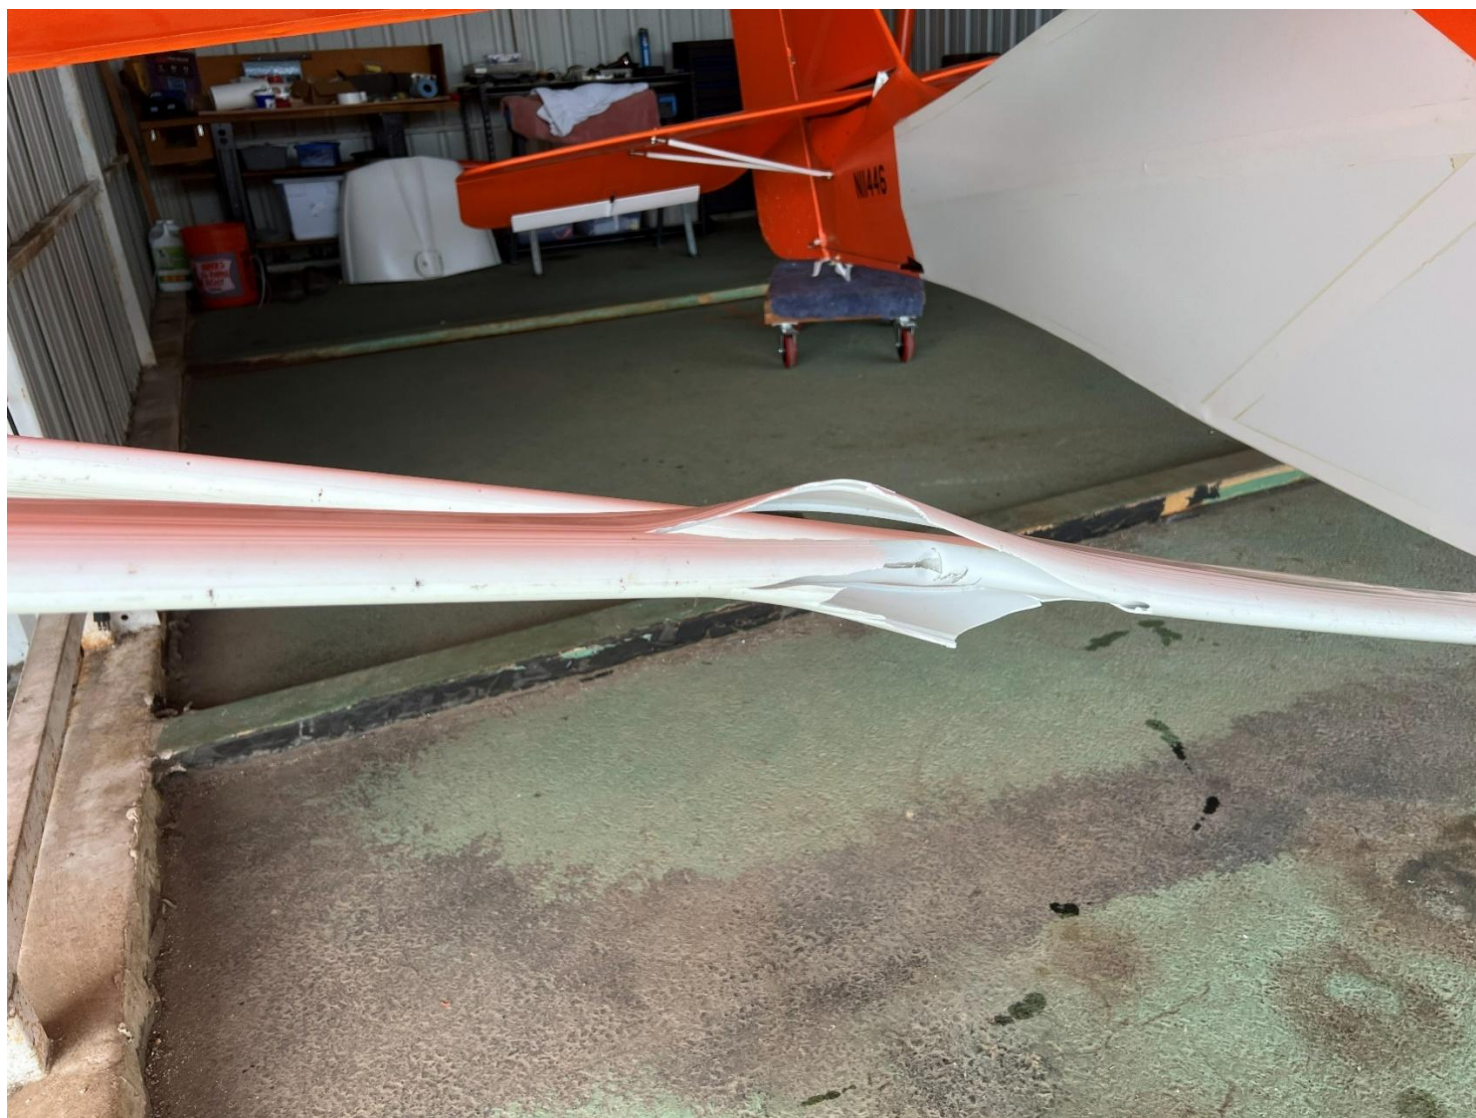
**Photograph 3 - View of damage to right strut (Courtesy of airfield operations)**

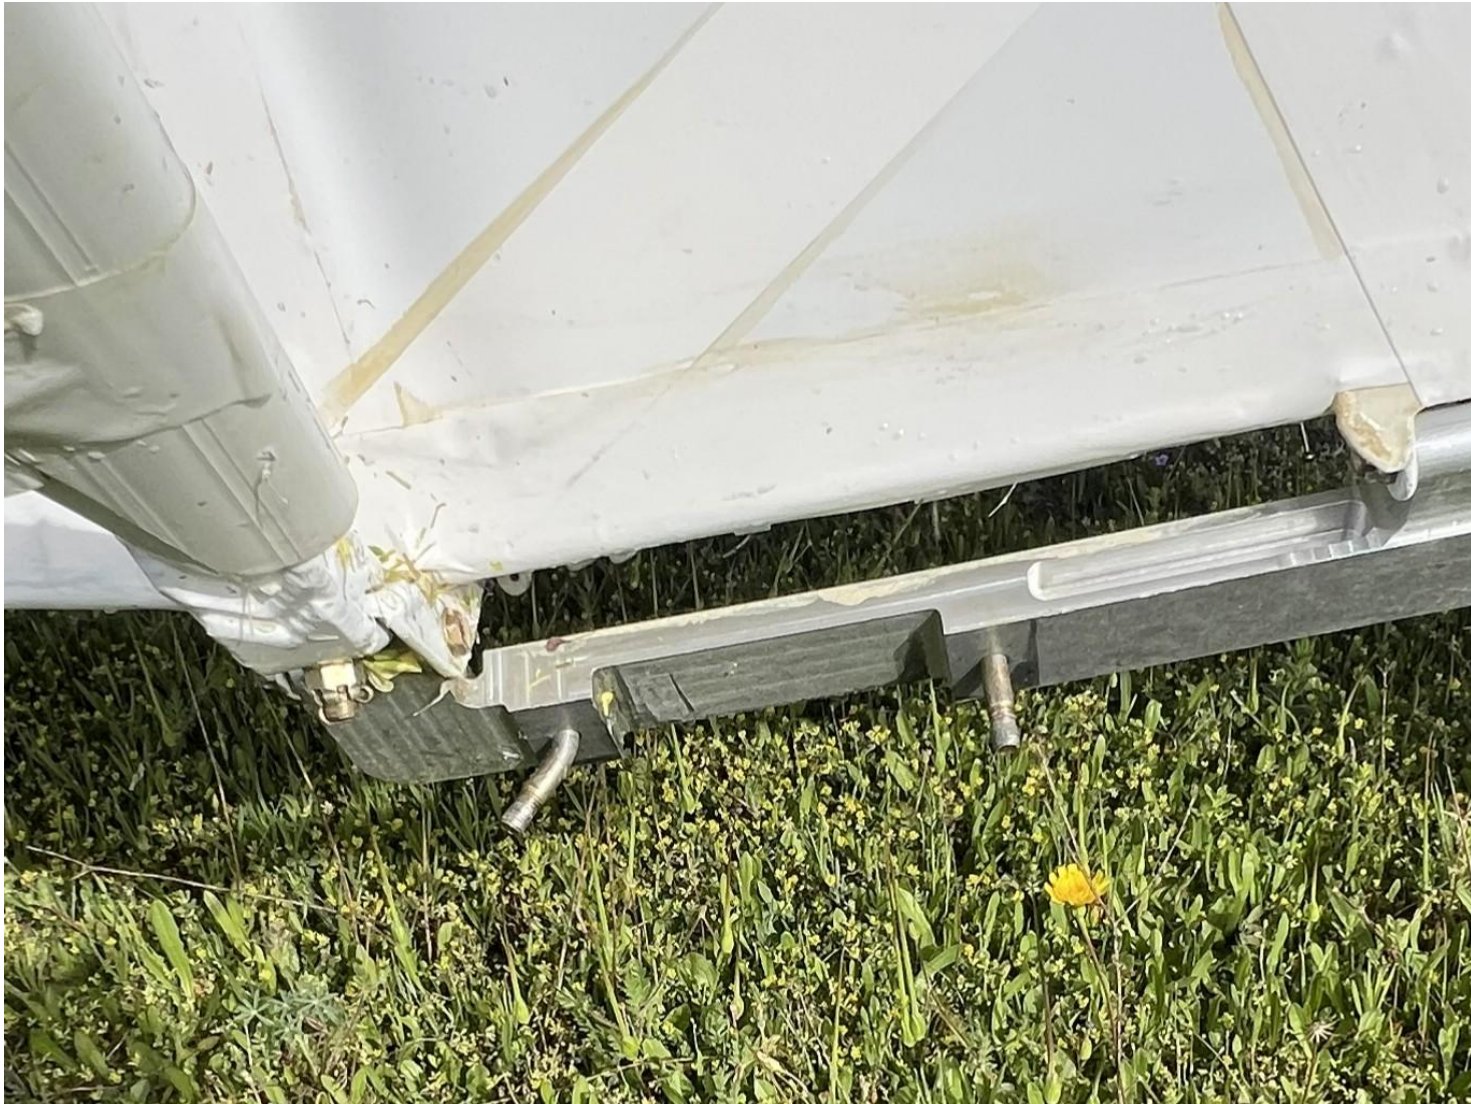
**Photograph 4 - View of damage to landing gear attachment point (Courtesy of airfield operations)**
