WPR26LA156

## INVESTIGATION PHOTOGRAPHS

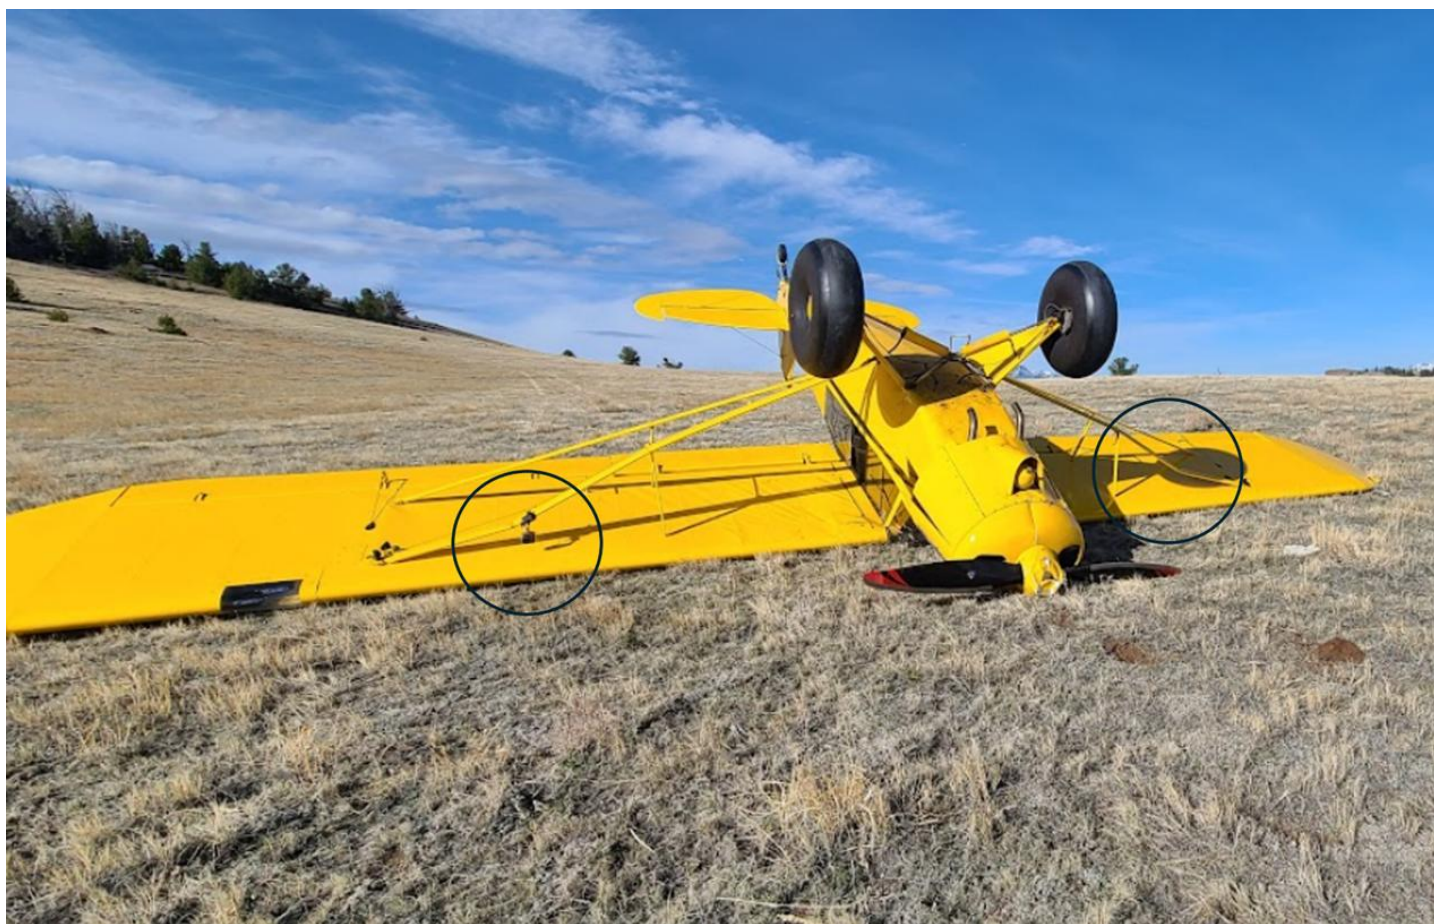
**Photograph 1 - View of bent struts. (Courtesy of Pilot)**

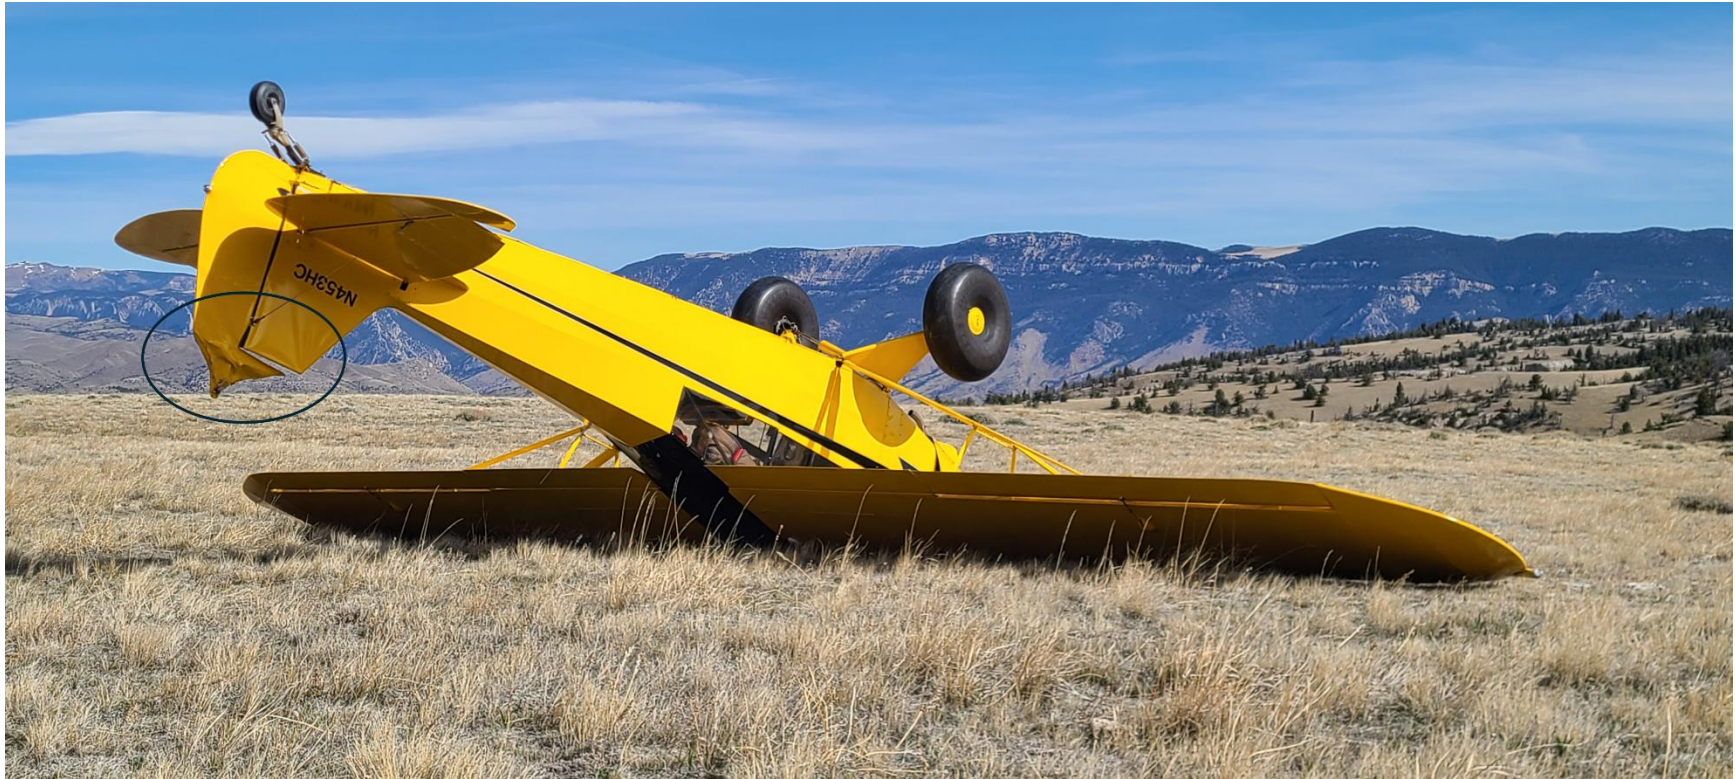
**Photograph 2 - View of rudder damage. (Courtesy of Pilot)**
