WPR26LA192

## INVESTIGATION PHOTOGRAPHS

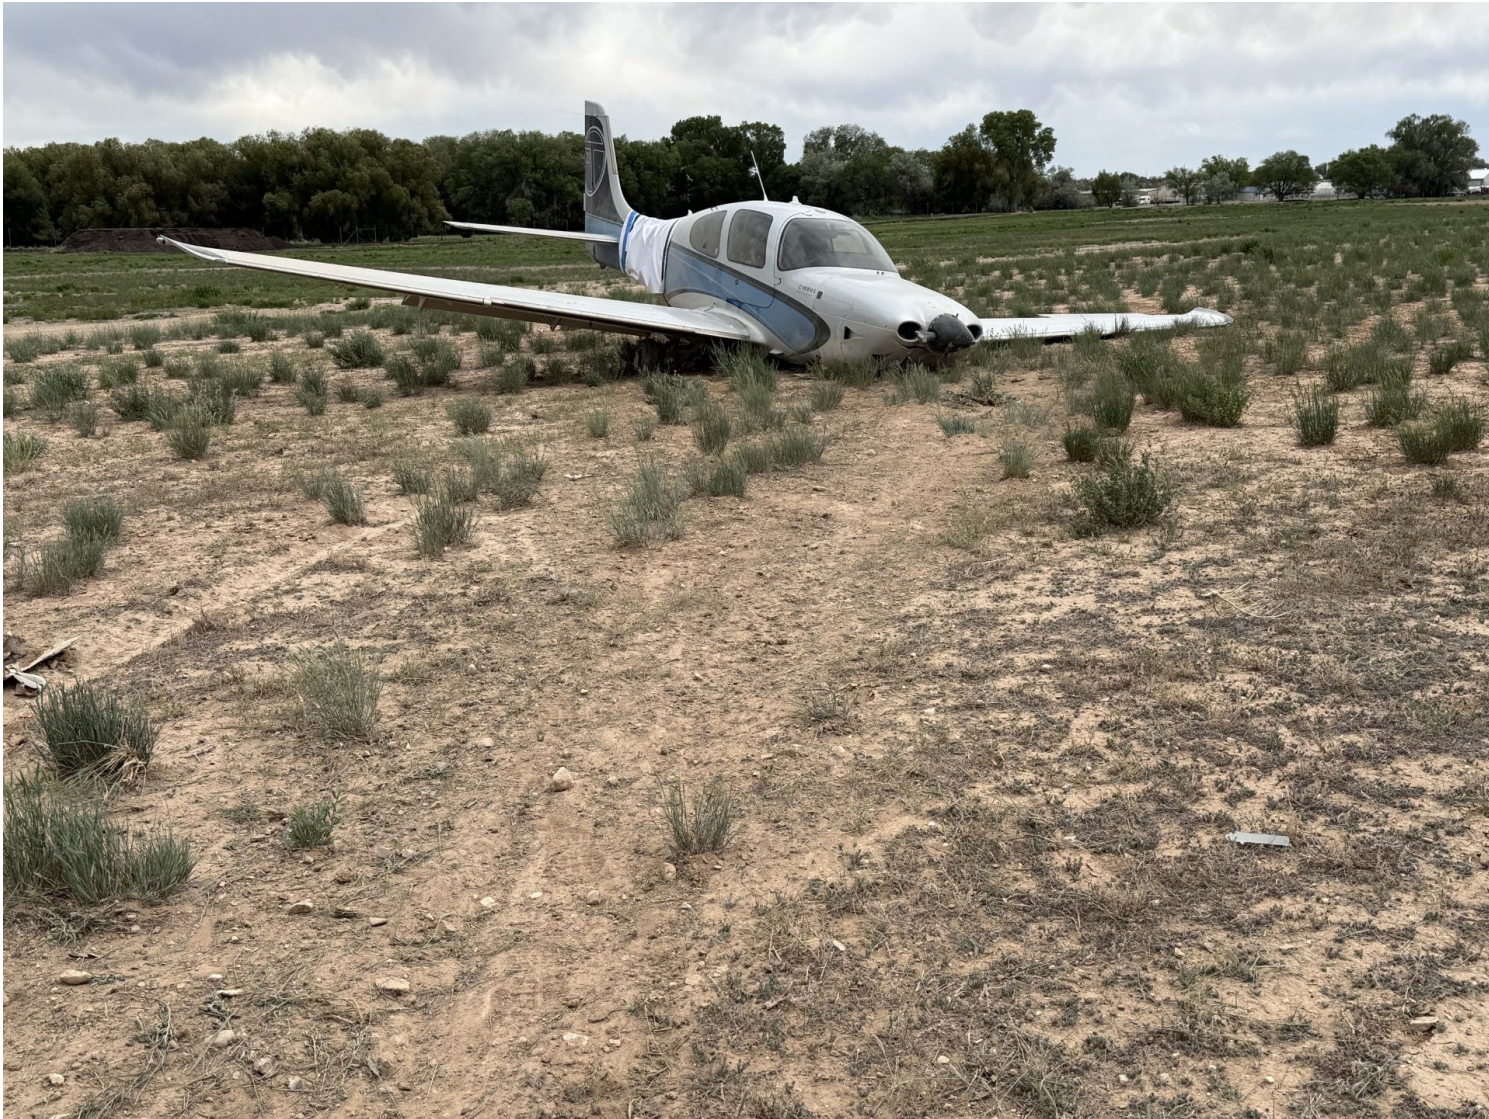
**Photograph 1 - Forward view of airplane (Courtesy of airport ops)**

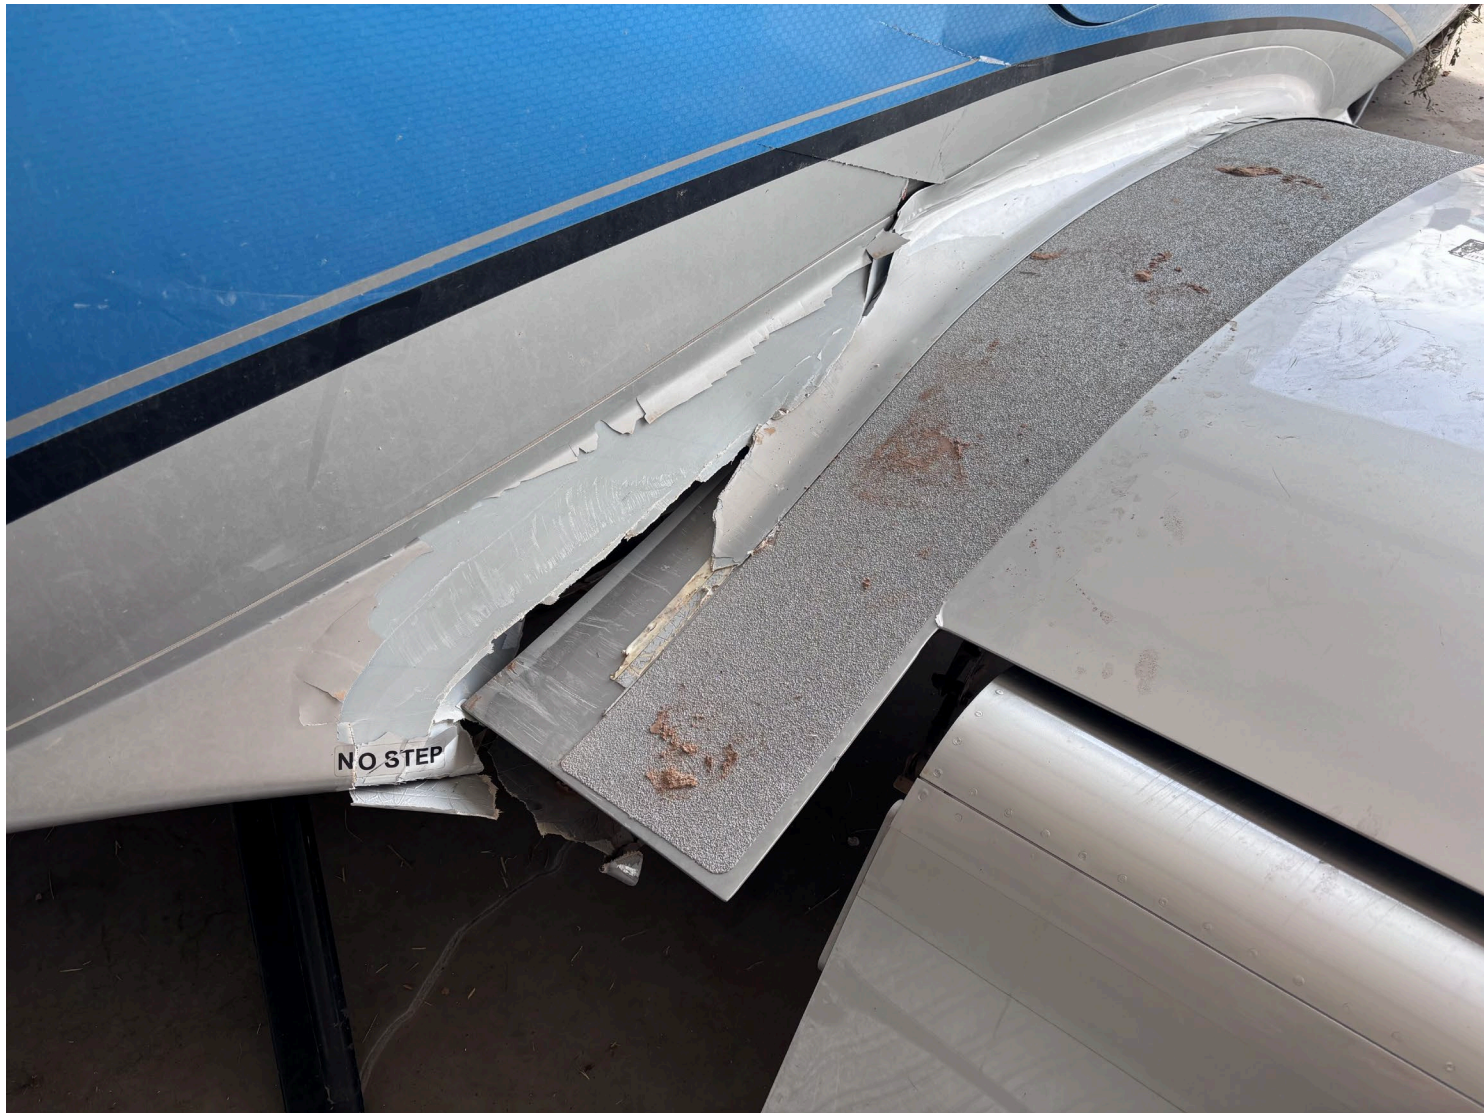
**Photograph 2 - Top view of broken wing root (Courtesy of insurance company)**

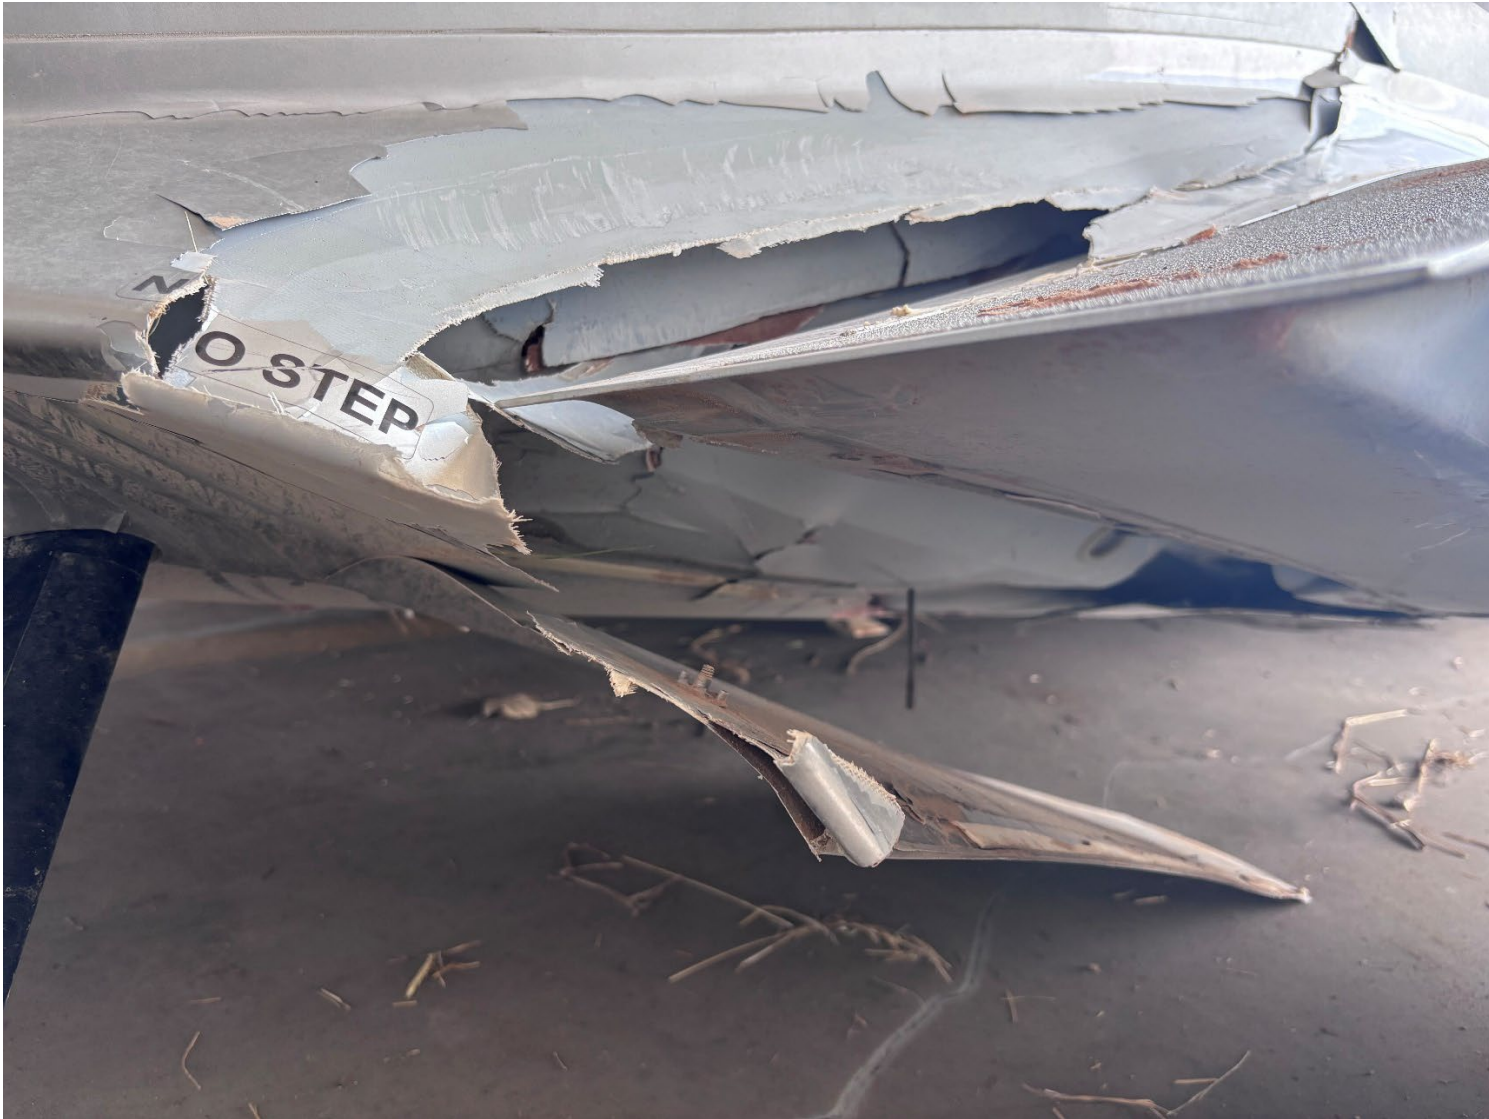
**Photograph 3 - Underside view of broken wing root (Courtesy of insurance company)**
